IKAR/CISA 2004
Zakopane - Poland
Kommission für Luftrettung
Commission pour le Sauvetage Aérien
Commission for Air Rescue

ACCIDENTS/INCIDENTS FROM MEMBER COUNTRIES:

2004 usa helicopter rescue accidents & incidents

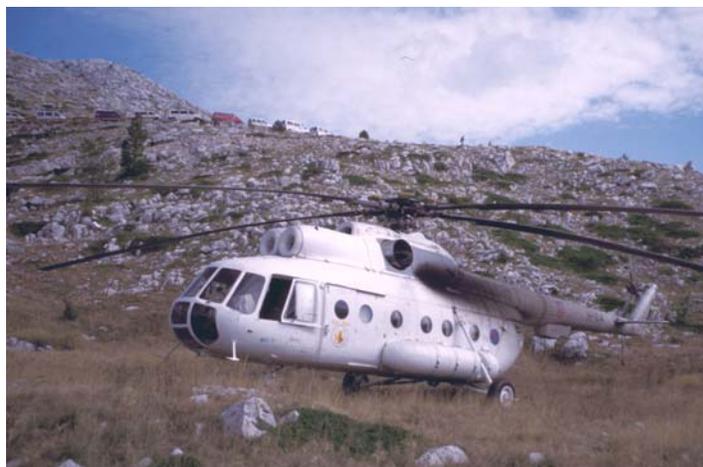
MI8, crash

During a night flight for a medevac operation, the helicopter is returning to base after dropping off the patient at a hospital. During taxi on the apron, the aircraft begins to bounce from left to right. The pilot pulls collective without applying pedal. This aircraft is reportedly unforgiving in this situation. The helicopter lifts about 6 meters off the ground, begins to spin and then crashes. The helicopter is carrying two tons of fuel. Both pilots and one passenger are badly injured.

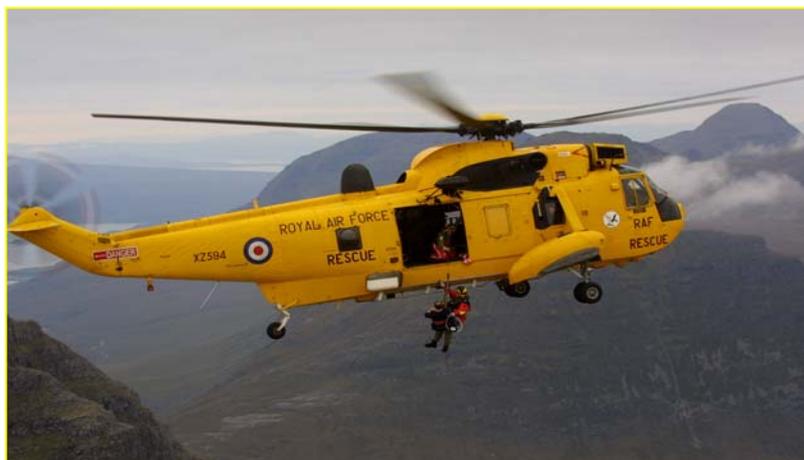
Sea King, rotor strike, Class D release

During a mountain rescue operation for a fallen climber in the Lake District, the aircraft main rotor strikes the cliff during the hoisting operation. The pilot calls for hoist cable release but the co-pilot hits the wrong switch on the overhead panel. The rescuer realizes that the aircraft is in difficulty and intentionally releases from the strop that he is riding in. He falls about 10 meters and is slightly injured. The Sea King is able to land safely after losing approximately 2.5 meters from the main rotor.

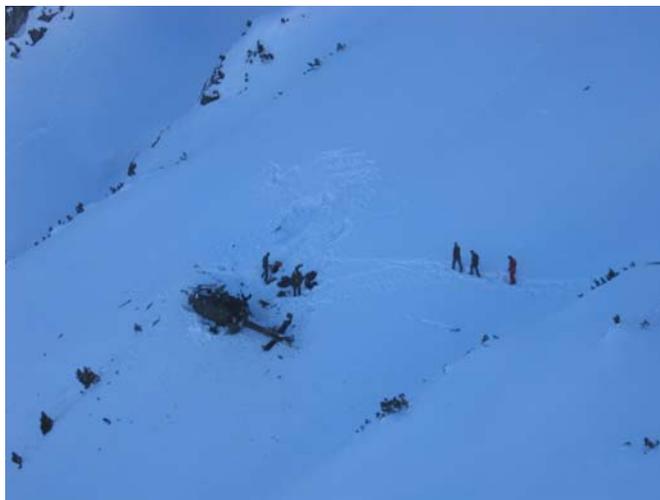
BO105, crash (2003)

While attempting a landing on a glacier in the Garmisch region, the military helicopter crashes. The pilot loses reference on final in self-imposed "whiteout" and attempts to land without reference on sloping ground. The main rotor strikes the ground and the helicopter rolls. The helicopter is destroyed. There are minor injuries.

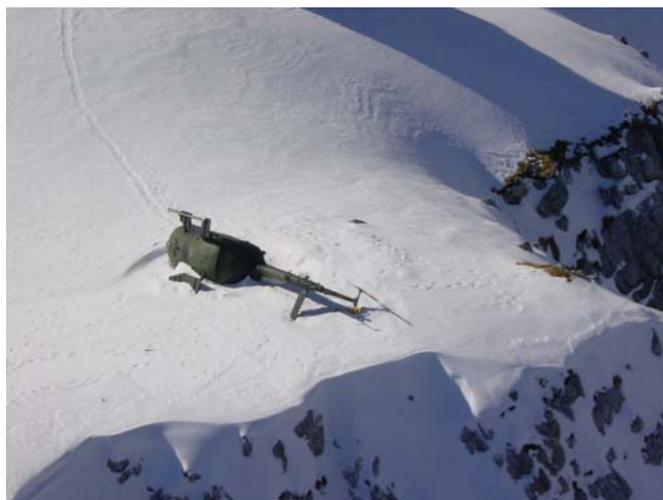
BO105, crash (2004)

While attempting a landing on a snow covered high altitude shoulder in the Allgau region, the helicopter crashes. The landing spot is not flat and there is little reference. The helicopter rolls and slides to the edge of a very large cliff. There are minor injuries.

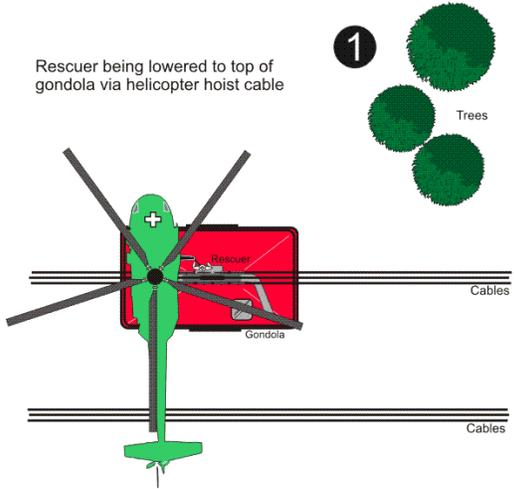
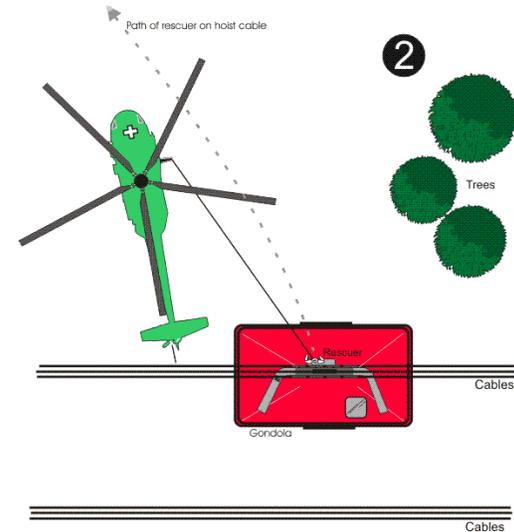
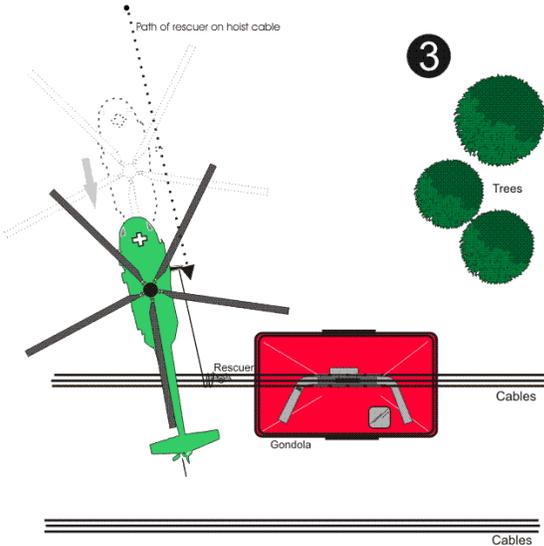
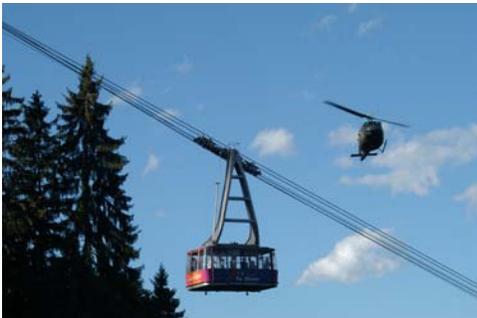
BH205, class D release

This accident occurred during a training mission for a cable car evacuation at the Fellhorn Ski Area in the Allgau region. A rescuer is hoisted down towards the roof of the cable car. In order to keep the aircraft into wind, the pilot keeps the helicopter and rescuer upwind of the cable car cable. There is 30 meters of hoist cable out. Since he cannot see the cable car, he uses trees in the distance for reference. There is no communication between the rescuer and the aircraft. At one point, a gust of wind makes him apply forward cyclic and the rescuer swings violently forward. When trying to recover, the rescuer swings back and wraps around the sloping cable car cable twice. He is injured but is within reach of the cable car cable. He manages to climb onto it before the hoist operator severs the hoist cable. He is then able to climb down to the cable car safely with the assistance of other rescuers in the cable car.

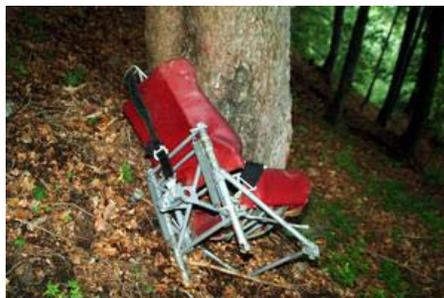
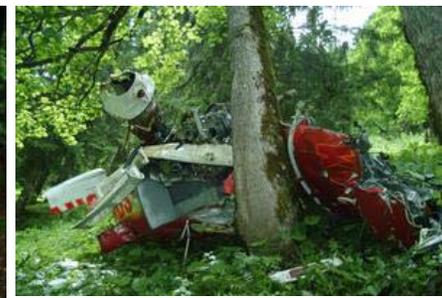
BH205, crash

While carrying a one-ton load on a long-line, during a commercial operation, the pilot experienced difficulty during a steep climb. He dropped the load and turned around but crashed into the forest. The pilot was killed.

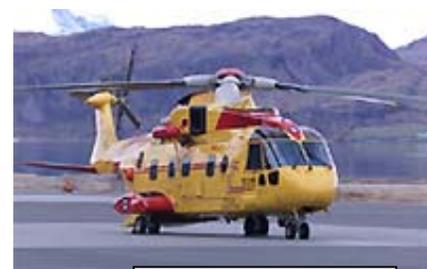
EH101, hoist problems

An incident occurred during a nighttime rescue in the North Atlantic for the crew of a capsized fishing vessel. The crew of six was floating in a life raft. Due to the very heavy seas with 15 metre waves, the lowering of the rescuer on the hoist was problematic. The rescuer lost his swim gear in the water and the hoist operator was having difficulty keeping him near the surface. The rescuer was brought back on board and it appears that with the constant up and down motion on the hoist, it overheated and was no longer operational.

The operation was transferred to the second hoist (this aircraft is equipped with two hoists) and a rescuer was lowered to the water. He recovered one of the fishermen. He returned to the water and for some reason, at some point, the hoist cable was jettisoned. The helicopter no longer had any hoist capability. The rescuer was recovered with a stretcher on a rope tied to the hoist arm and was subsequently long-lined to the top of the cliff above the shore. At that point, the rest of the fishing vessel crew had drifted onto the rocky shore. The helicopter rescue crew along with the help of ground rescue crews recovered two more fishermen with rope work. One other person managed to scramble to the top unaided. Two fishermen died in the incident.

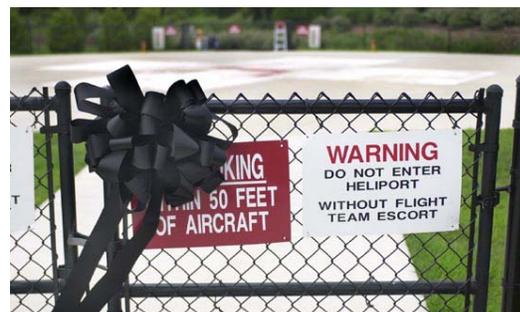
NEWBERRY, SOUTH CAROLINA- AIR AMBULANCE CRASH

On July 13, 2004 Spartanburg *Regional One* (Spartanburg, SC) Air Ambulance Bell 407 helicopter crashed during a patient transport. Pilot, flight nurse, flight paramedic, and patient were killed. The aircraft crashed at 5:36 a.m., seconds after it took off from an accident near an Interstate 26 rest area. This aircraft had been operated by the Med-Trans Corporation for Spartanburg Regional Healthcare since May 2003. There were two other fatal USA air ambulance accidents during 2004 (as of October 2004), but the circumstances behind this tragedy are worth reviewing. Spartanburg Regional One was contacted after three other air ambulance units had declined the mission based on weather conditions.

- Spartanburg Regional Healthcare System is contacted, which agrees to send a helicopter.....
- Before lifting off from Spartanburg, the pilot checked weather radar. Aviation Weather Center in Kansas City, Mo., issued a visibility advisory two hours before the crash. This was for a four-state region of the Southeast, including where the helicopter went down.

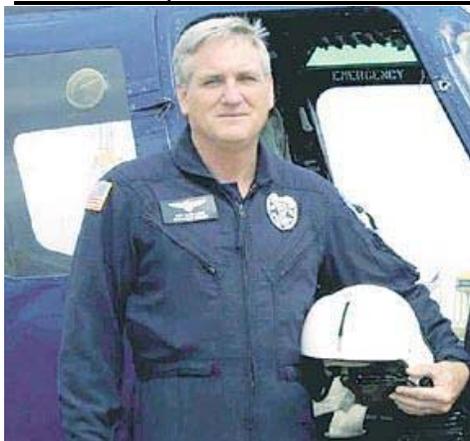
BEAUMONT, TEXAS- SHERIFF'S DEPARTMENT HELICOPTER CRASH

On September 15, 2004 a Bell OH-58C (military BH-206) crashed during a search & rescue mission. 54 year-old Jefferson County Sheriff's Sergeant, Mike Lane was killed when a helicopter owned by the Sheriff's Department crashed into Sabine Lake. Sabine Lake is connected to the Gulf of Mexico. The pilot and Mike Lane, a pilot-rated sheriff's deputy spotter, were looking for a victim of a reported boat fire. After locating the fire, which turned out to be burning garbage on shore, they continued to search the area for any boat fire "survivors". The aircraft descended from an altitude of 500 feet to better locate objects in the water. Mike Lane was operating the

Night Sun spotlight. The pilot, who was an instrument rated instructor, was flying IFR relying on his radar altimeter. As he made a sharp turn to the right, while trying to identify something in the water, the front skid made contact with the water. The helicopter plunged into the lake.

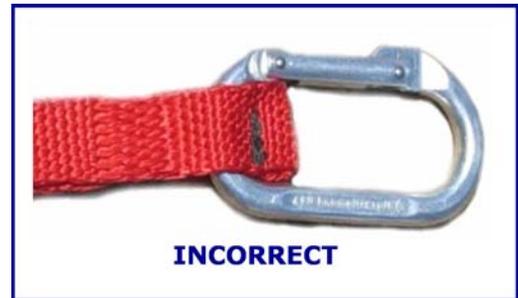
No. 04-05

During annual short-haul training, a check spotter observed an Omni-Sling™ brand webbing multi-loop strap being used incorrectly to connect a short-hauler to the main short-haul line.

The Omni-Sling multi-loop strap features an interwoven design which allows the user to safely attach a carabiner to multiple rigging loops along the length of the strap (see detailed blow-up for correct attachment of carabiner).

Do not attach a carabiner to the end of the strap (see detailed blow-up of incorrect attachment of carabiner). The sewn stitching at the end of the strap (used to attach a manufacturer's label) is not intended to be load bearing.

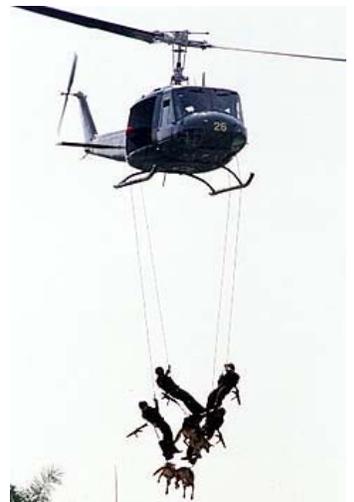
INDONESIA- SHORT HAUL ACCIDENT

On October 4, 2003 eight Indonesian Kopassus soldiers plunged 180 meters to their death, after being suspended below a military helicopter during a training exercise for a ceremony. Inhabitants of the coastal village of Lhokseumawe watched the accident, which occurred 300 meters offshore. According to Army spokesman, Col. Yani Basuki “A blast of wind rocked the Bell helicopter making it highly unstable”, and the crew “had no option but to cut the rope to which the men were attached.” Basuki said cutting the rope was “normal operating procedure” and done to save those on board the helicopter. No trace of the soldiers in full battle gear was ever found after they hit the water.

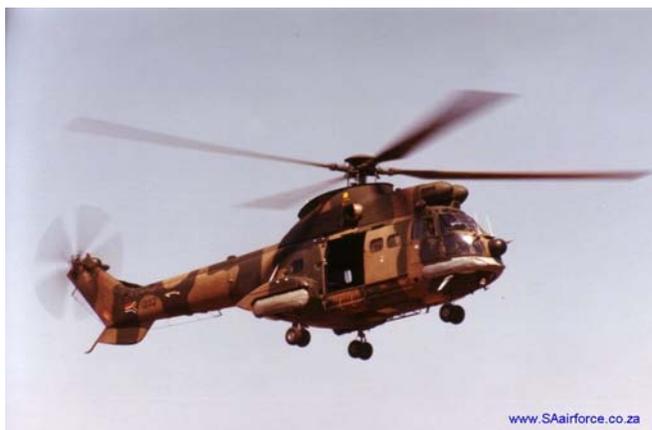
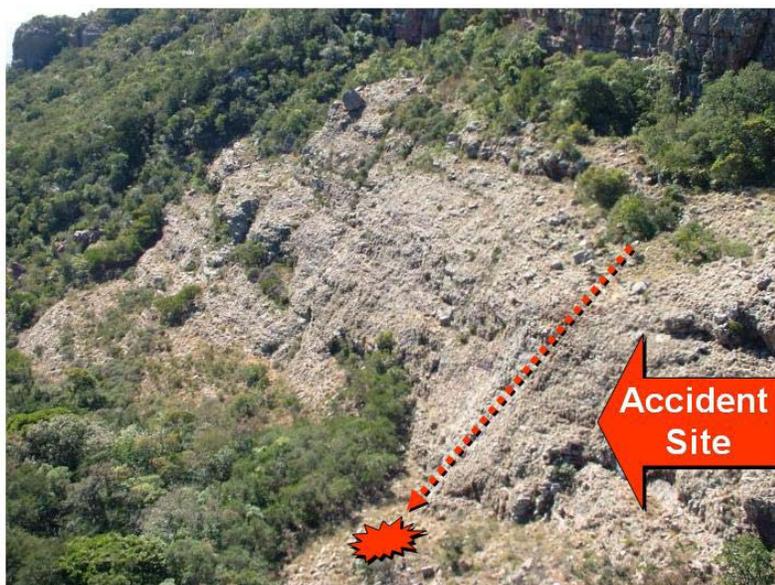
SOUTH AFRICA- HELICOPTER RESCUE TRAINING FATALITY

The accident occurred during a refresher training, when two teams were conducting hoisting evolutions and one-wheel loads/unloads. The helicopter involved was **Aerospatiale Oryx**, which is the local South African modified version of the SA 330 Puma and is fitted with wheeled tricycle landing gear. This was a South Africa Air Force aircraft piloted by a colonel and lieutenant.

Seven members of the team had boarded the aircraft. The eighth member (Carr) was placing his pack into the aircraft, when the aircraft wheel on the ground slipped, and the pilot pulled power lifting the aircraft into the air. Clive was placing his pack into the aircraft, his balance was forward at the time and he was caught off guard- he appeared to lunge at the aircraft. He momentarily grabbed the aircraft, pulling the pack out in the process before apparently

losing his grip and dropping back to the ground, tumbling about 15 meters down a very steep slope. Clive was declared dead at the scene....

- ❖ **Formalize introductory helicopter training.**
- ❖ **Development of a series of ratings of helicopter competence.**
- ❖ **Rescue Officer (RO) / Team Leader / Dispatcher has the discretionary rights to select an appropriate team for a job.** (*Dispatcher is a position on the ground SAR team like a loadmaster, who is a liaison to the helicopter crew chief*)

- ❖ **Formalize the Team Leader /Assistant Team Leader's training program.**
- ❖ **"Height-safety equipment", MUST have a standards rating for work at height.** (*e.g. No bicycle helmets, swift-water helmets, etc.*)

- ❖ **All carabiners used in helicopter work must be twist-lock.** (*To overcome aircraft vibration*)
- ❖ **Dog-handlers are excluded from one-wheel landing situations.** *MUST be hoisted.*

- ❖ **No excess equipment suspended from harness.** *This is due to the snag potential.*
- ❖ **Stretchered patients are not to be loaded in a one-wheel landing.** *They must be loaded by short hoisting evolution instead.*
