Dyneema incident on Mt. Świnica

authors: Andrzej Marasek, Witold Cikowski, Marcin Józefowicz, prof. dr hab. inż. Jerzy Zych, mgr inż. Tomasz Snopkiewicz, PhD
Eng. Michał Ciszewski, Andrzej Górka

causes of rope failure

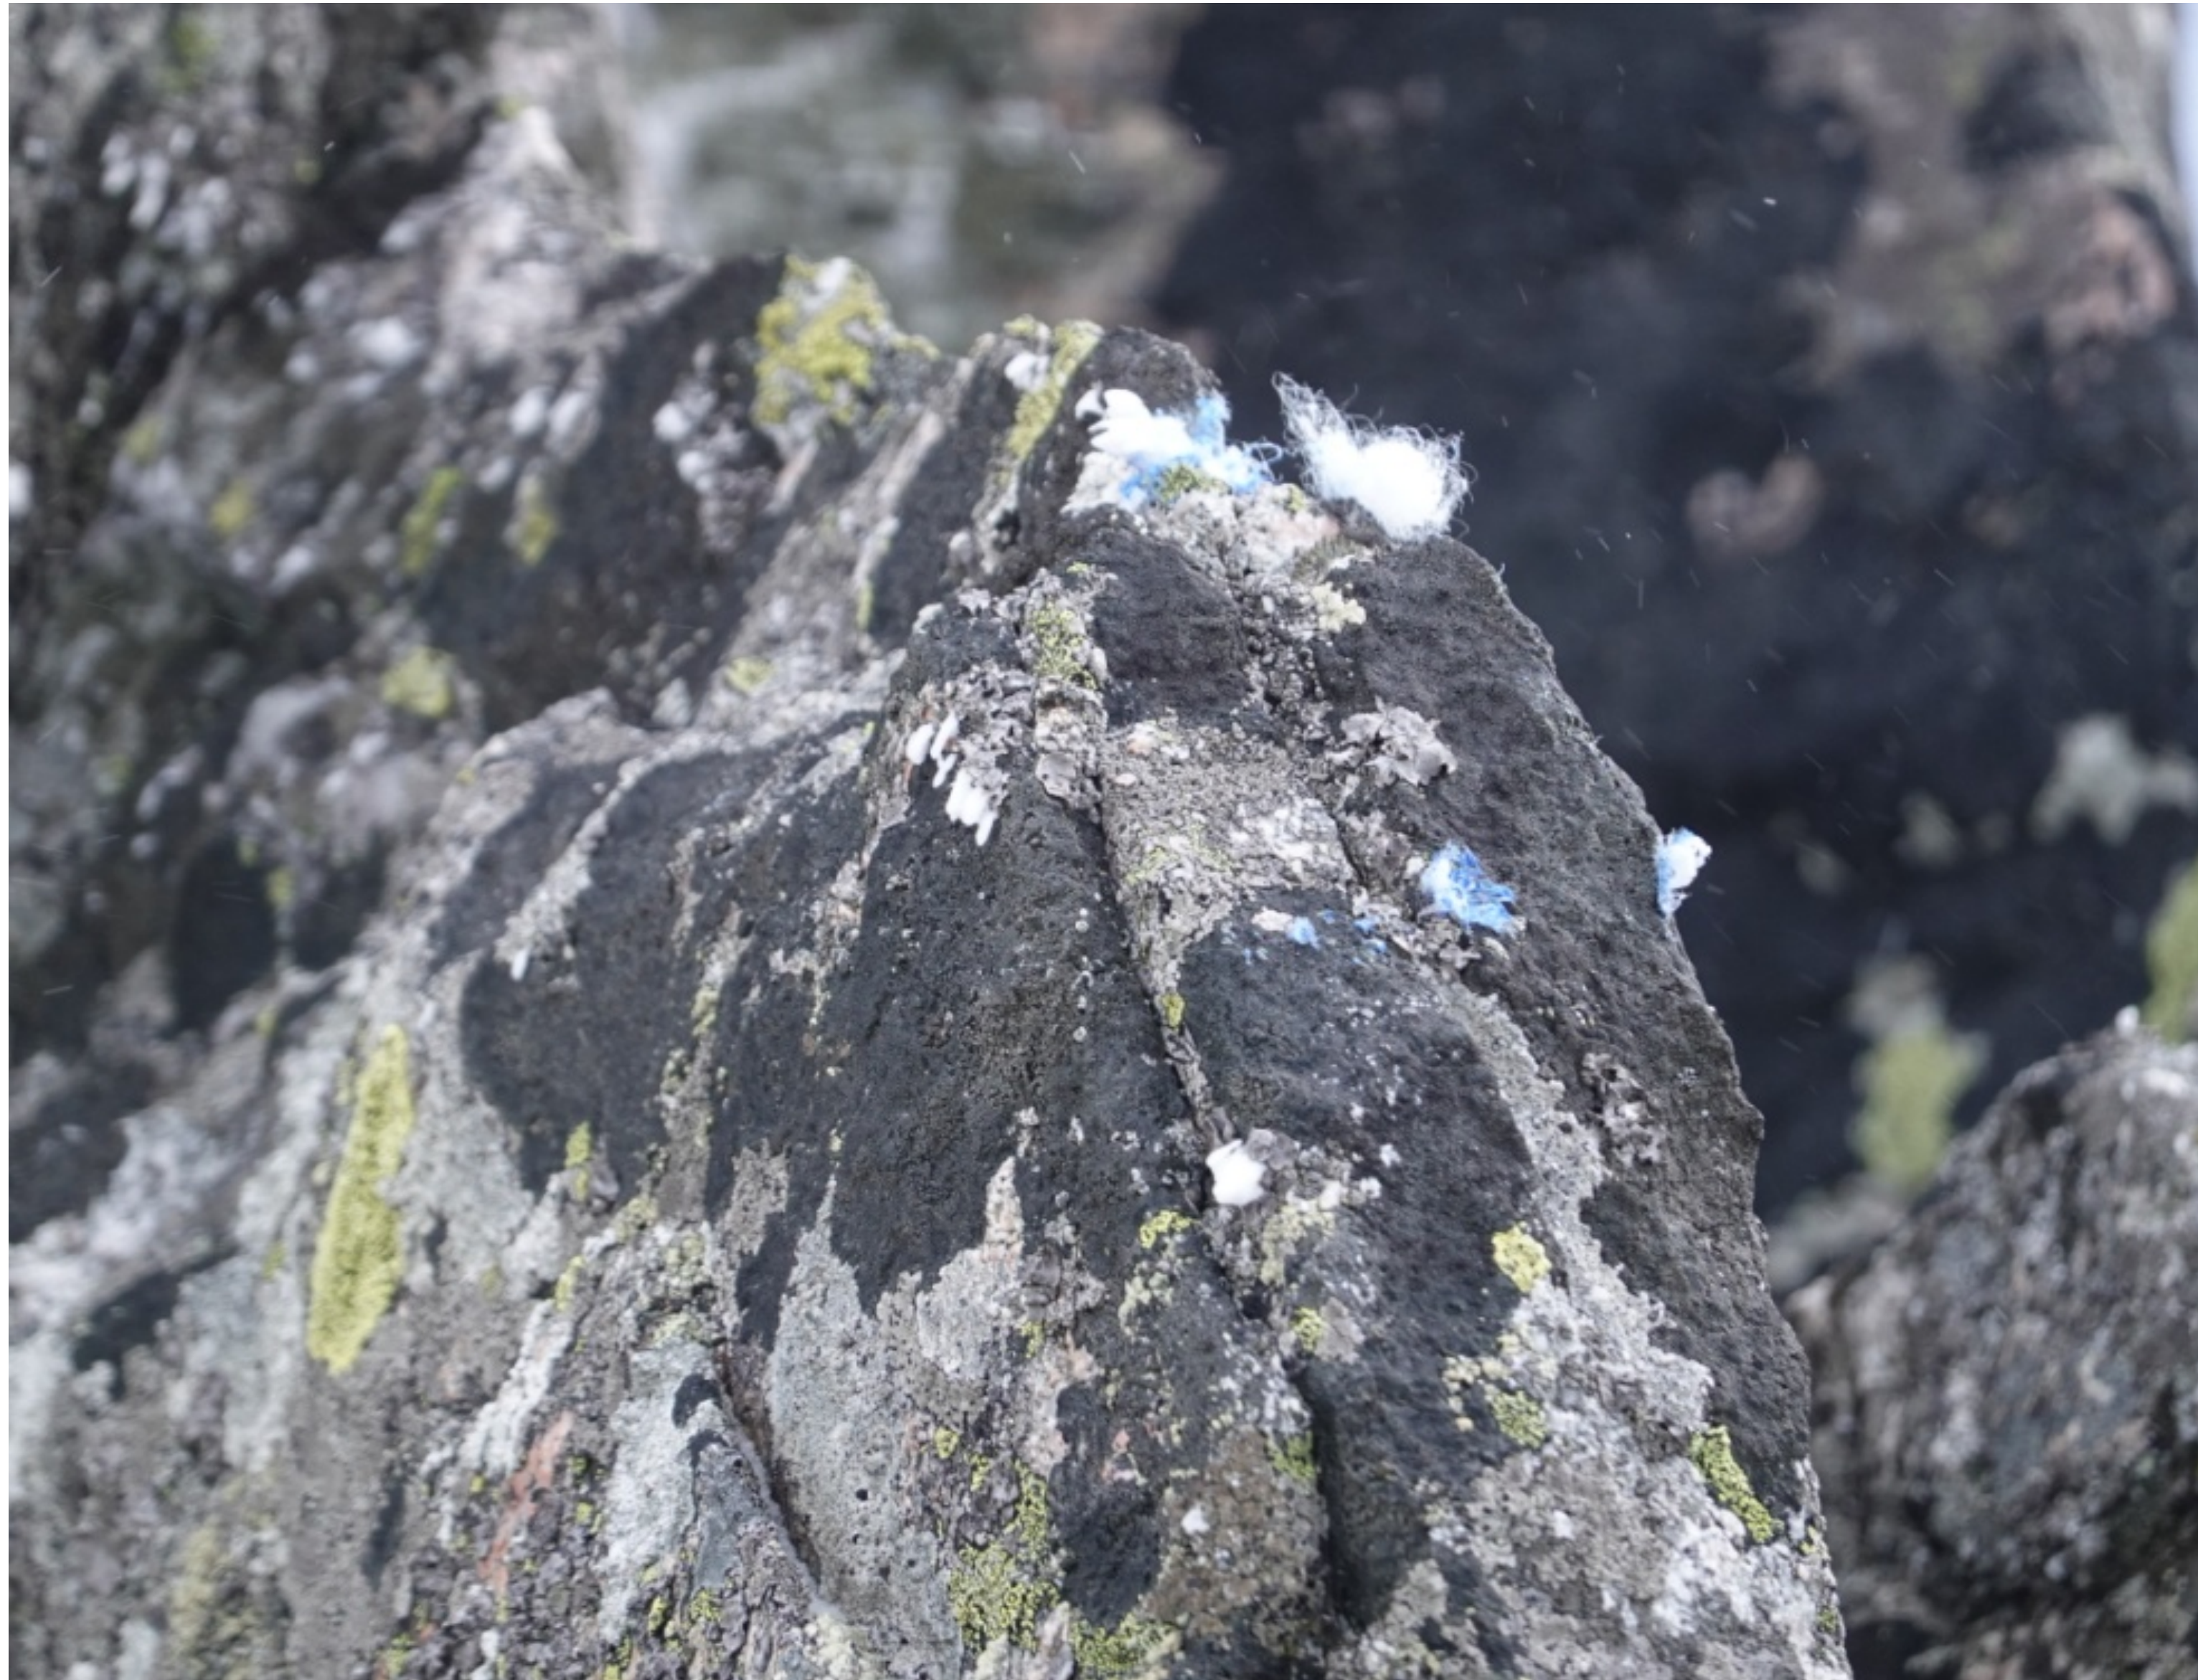
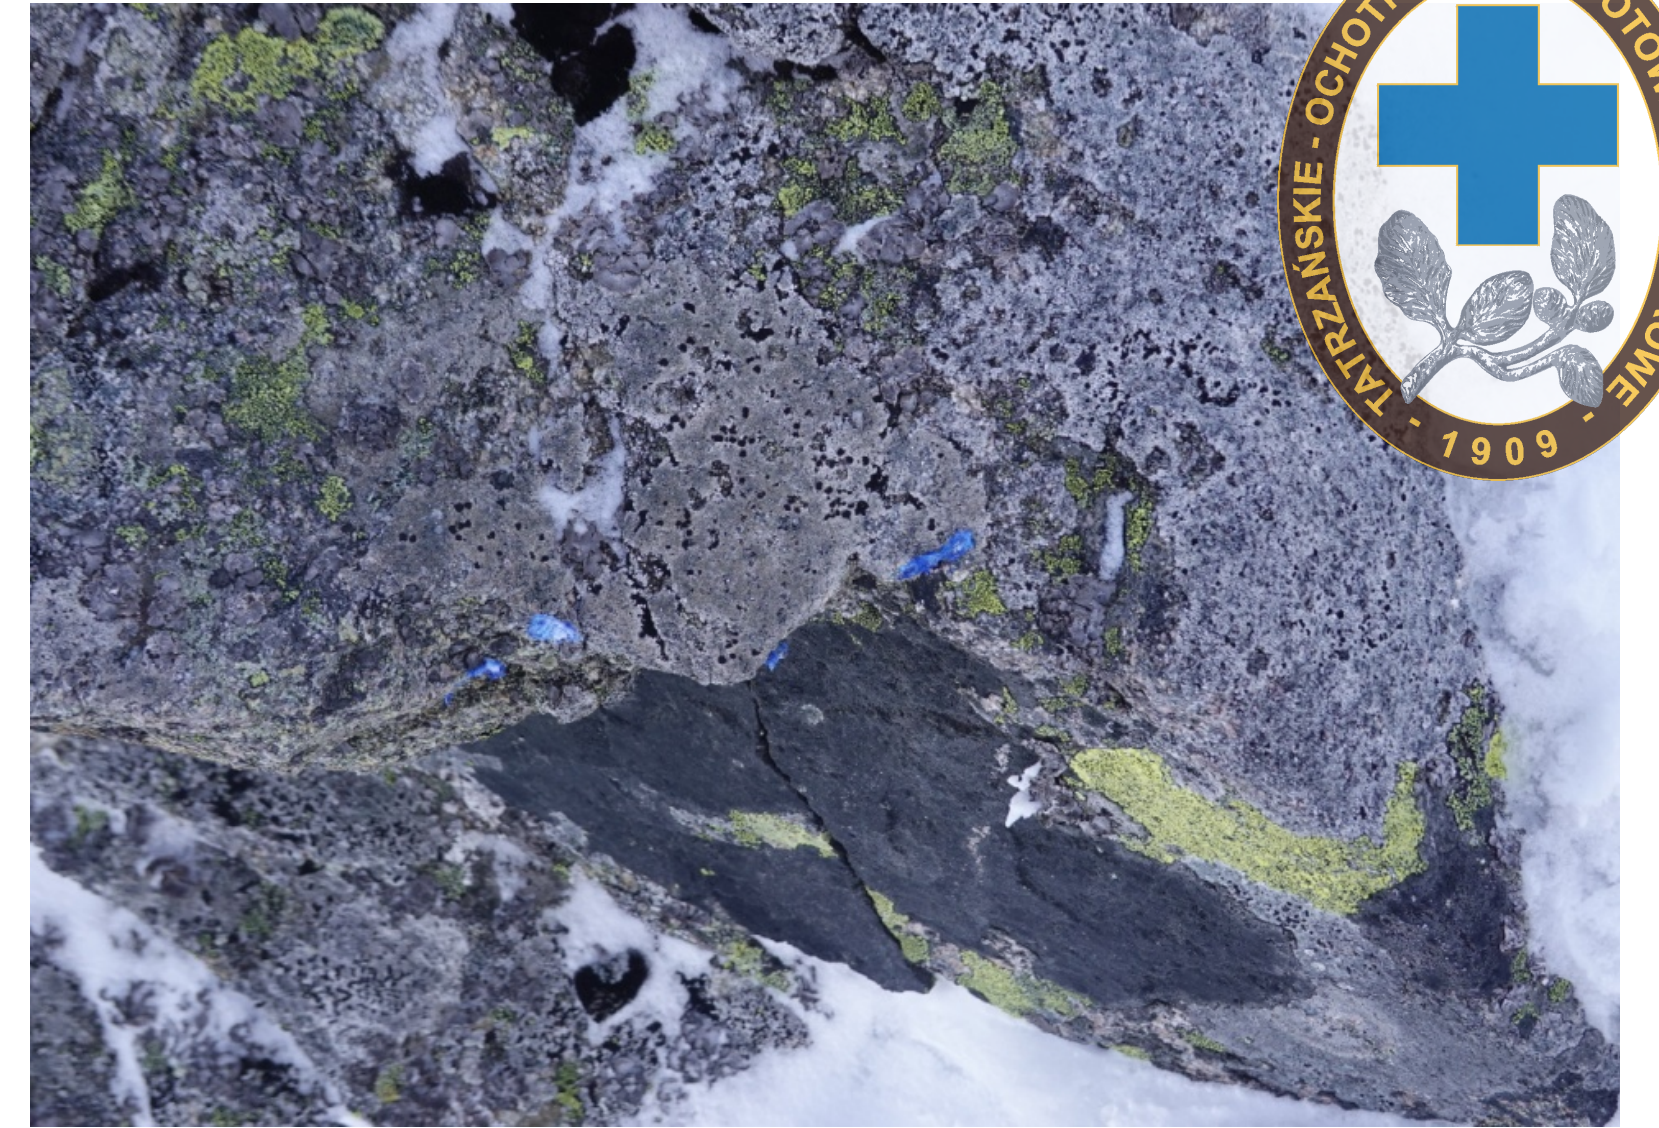
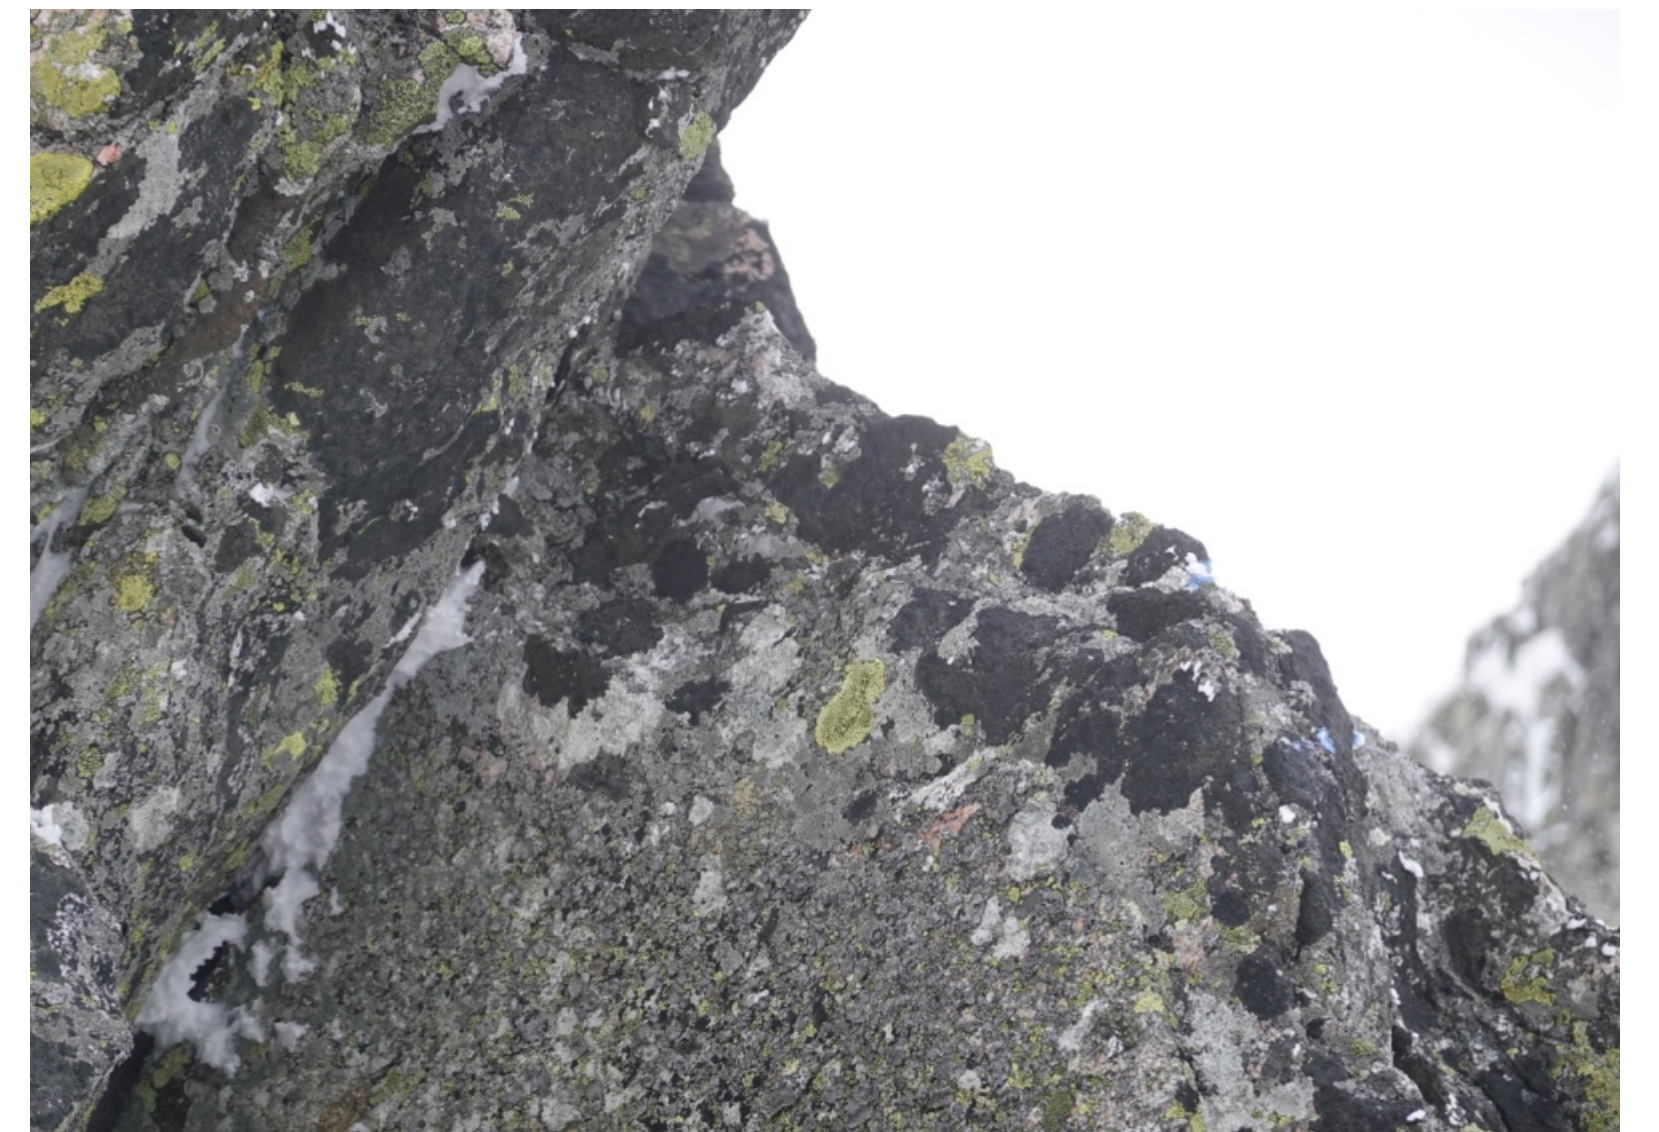
on the following the days the rocks on the pillar are examined: some possess sharp, jagged features, the dyneema “fluff” is visible

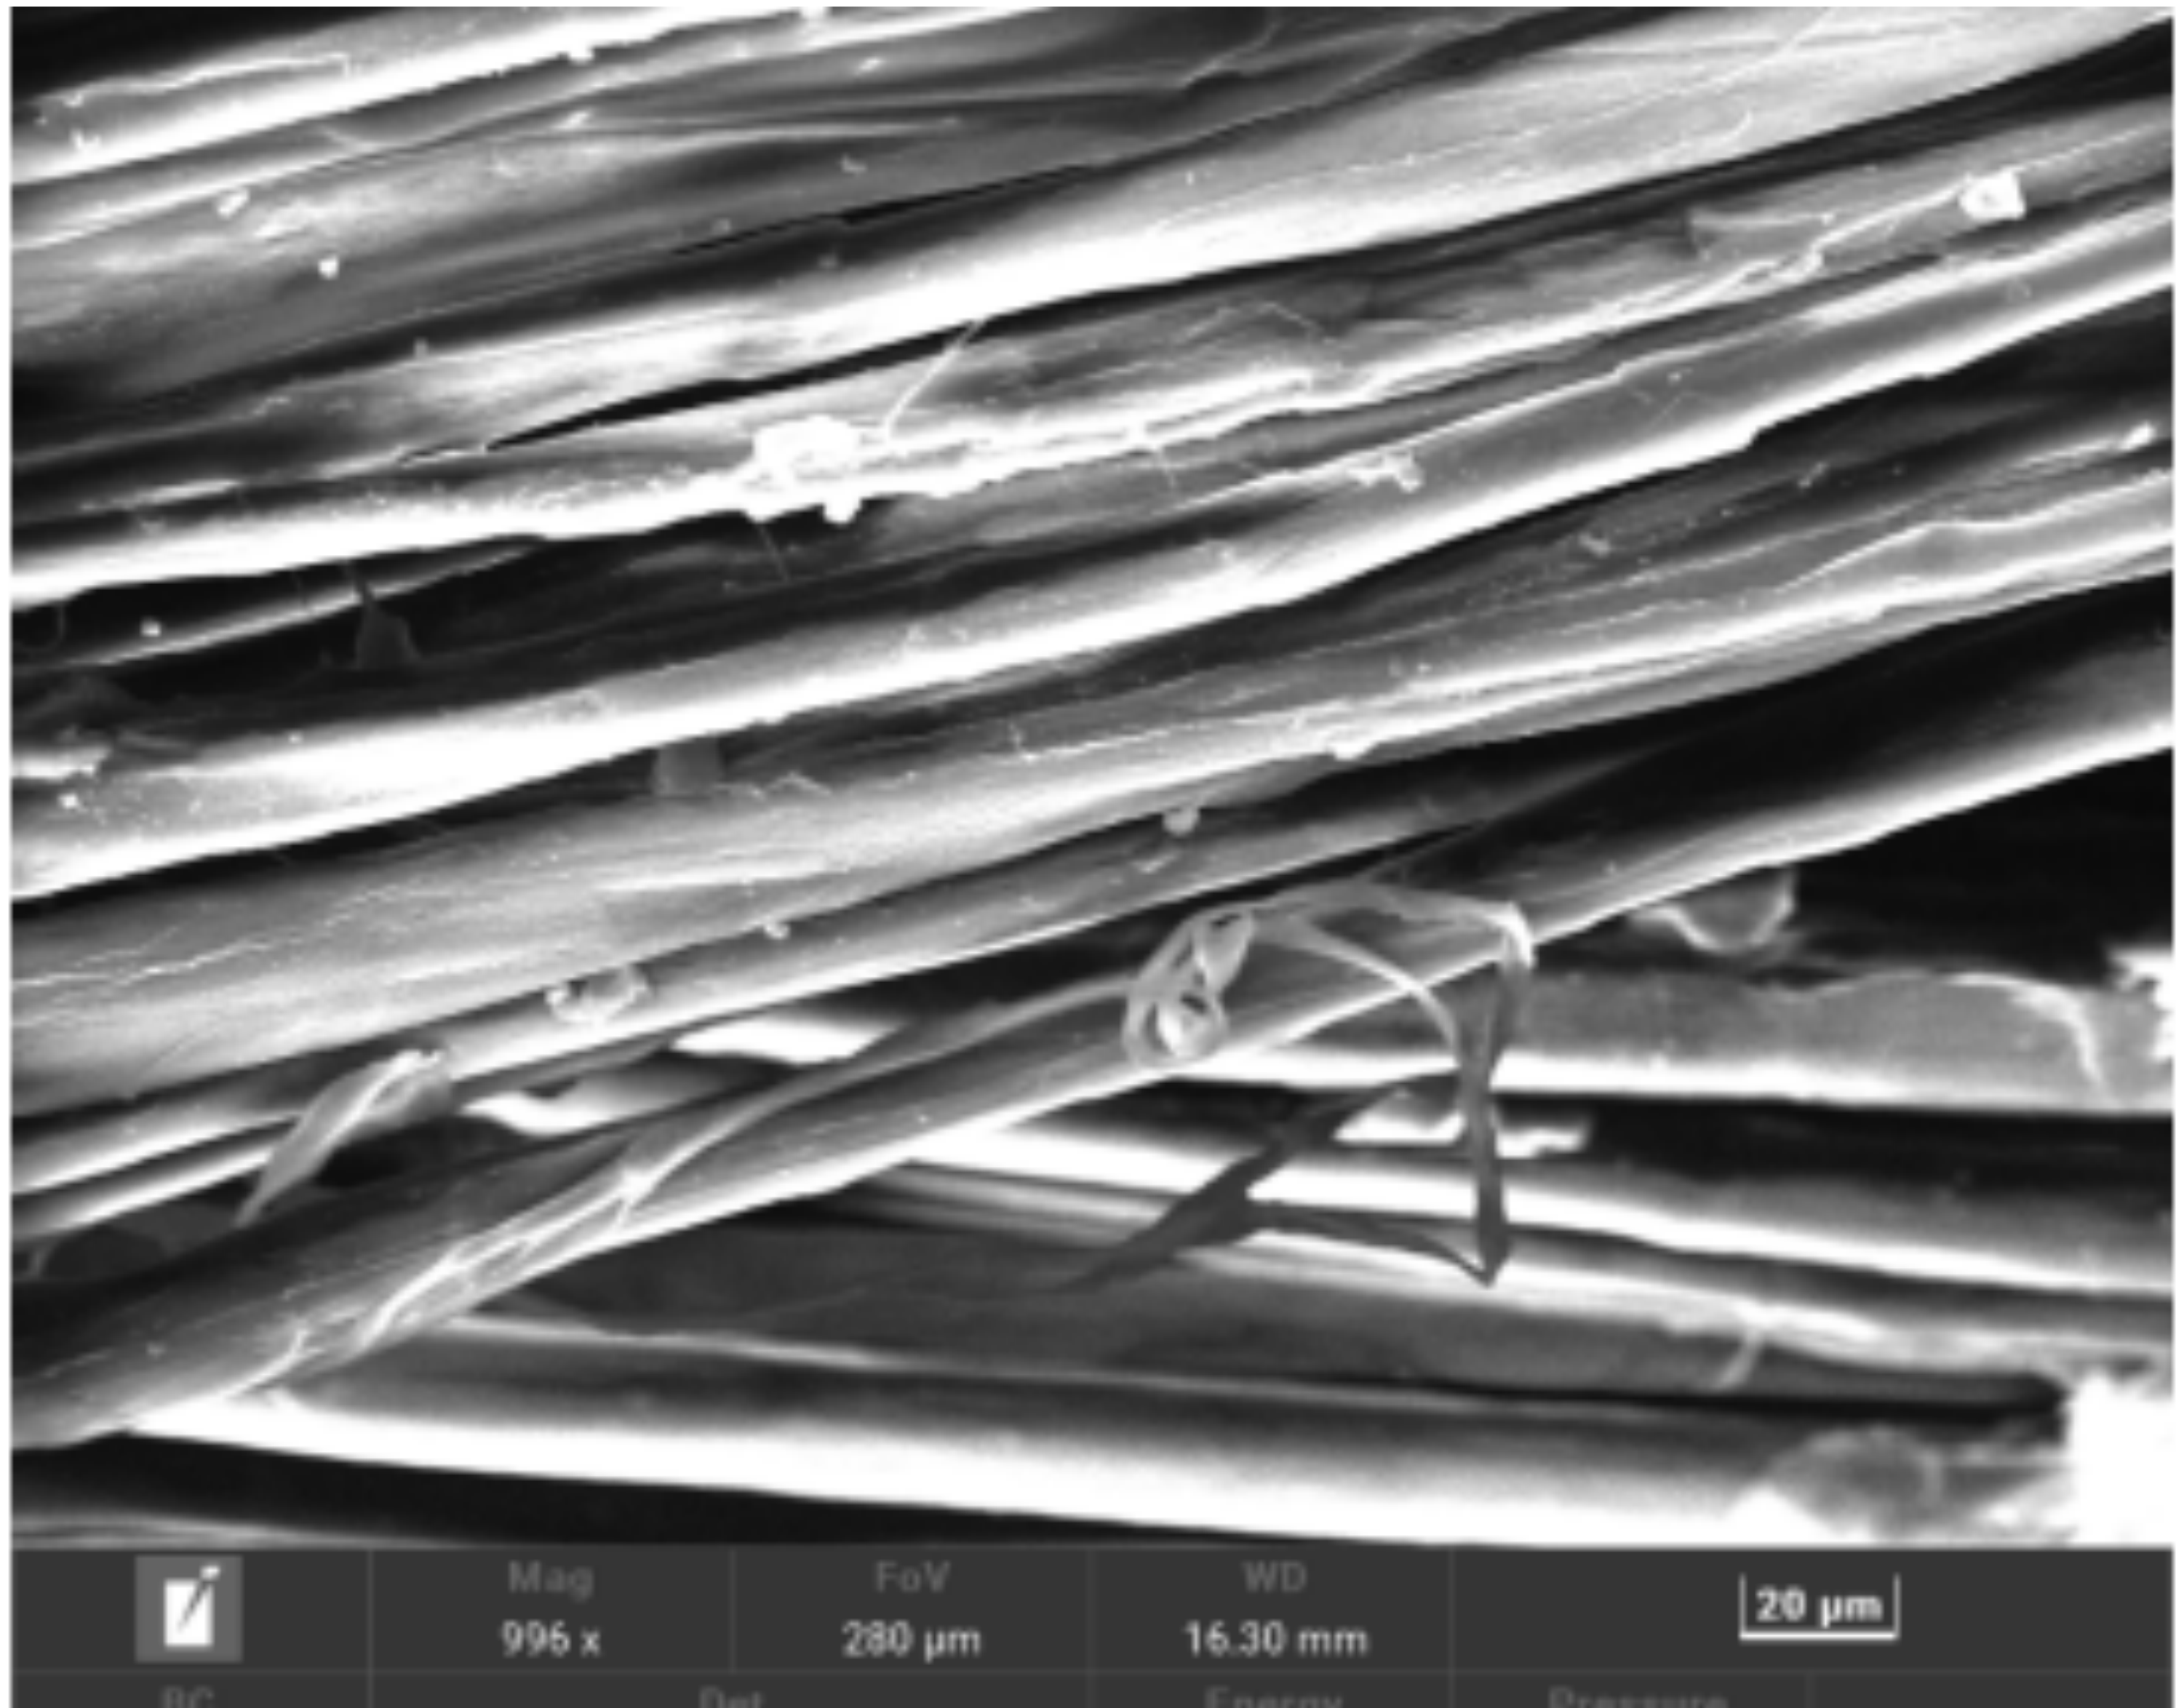
microscopic view of the (undamaged) structure of the blue rope

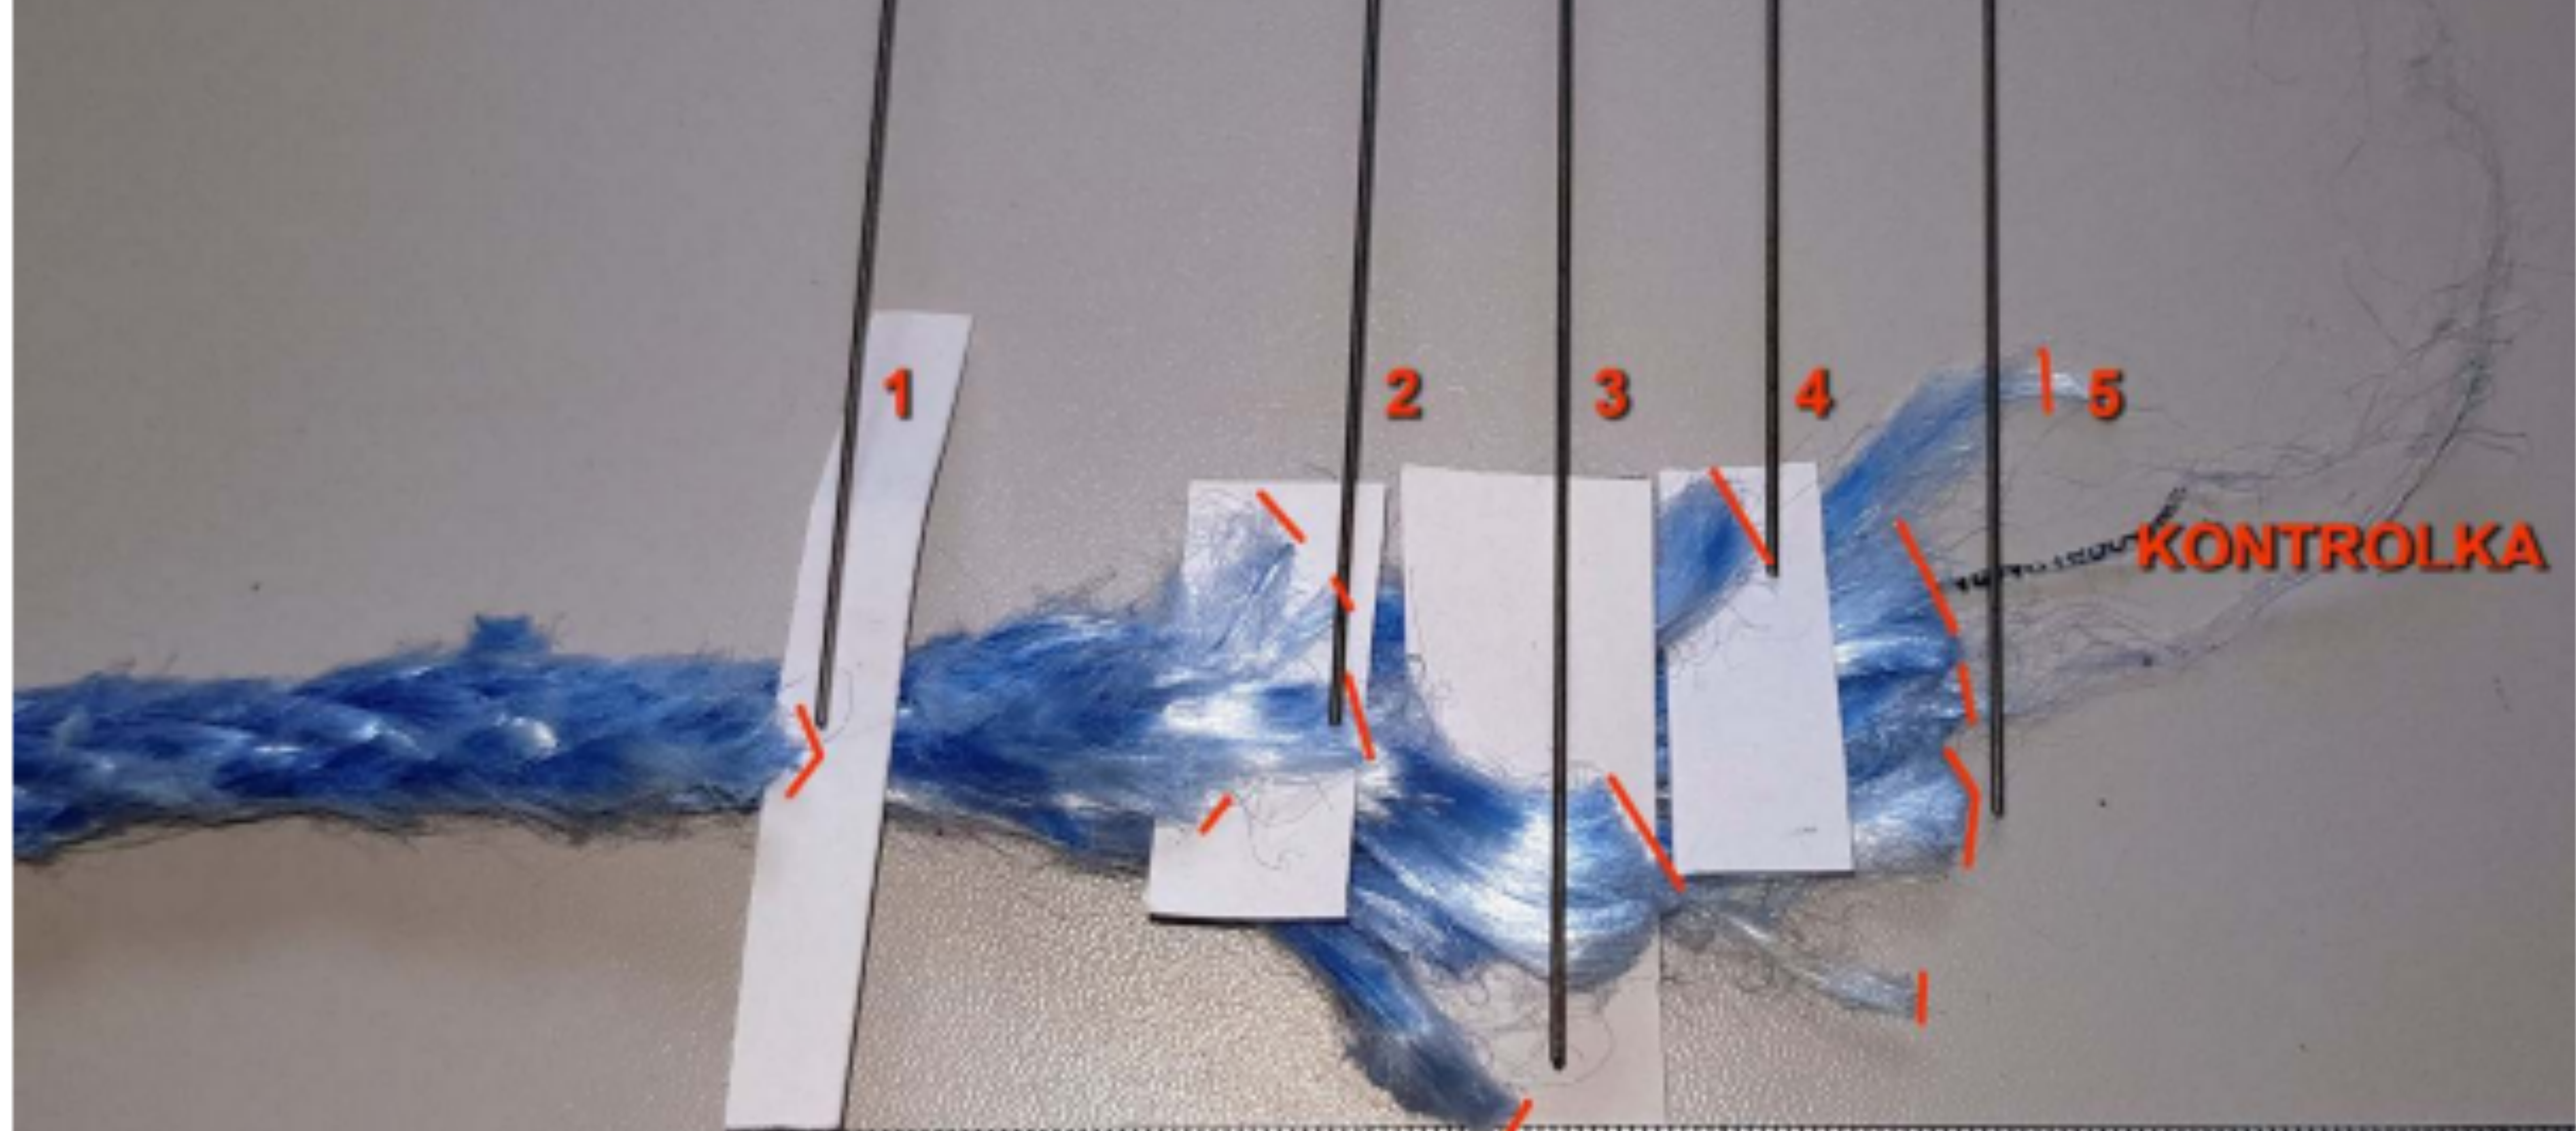
marker threads of both ropes

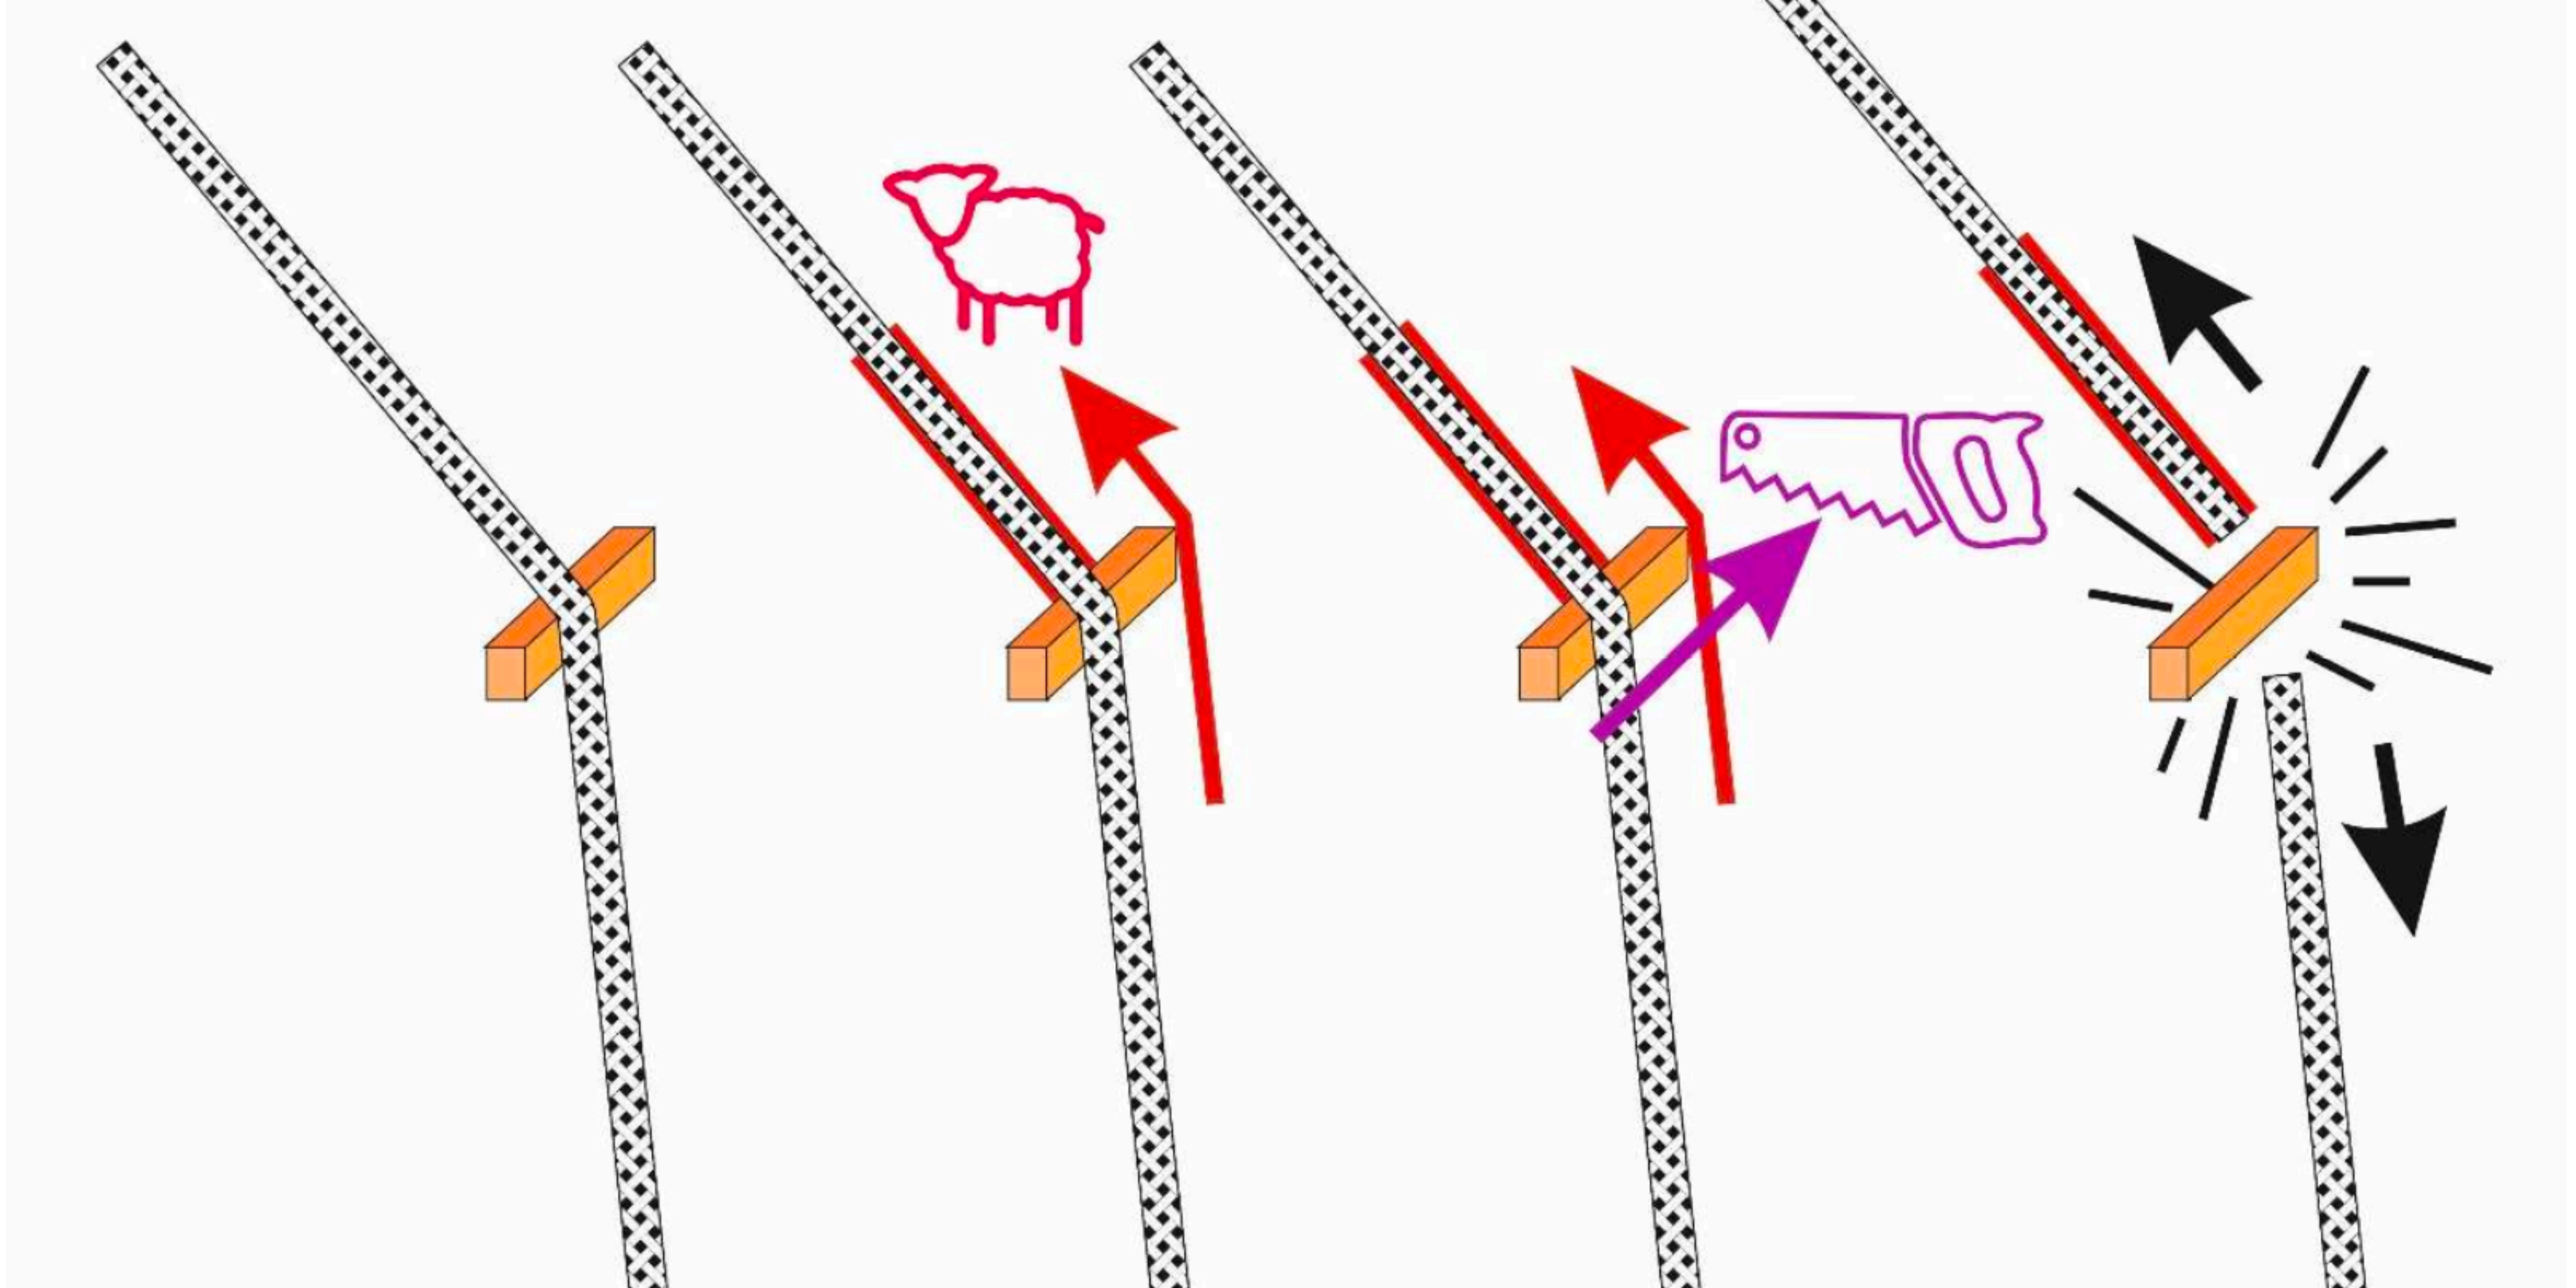
the research indicated that the rope was
in 90-95% cut (11 strands), only one strand broke

**the entire damage occurred on total
9 cms of rope**

proposed mechanism of the
destruction of the rope
