Dyneema incident on Mt. Świnica

authors: Andrzej Marasek, Witold Cikowski, Marcin Józefowicz, prof. dr hab. inż. Jerzy Zych, mgr inż. Tomasz Snopkiewicz, PhD
Eng. Michał Ciszewski, Andrzej Górka

causes of rope failure

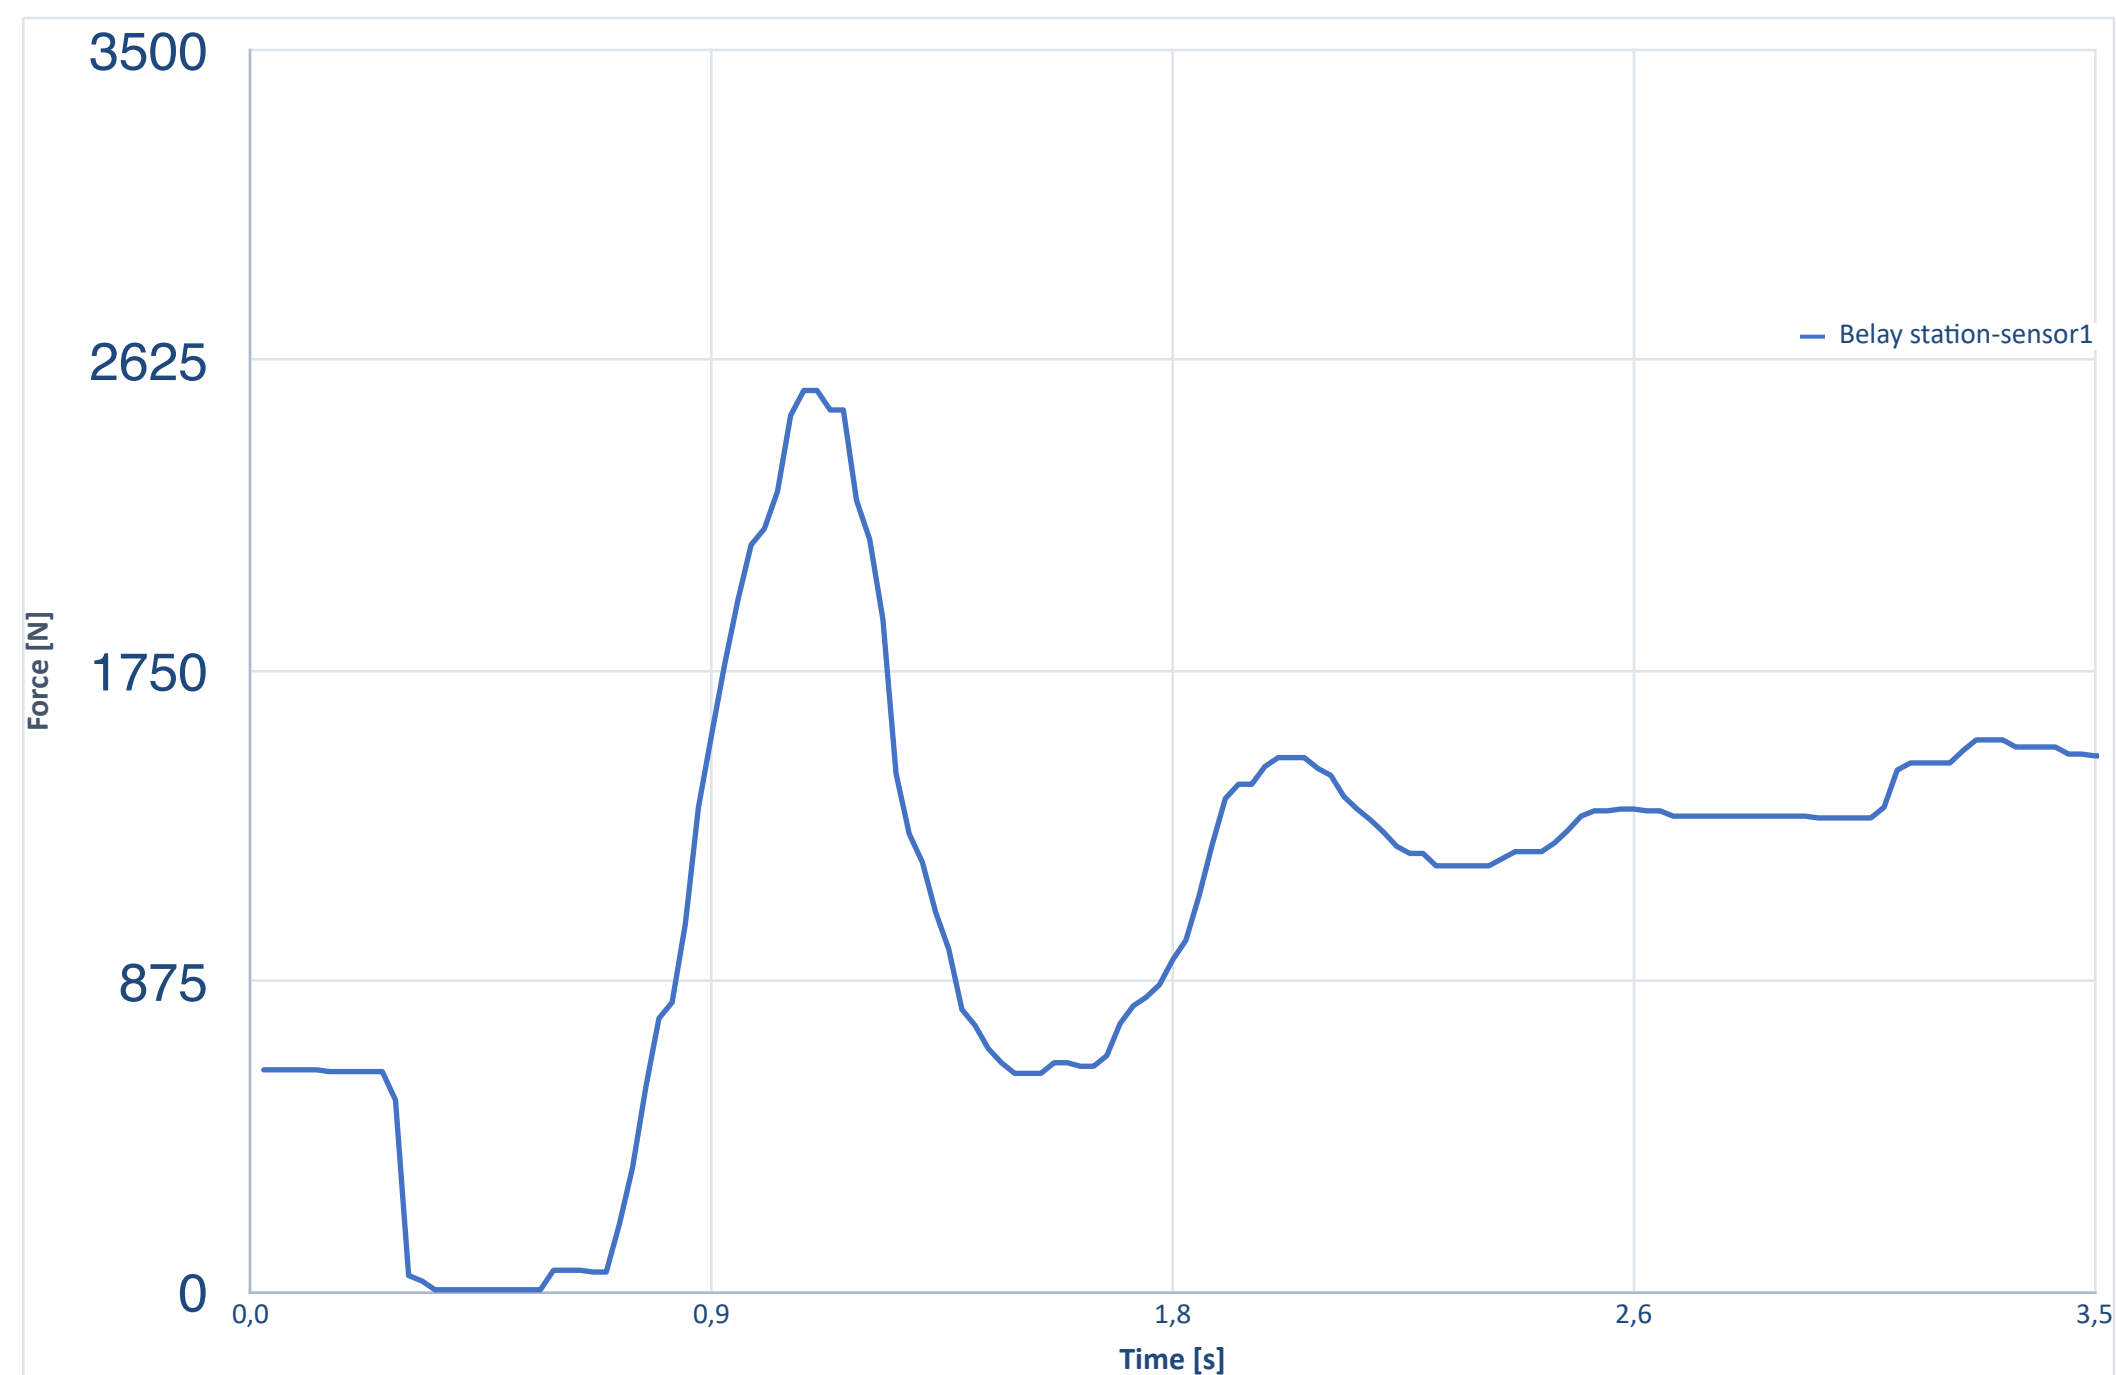
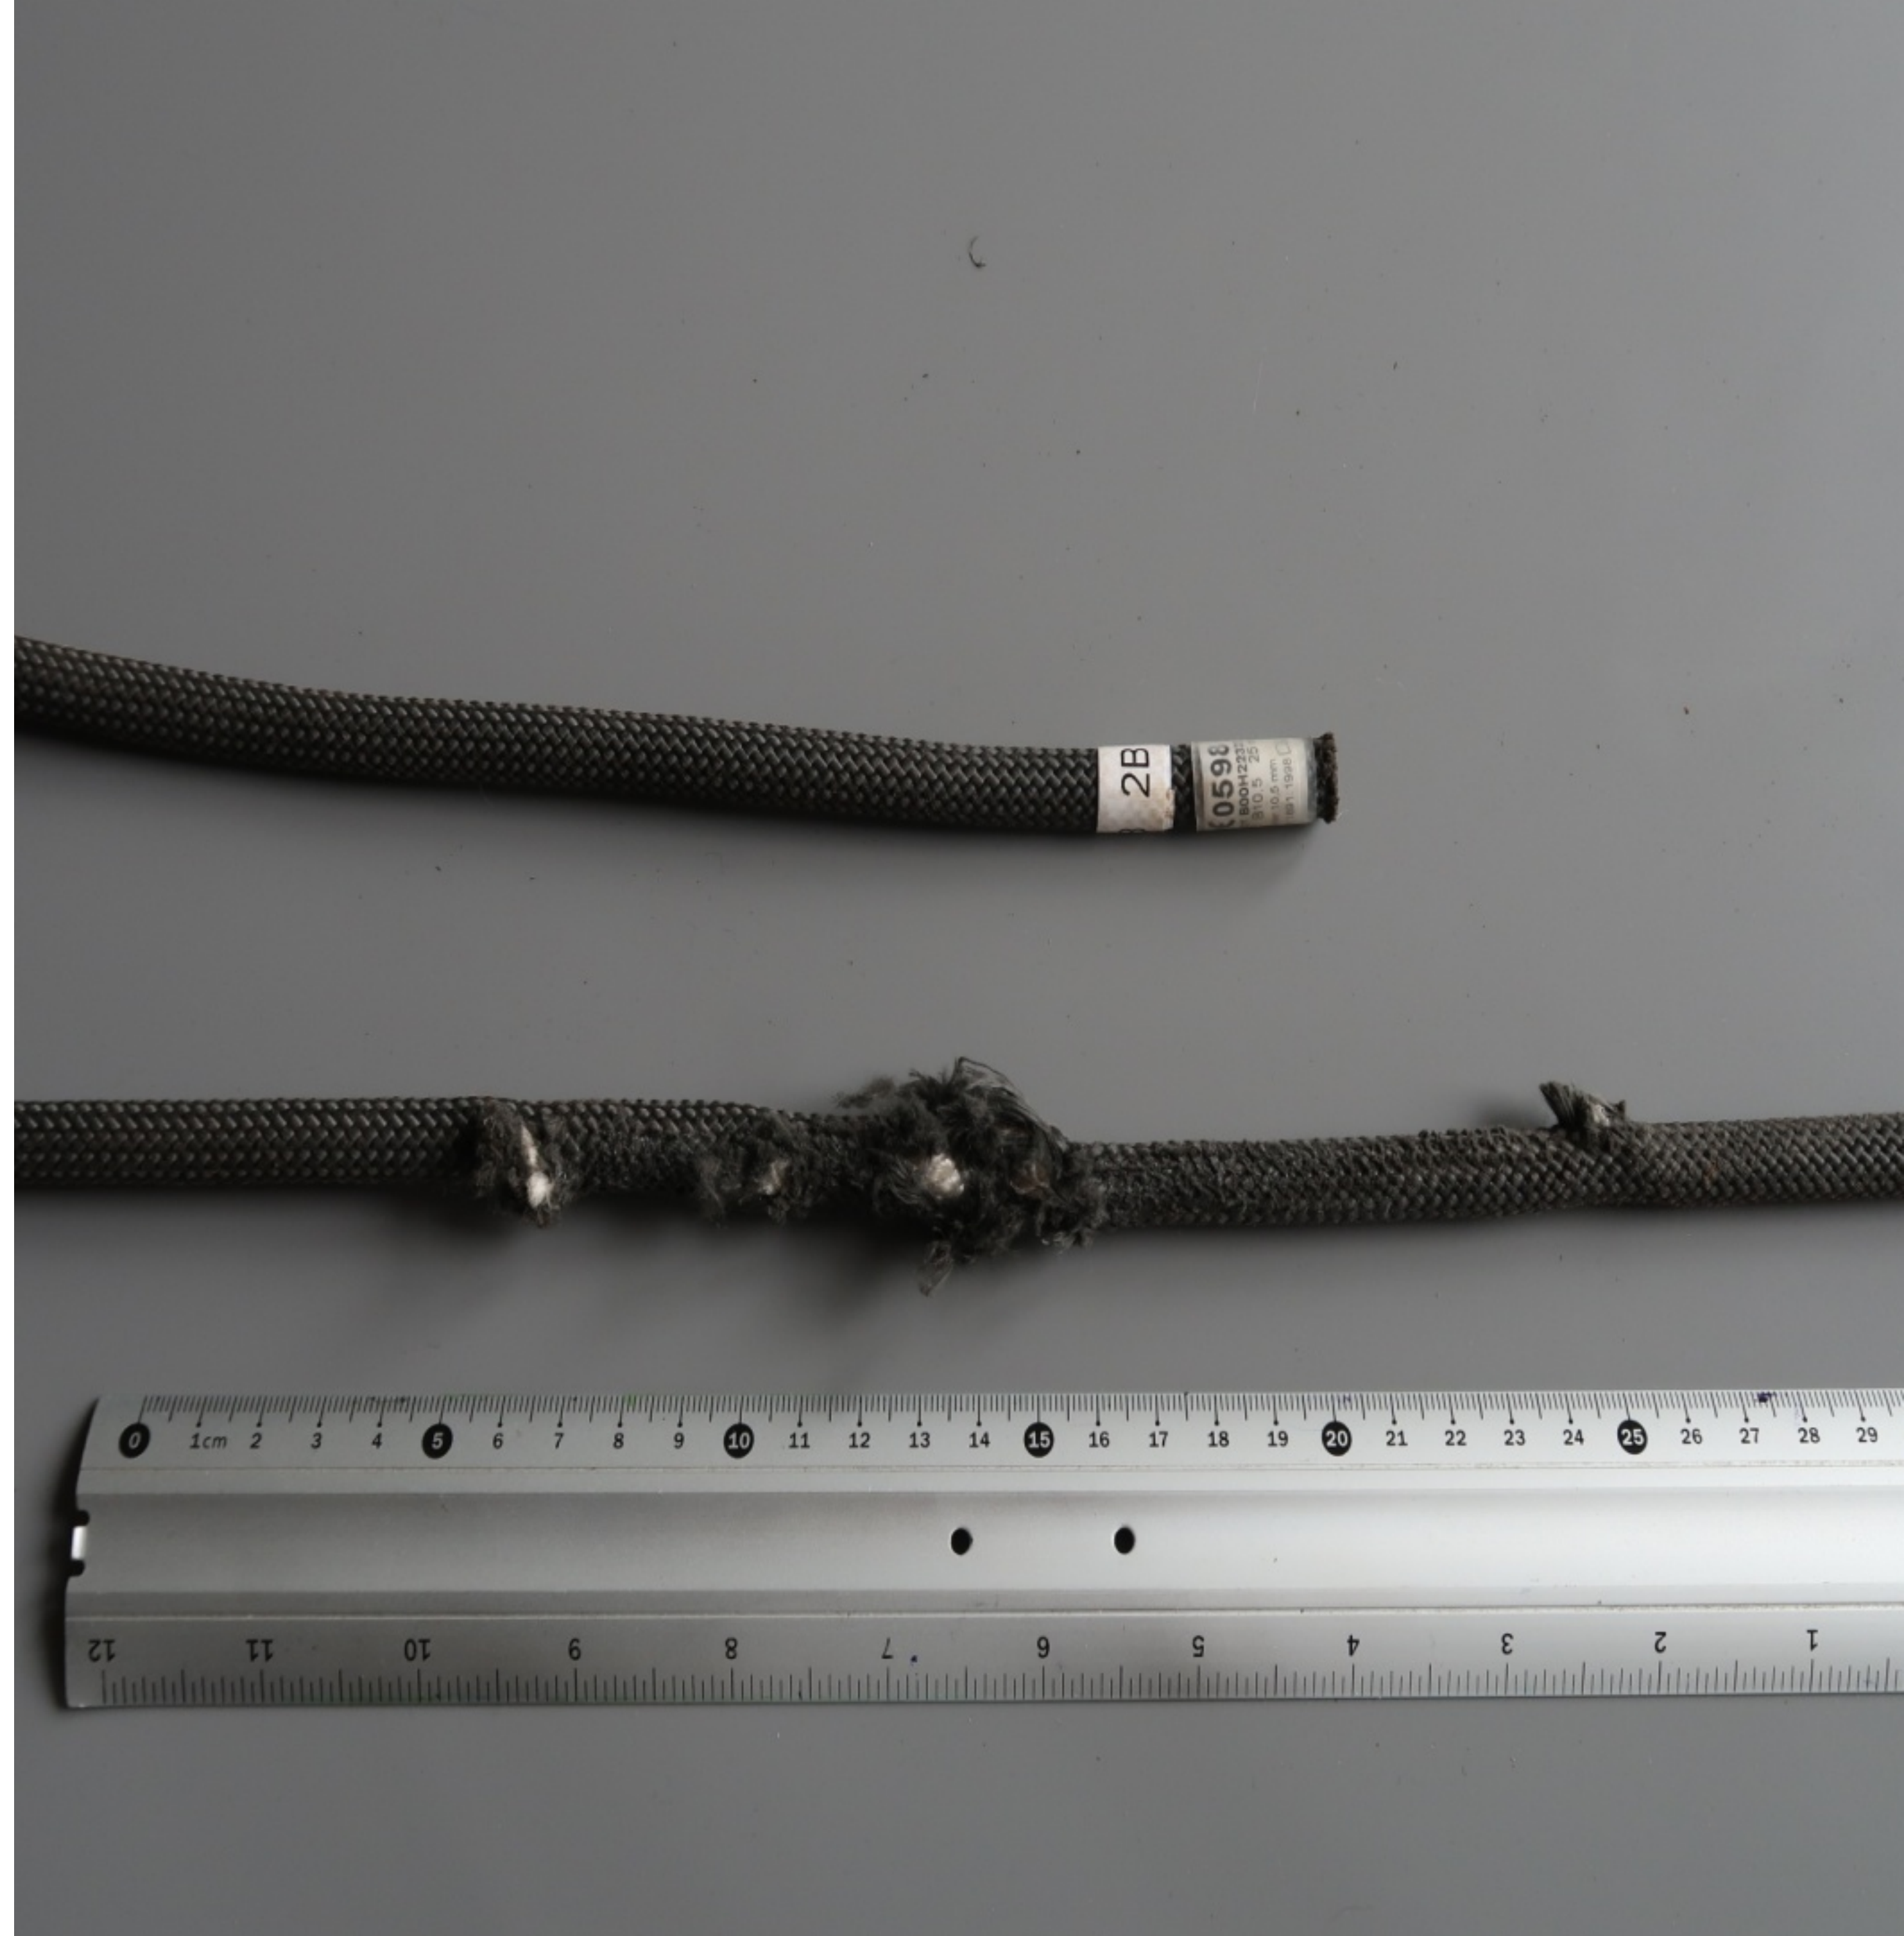
- rope 2B
- Aramid/polyamide 10,5 mm - 140 kg load

- **THE ROPE DID NOT BREAK!**
- **The best cut resistance among semi-static ropes, densely braided aramid sheath**

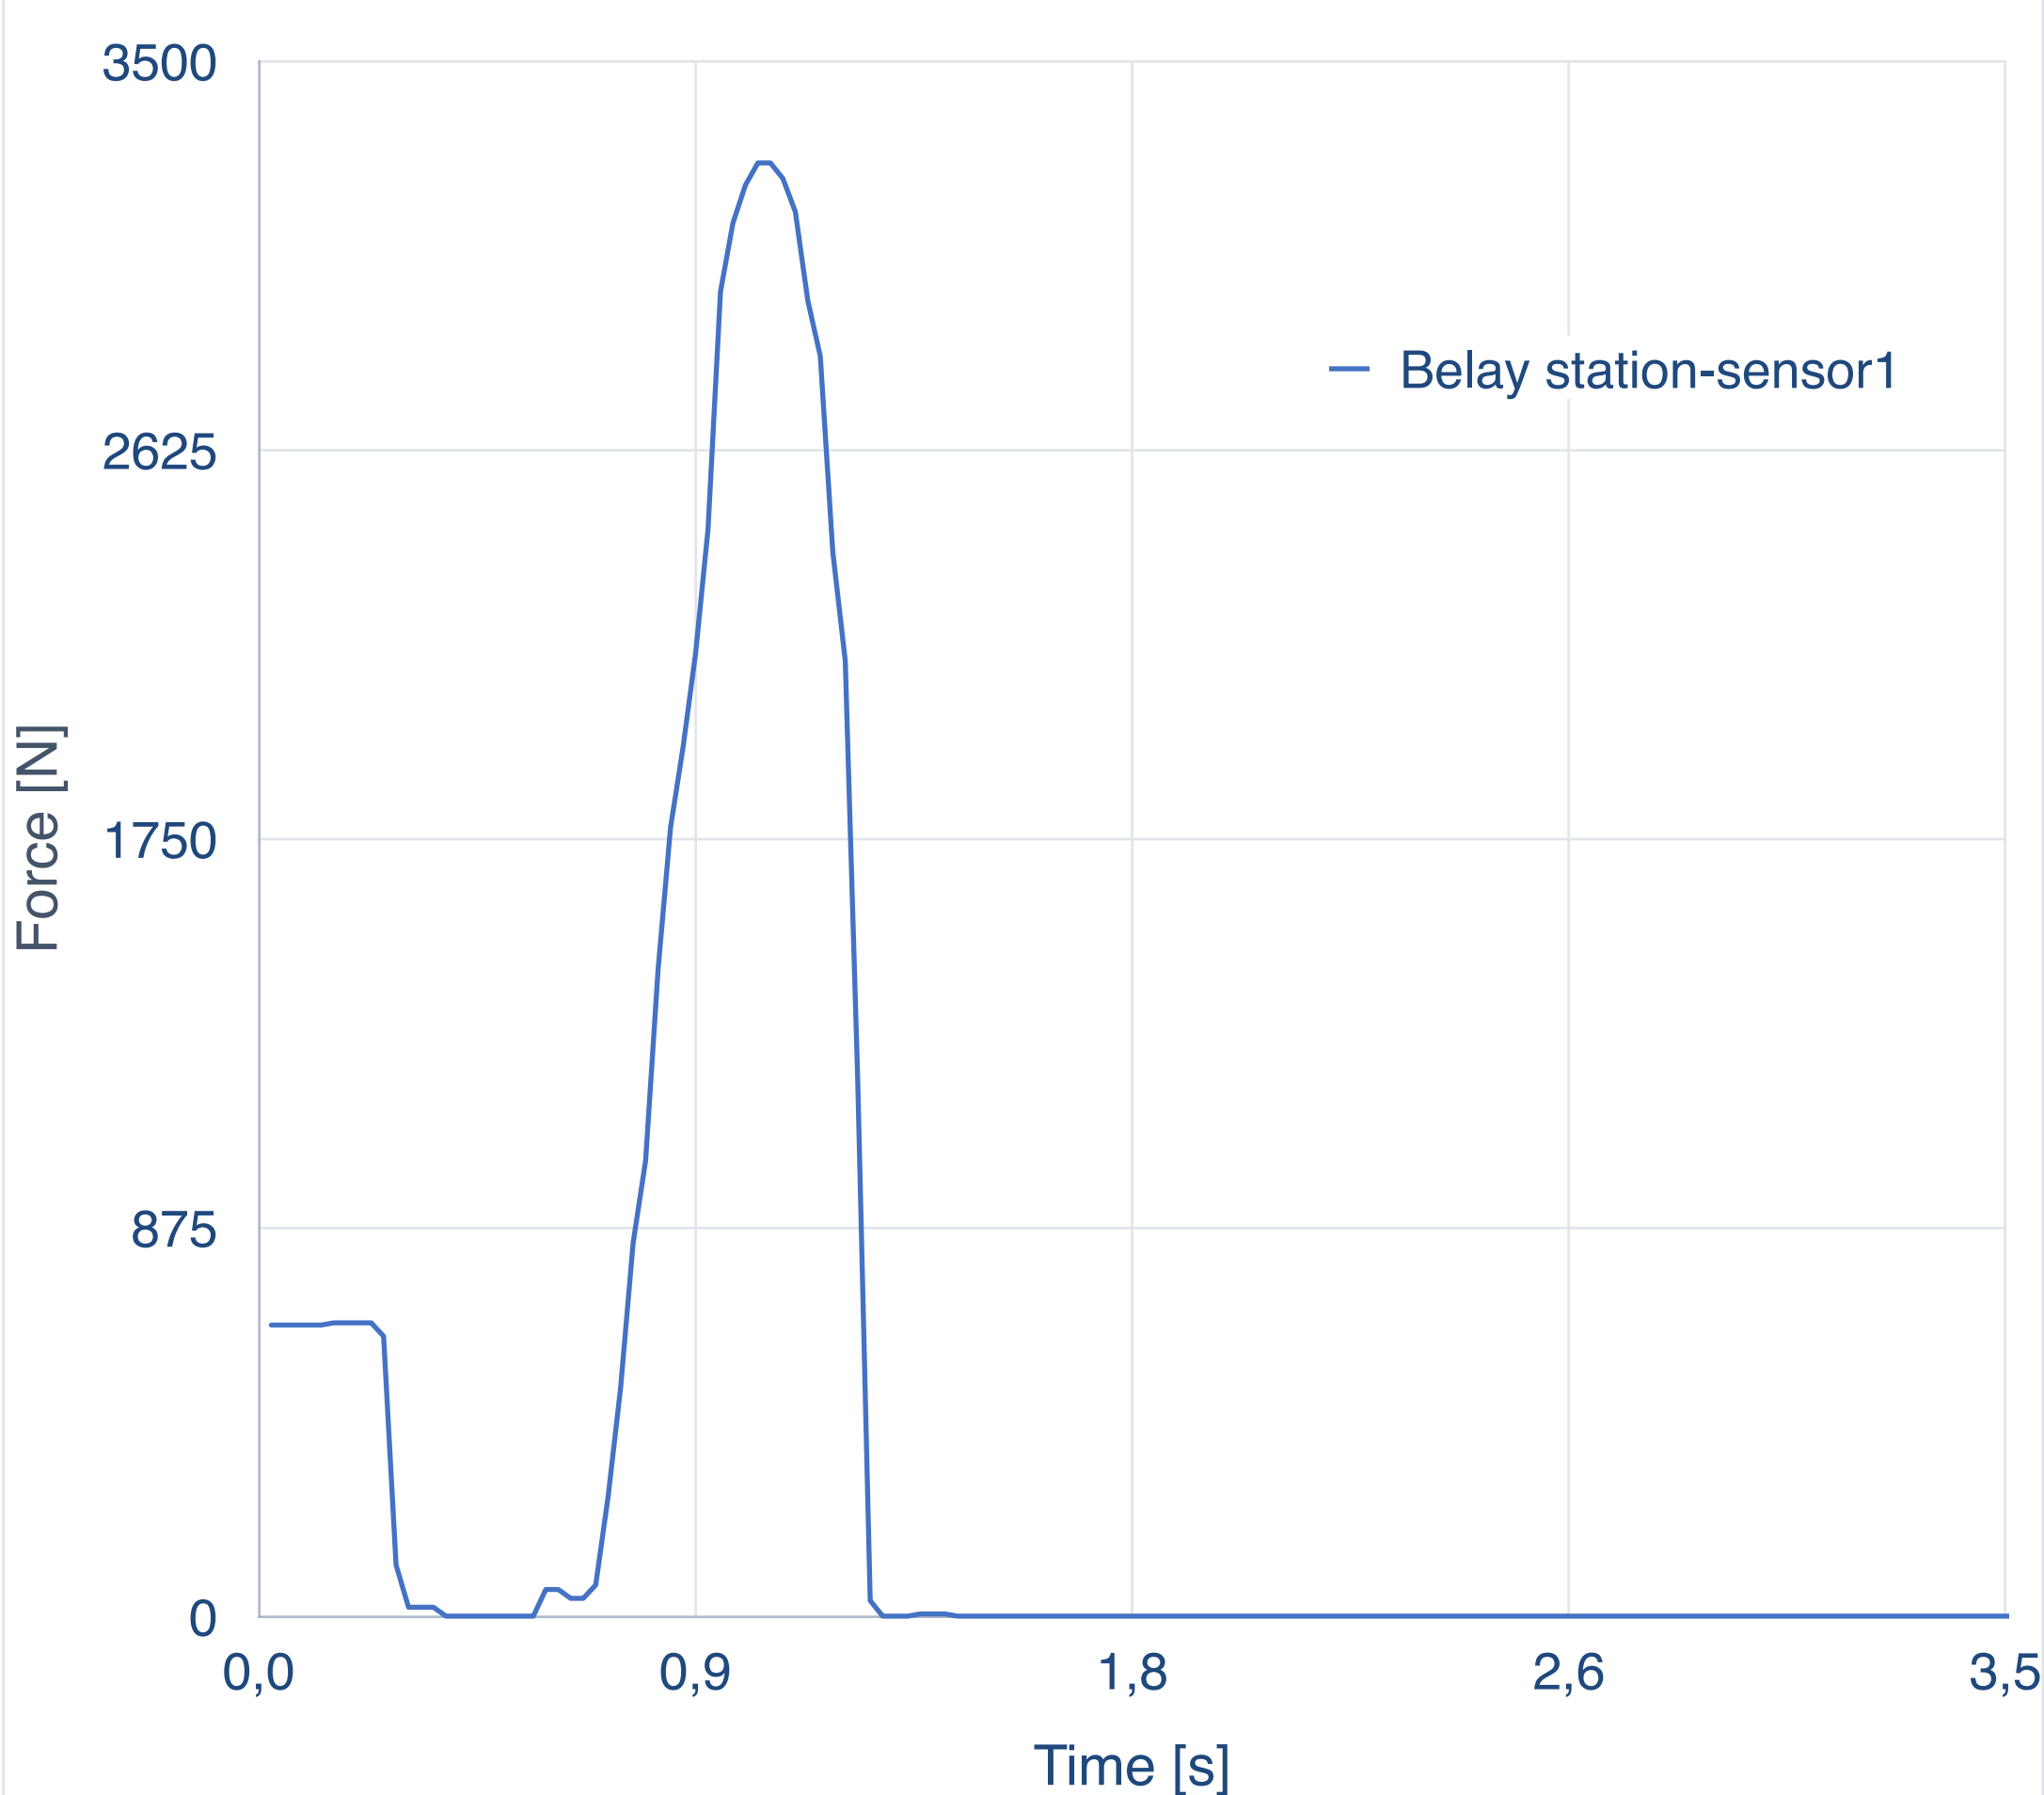
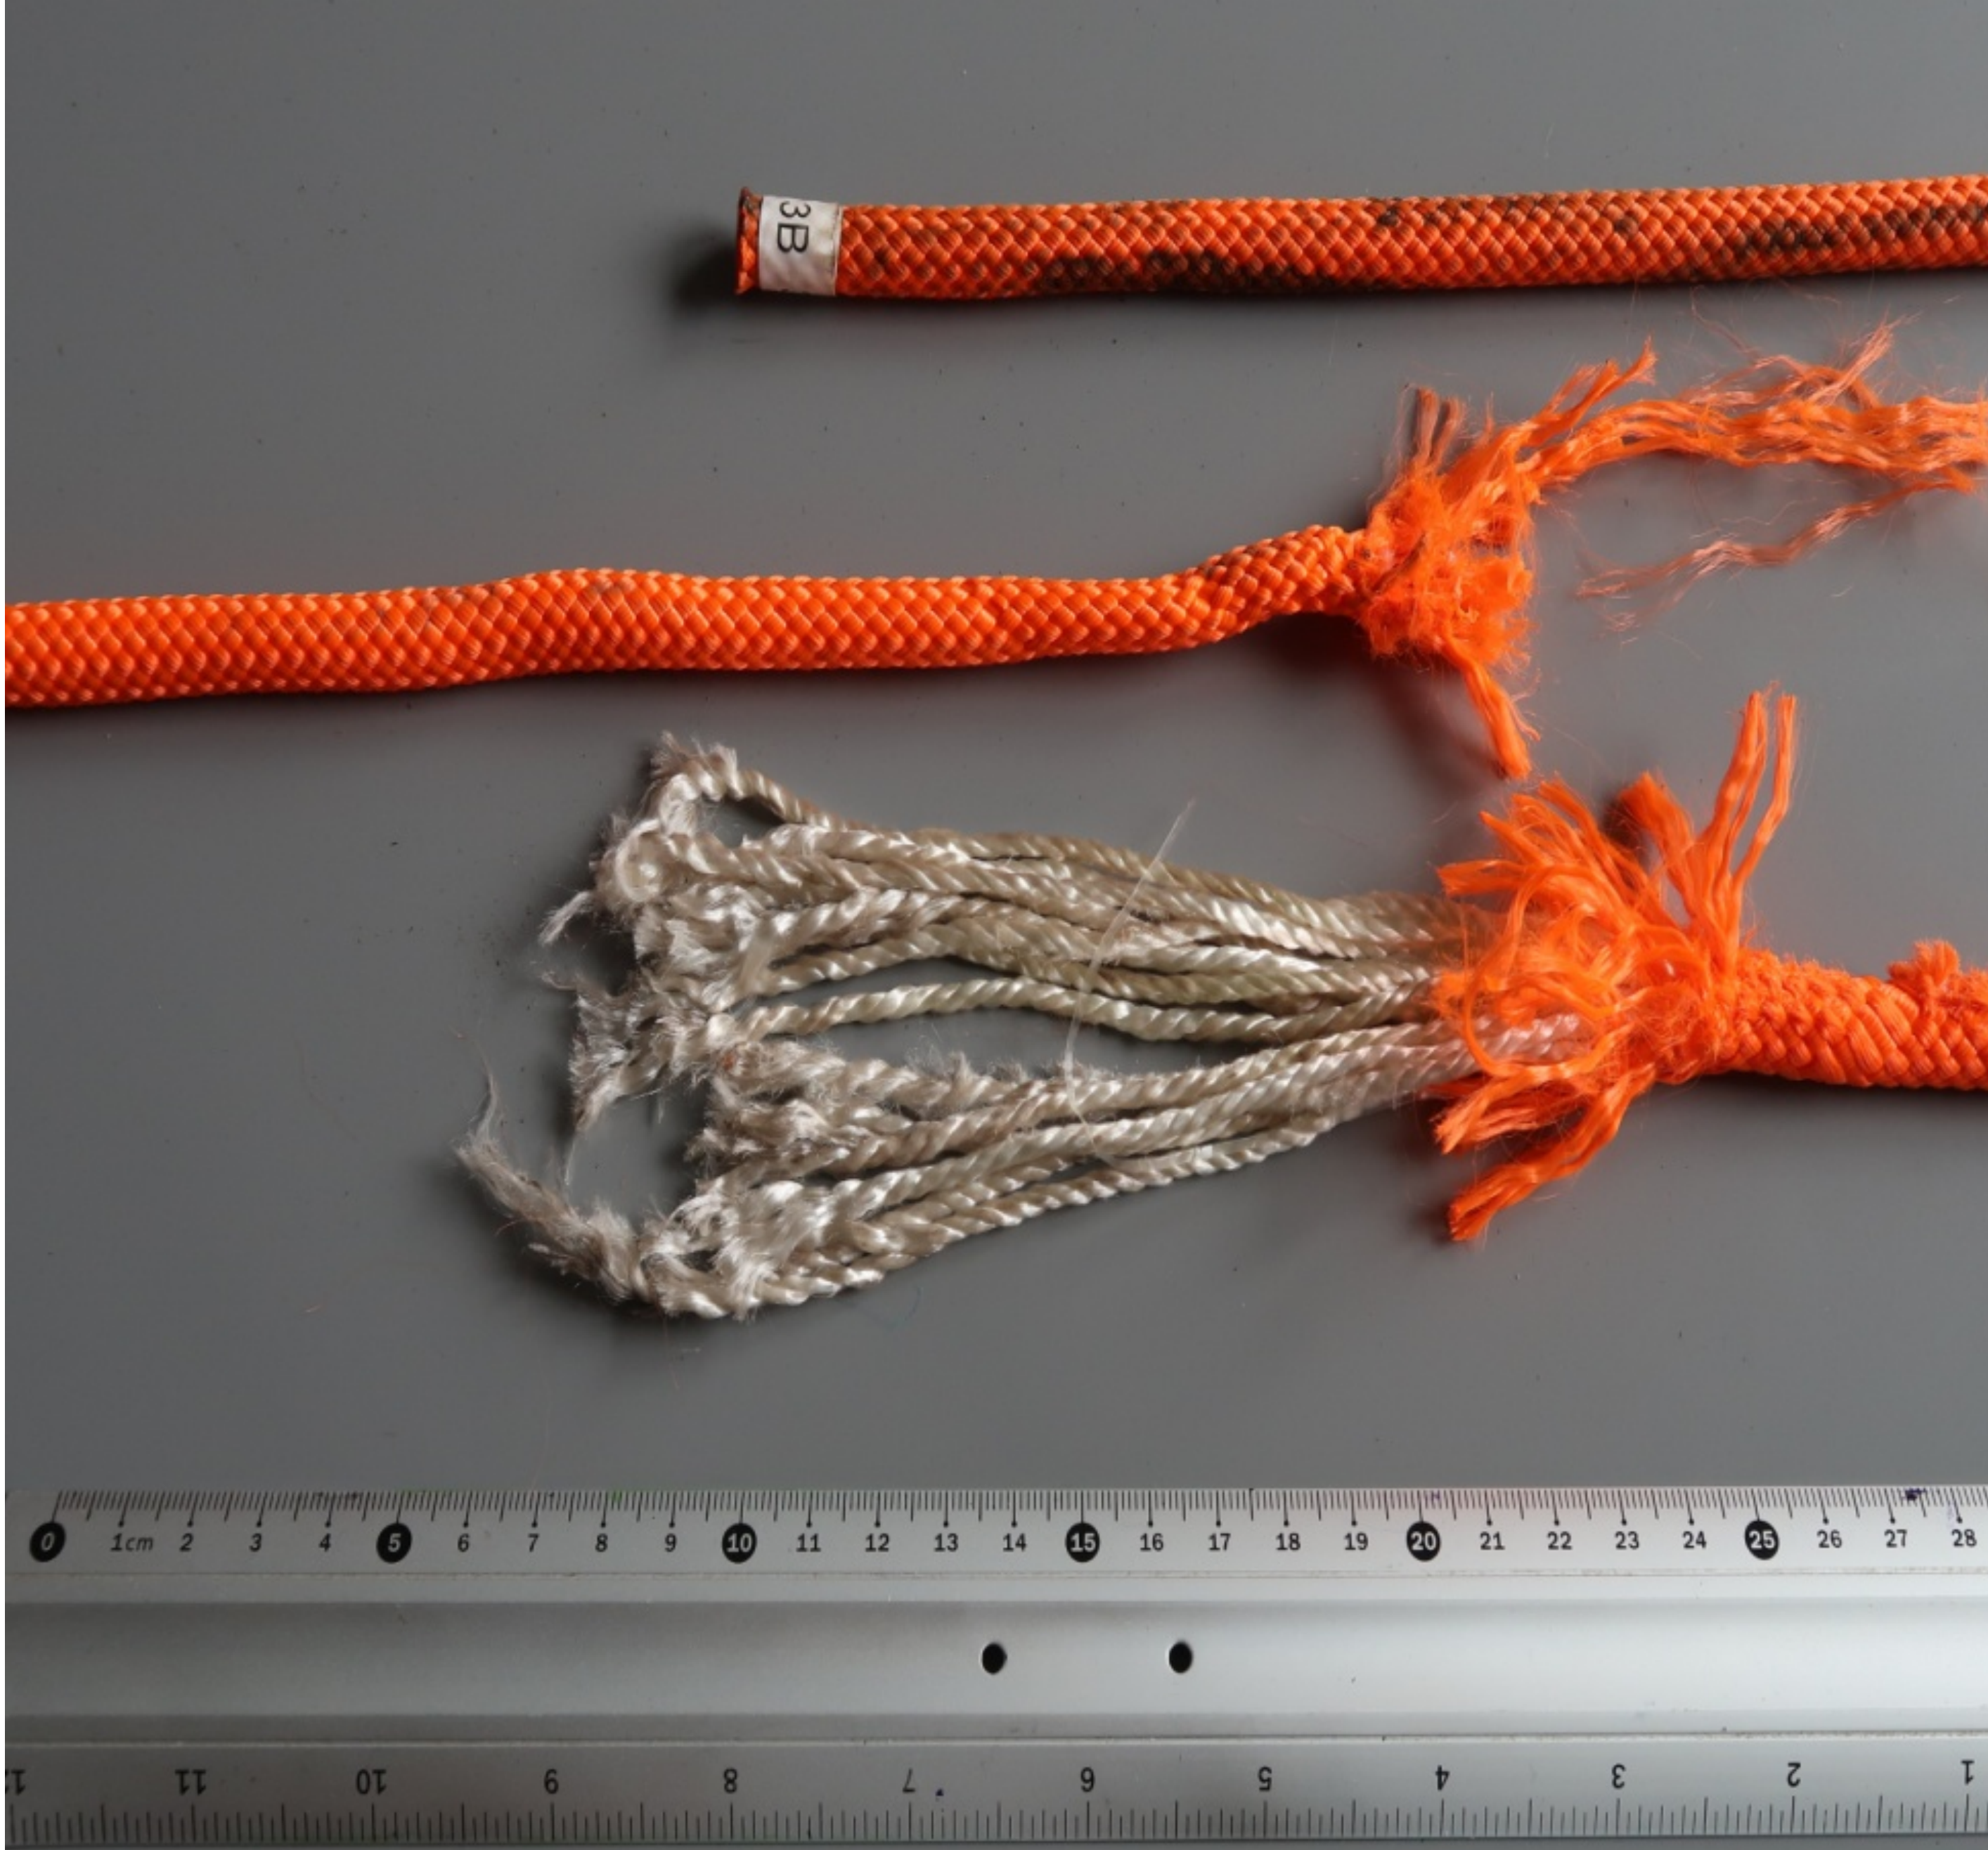
Sharp edge test with a pendulum
- rope 3B
Polyester/polyamid 10,5 mm - 140 kg load

• THE ROPE WAS CUT!

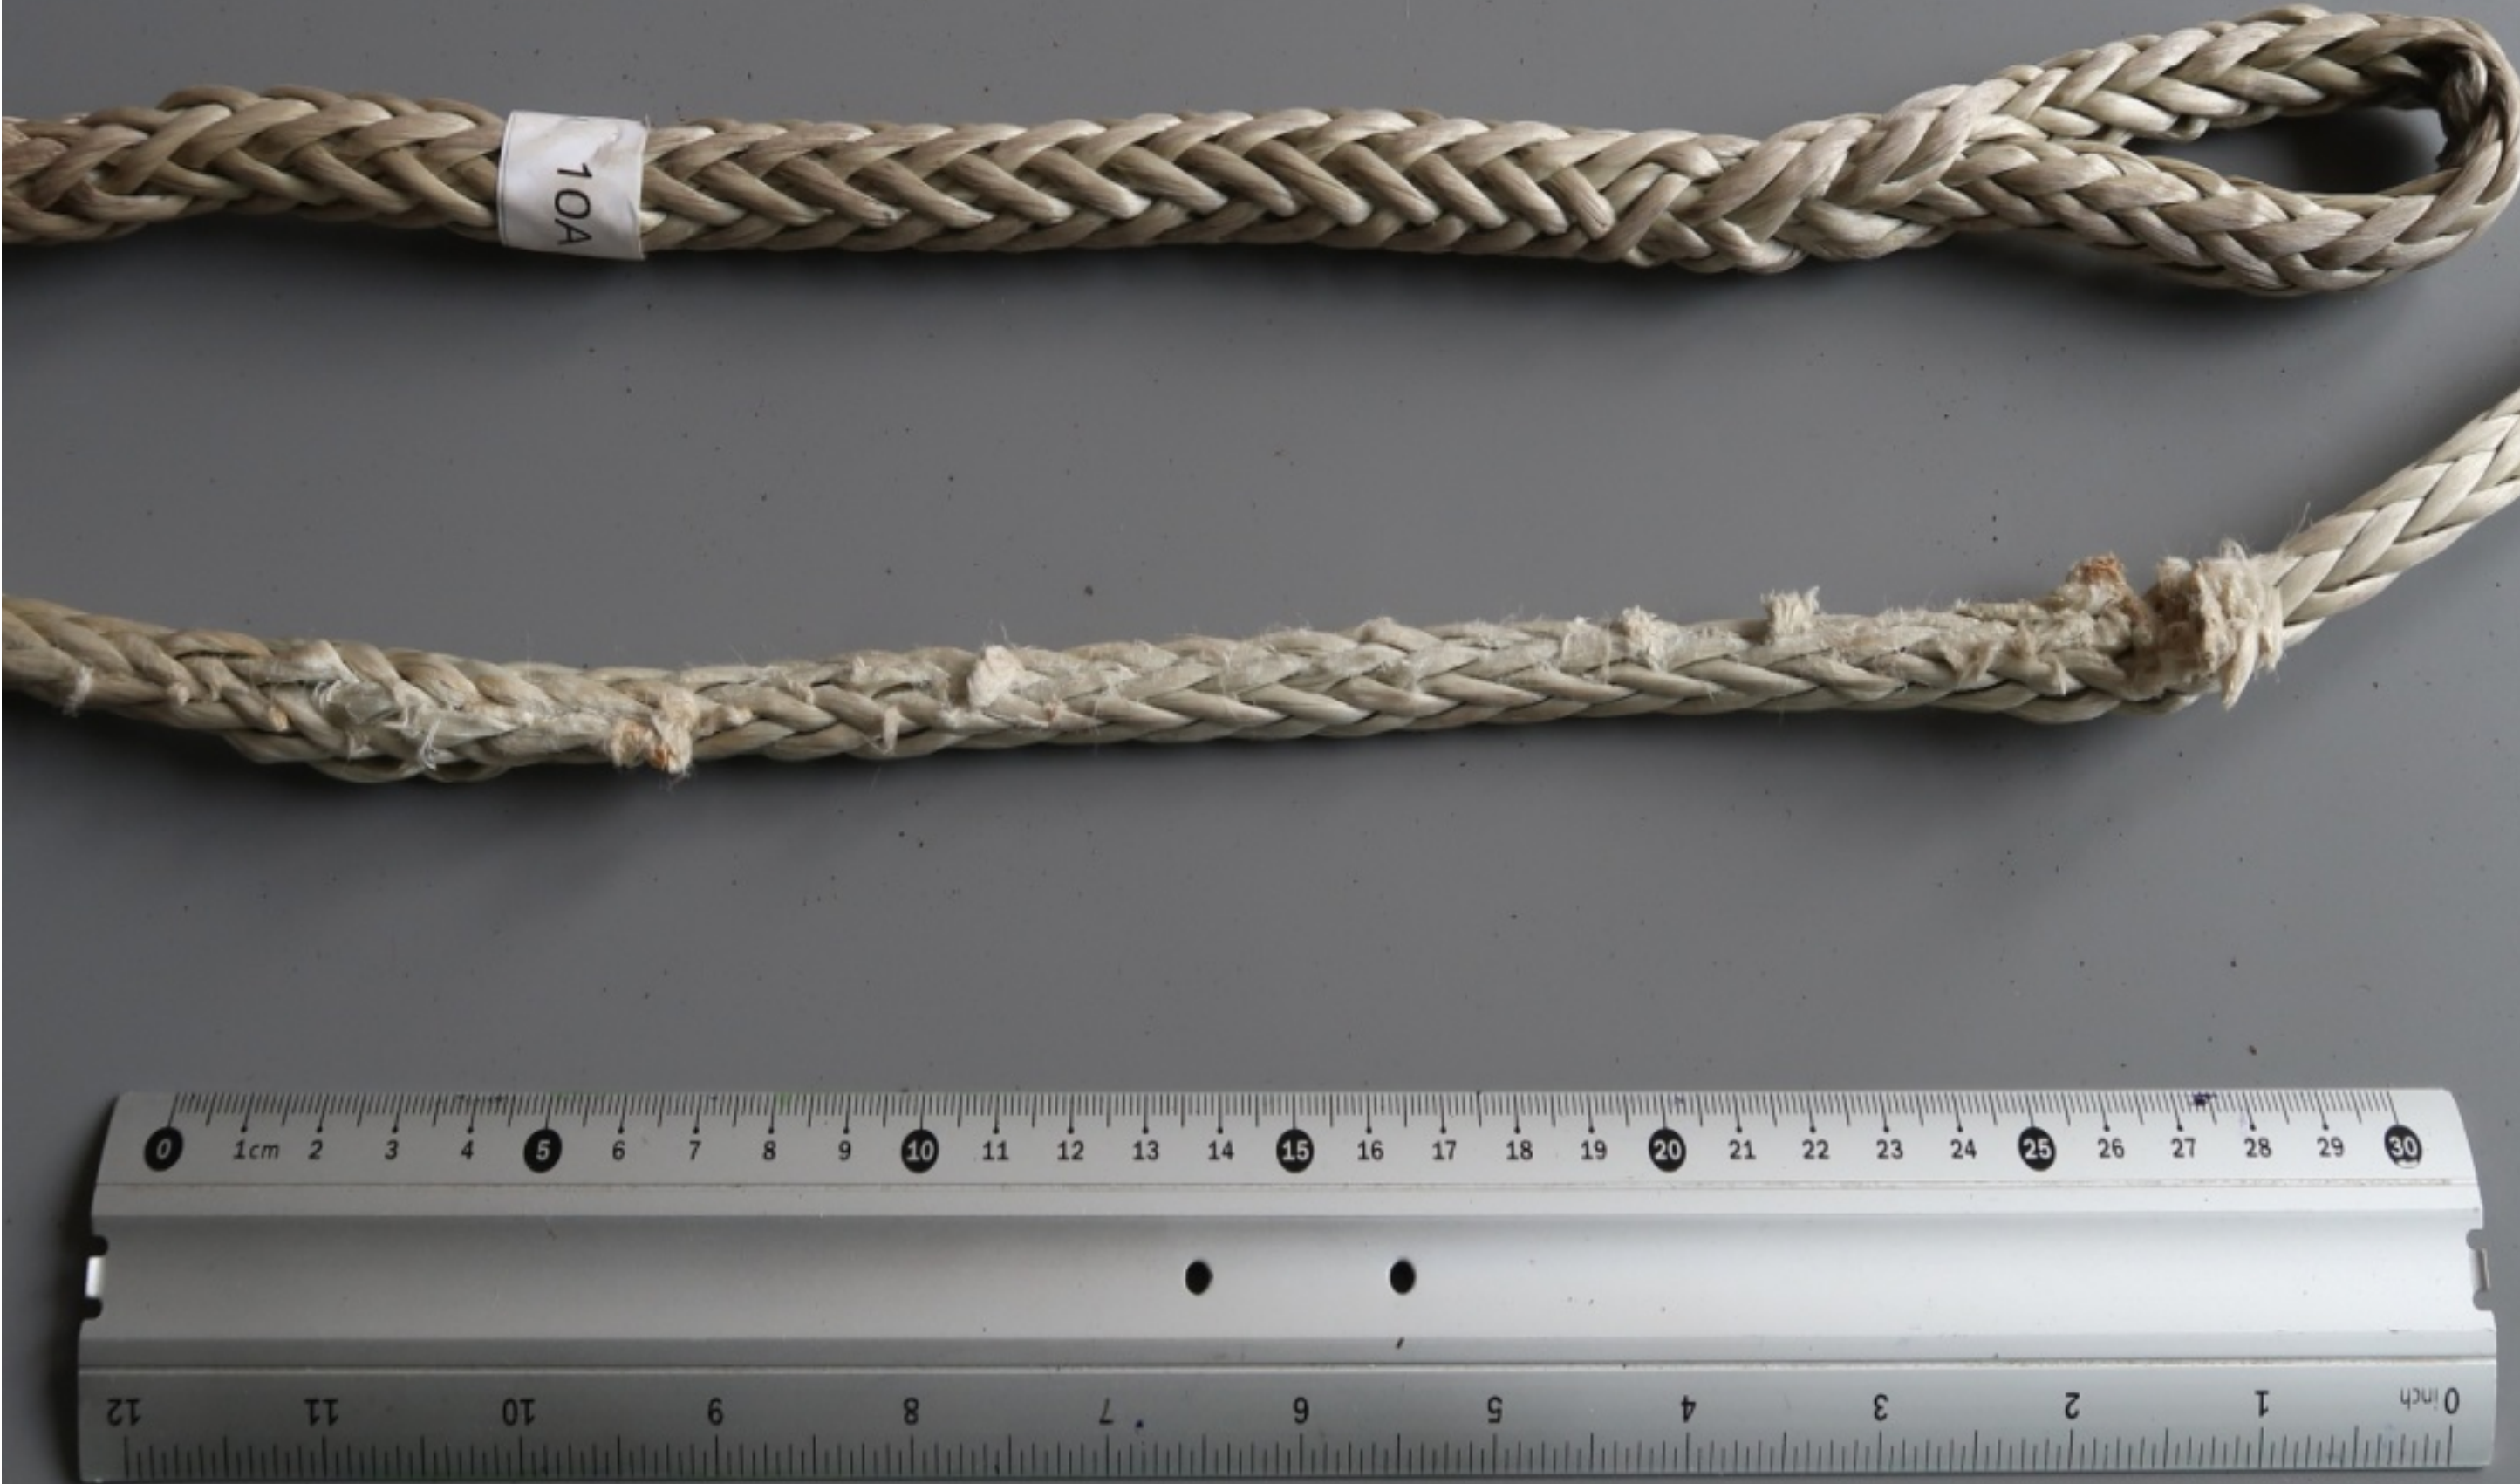
Sharp edge test with a pendulum
200 kg load
UHMWPE 8 mm additionally heat treated

- **THE ROPE DID NOT BREAK!**
The best cut resistance among the tested ropes
