Dyneema incident on Mt. Świnica

authors: Andrzej Marasek, Witold Cikowski, Marcin Józefowicz, prof. dr hab. inż. Jerzy Zych, mgr inż. Tomasz Snopkiewicz, PhD
Eng. Michał Ciszewski, Andrzej Górka

causes of rope failure

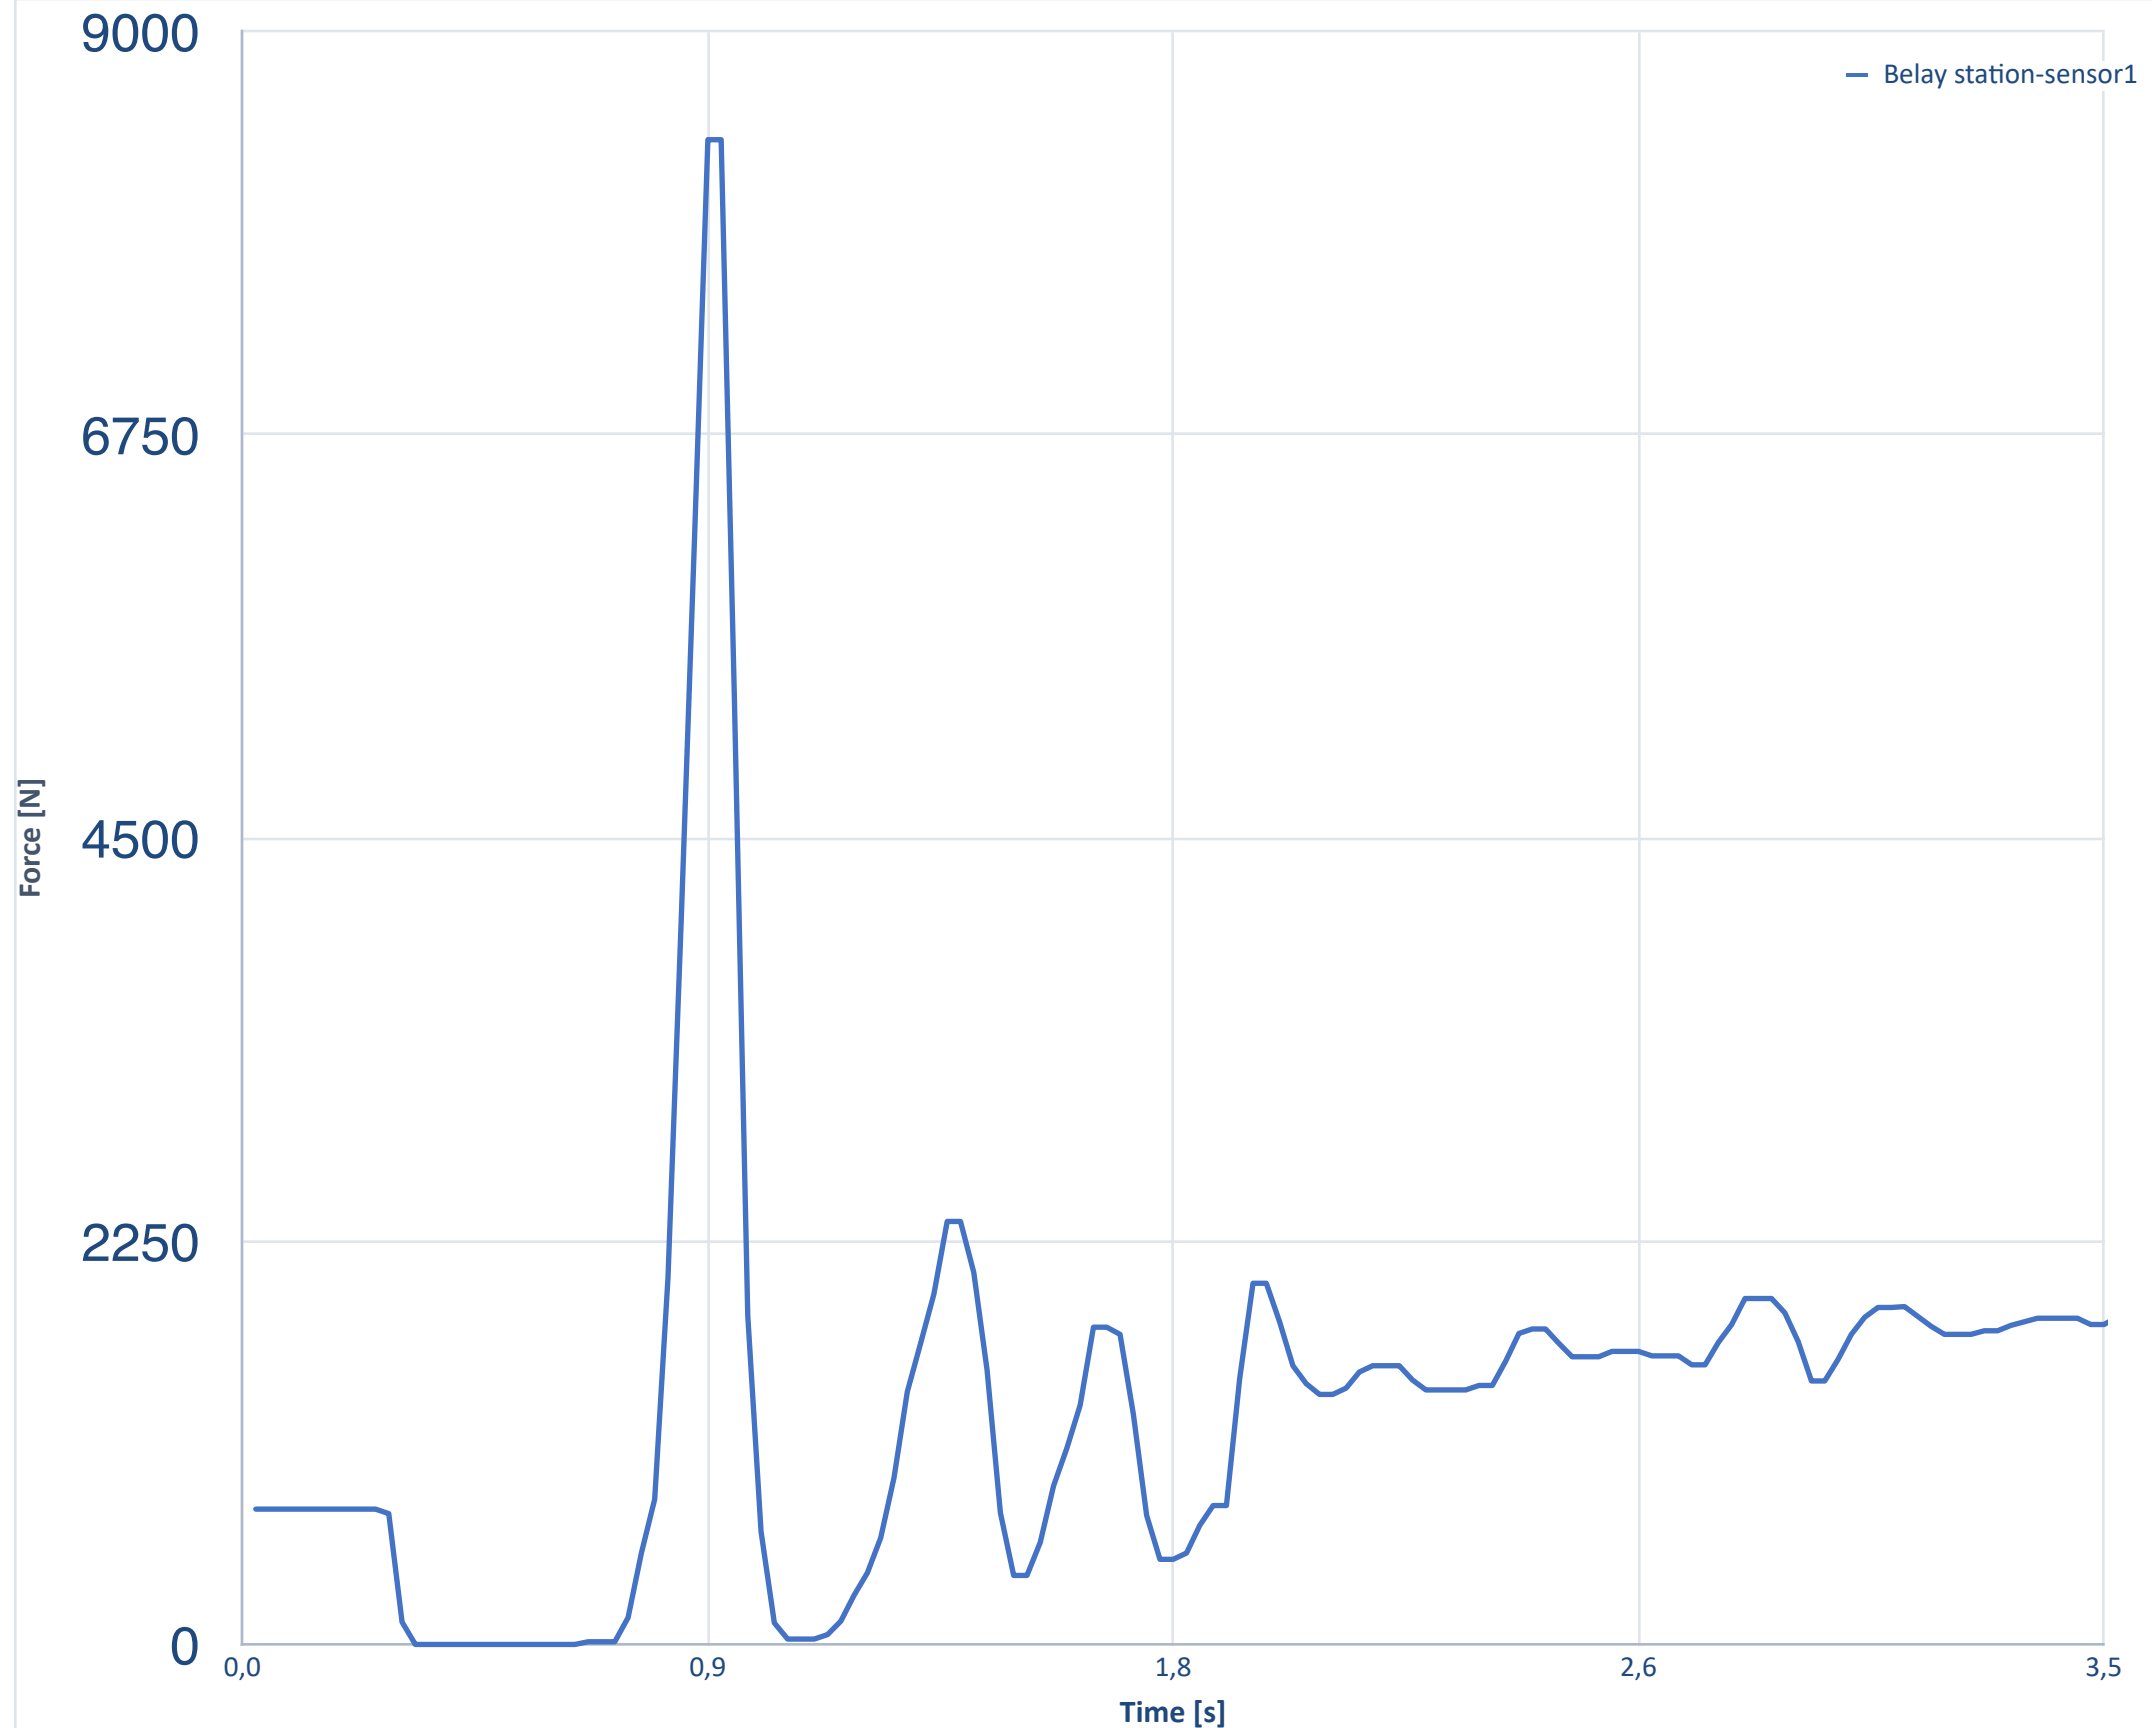
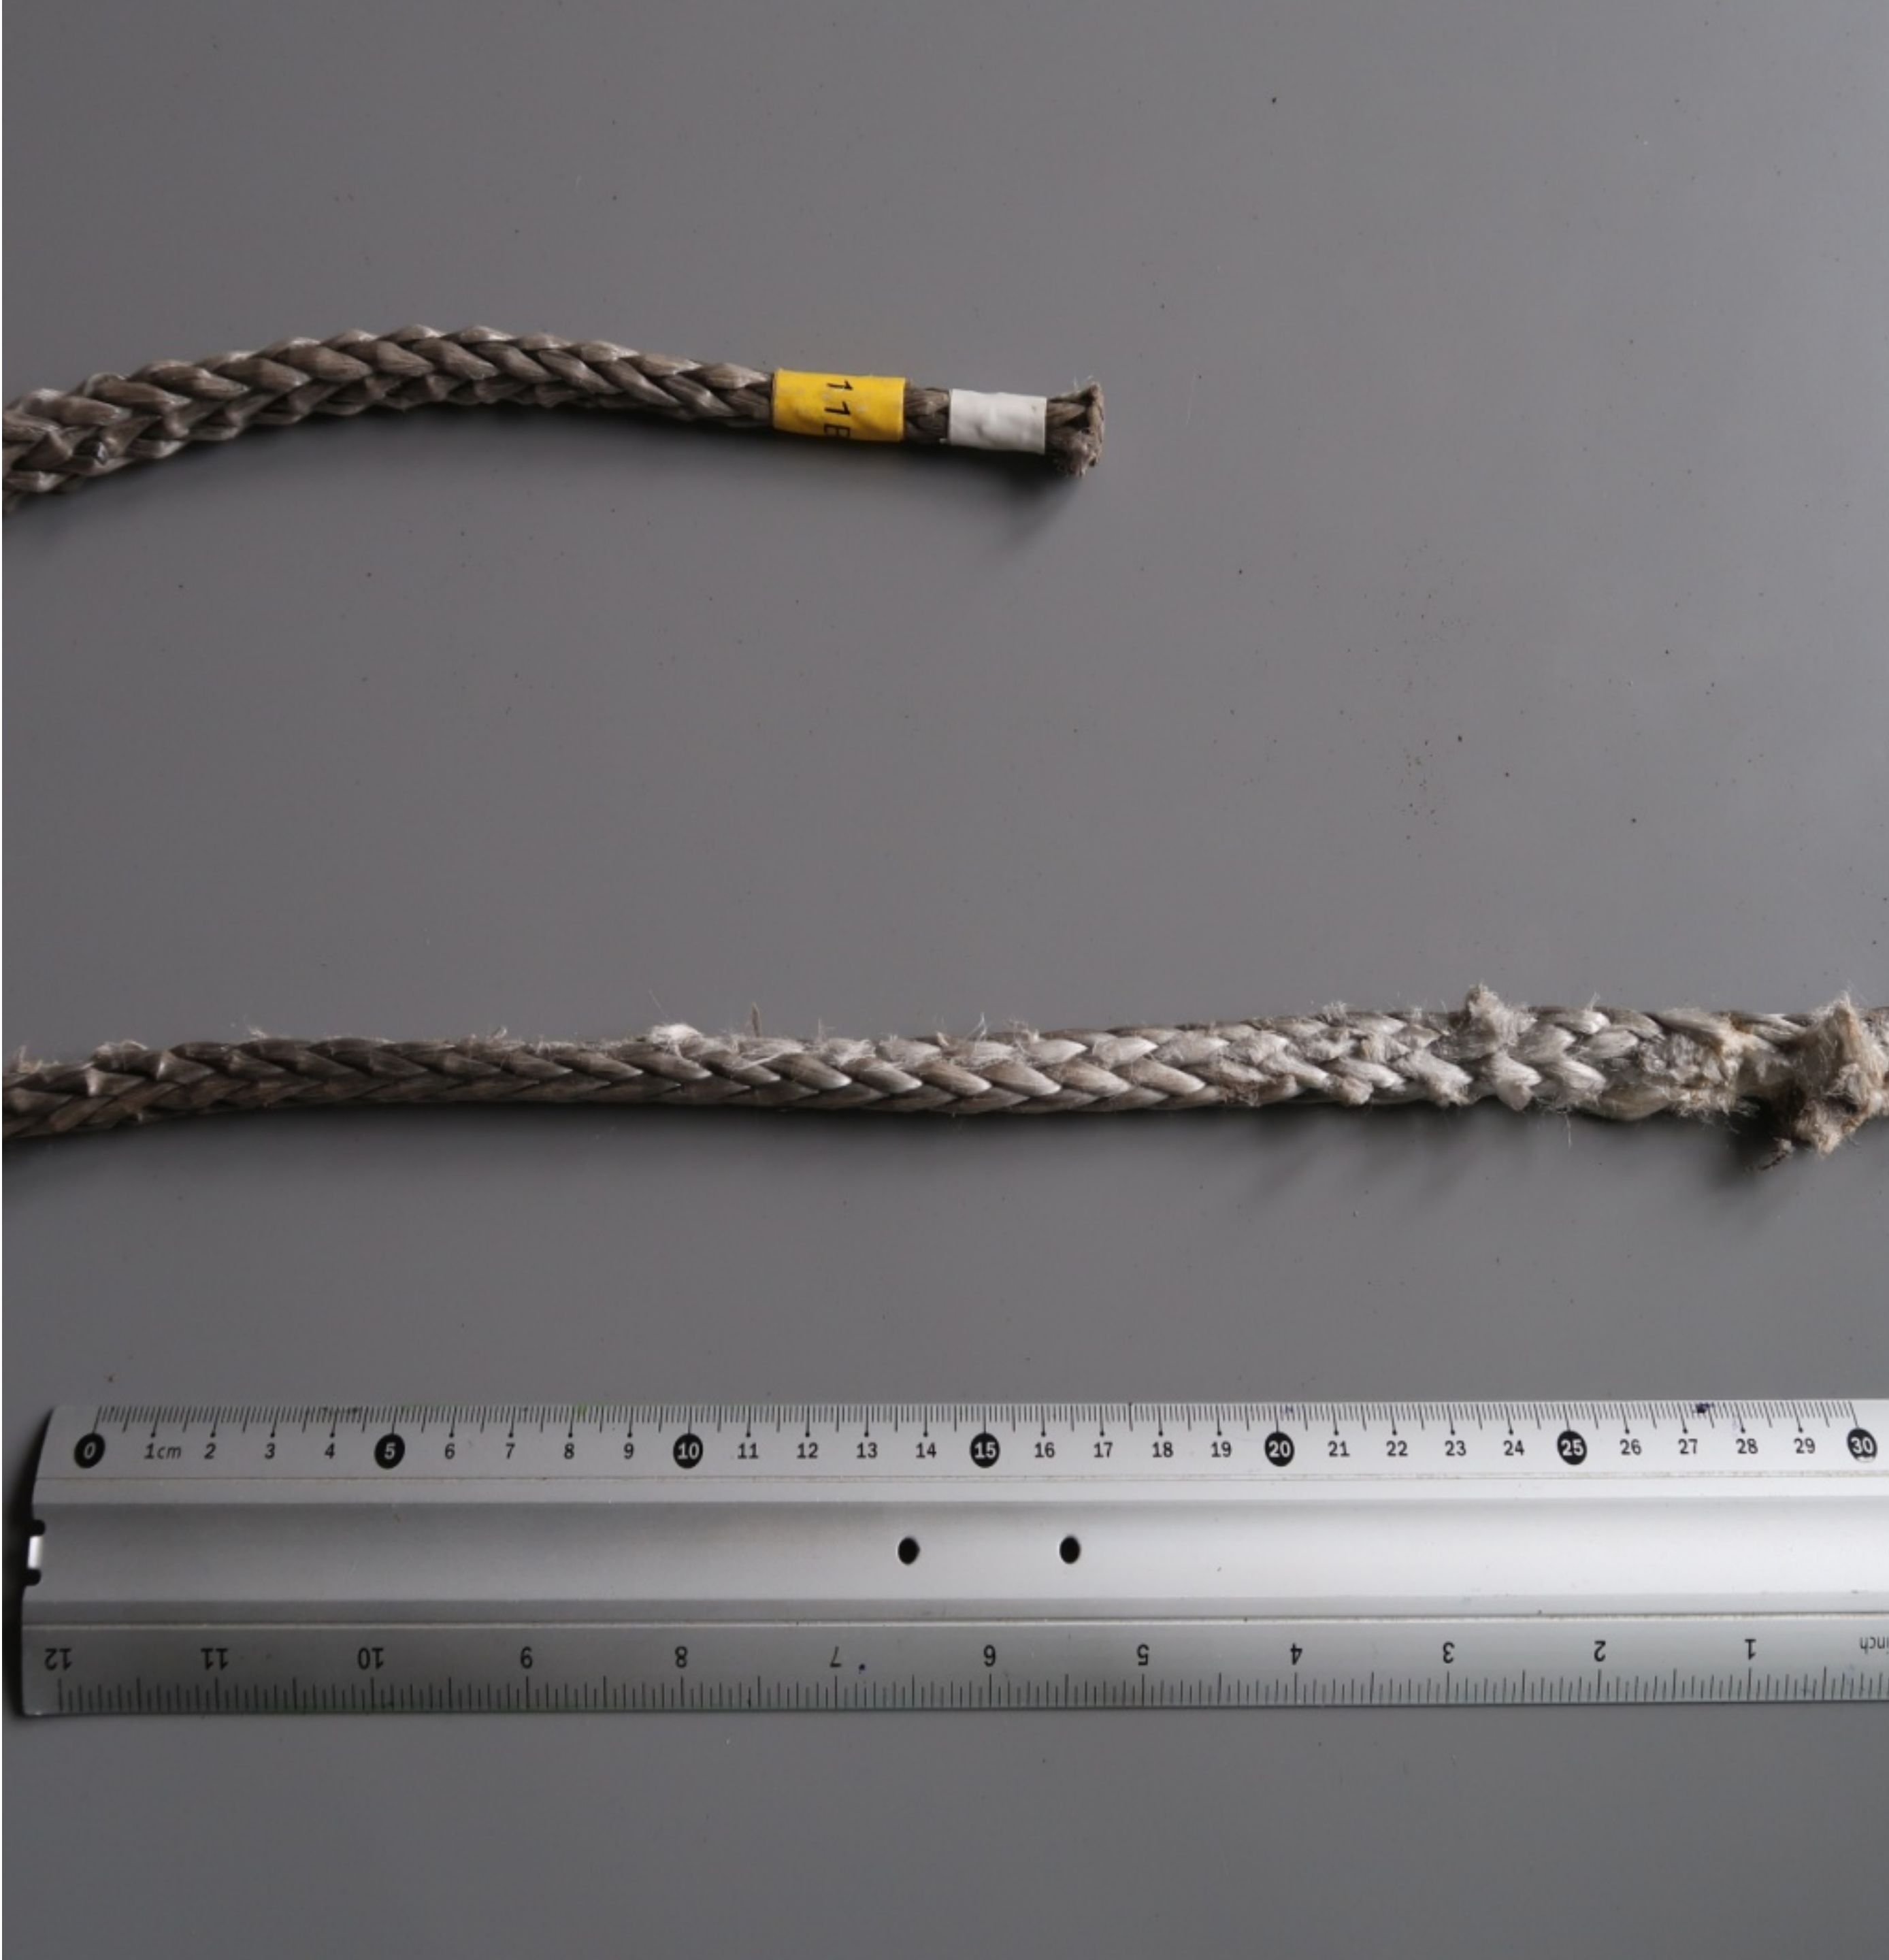
**Sharp edge test with a pendulum - rope 11B
Dyneema 8 mm - 140 kg load
additionally heat treated**

- **THE ROPE DID NOT BREAK**
Medium damage of the rope structure

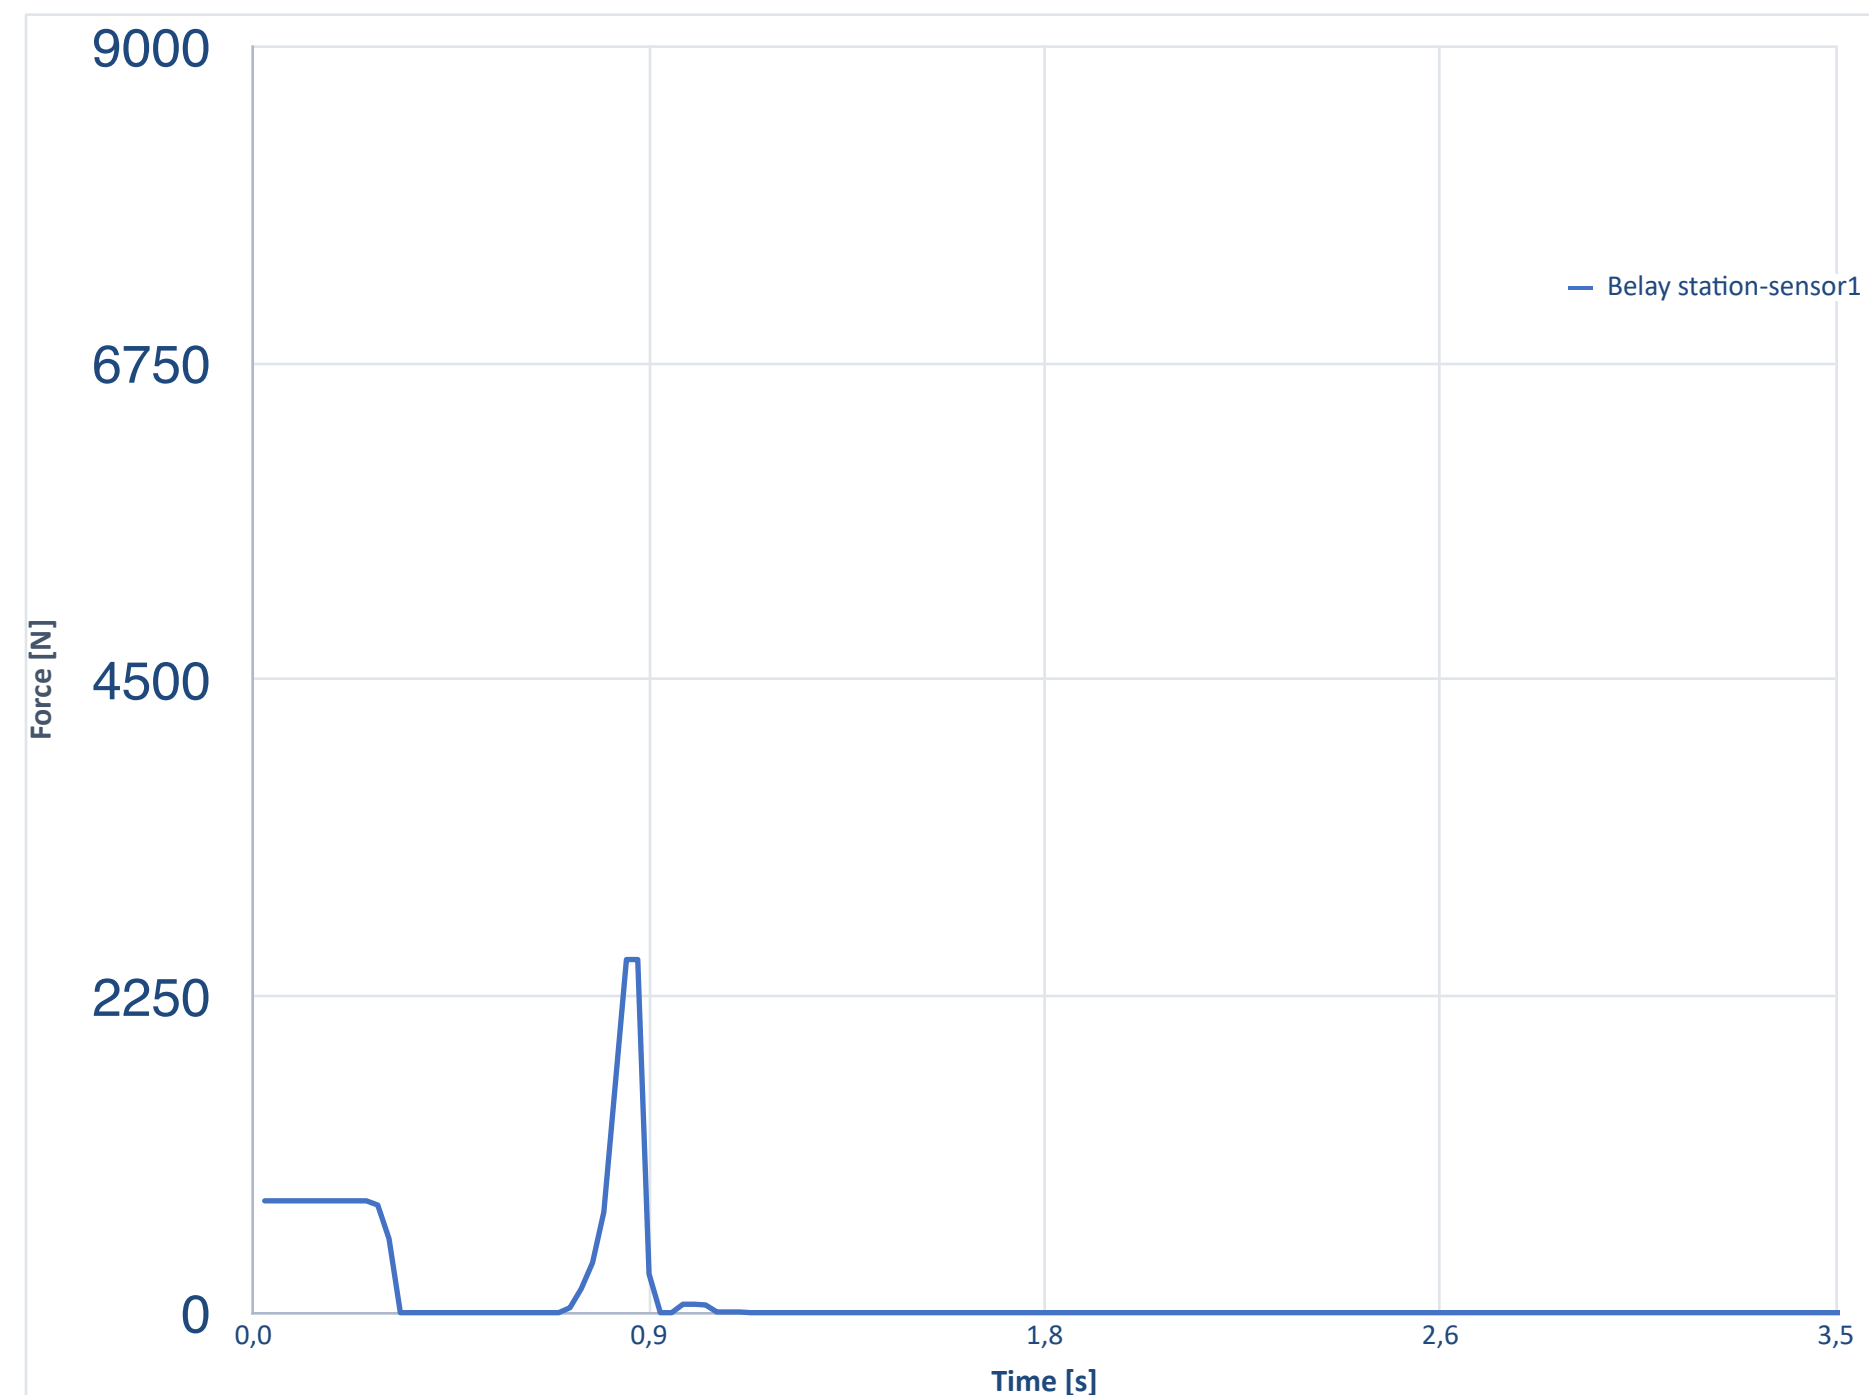
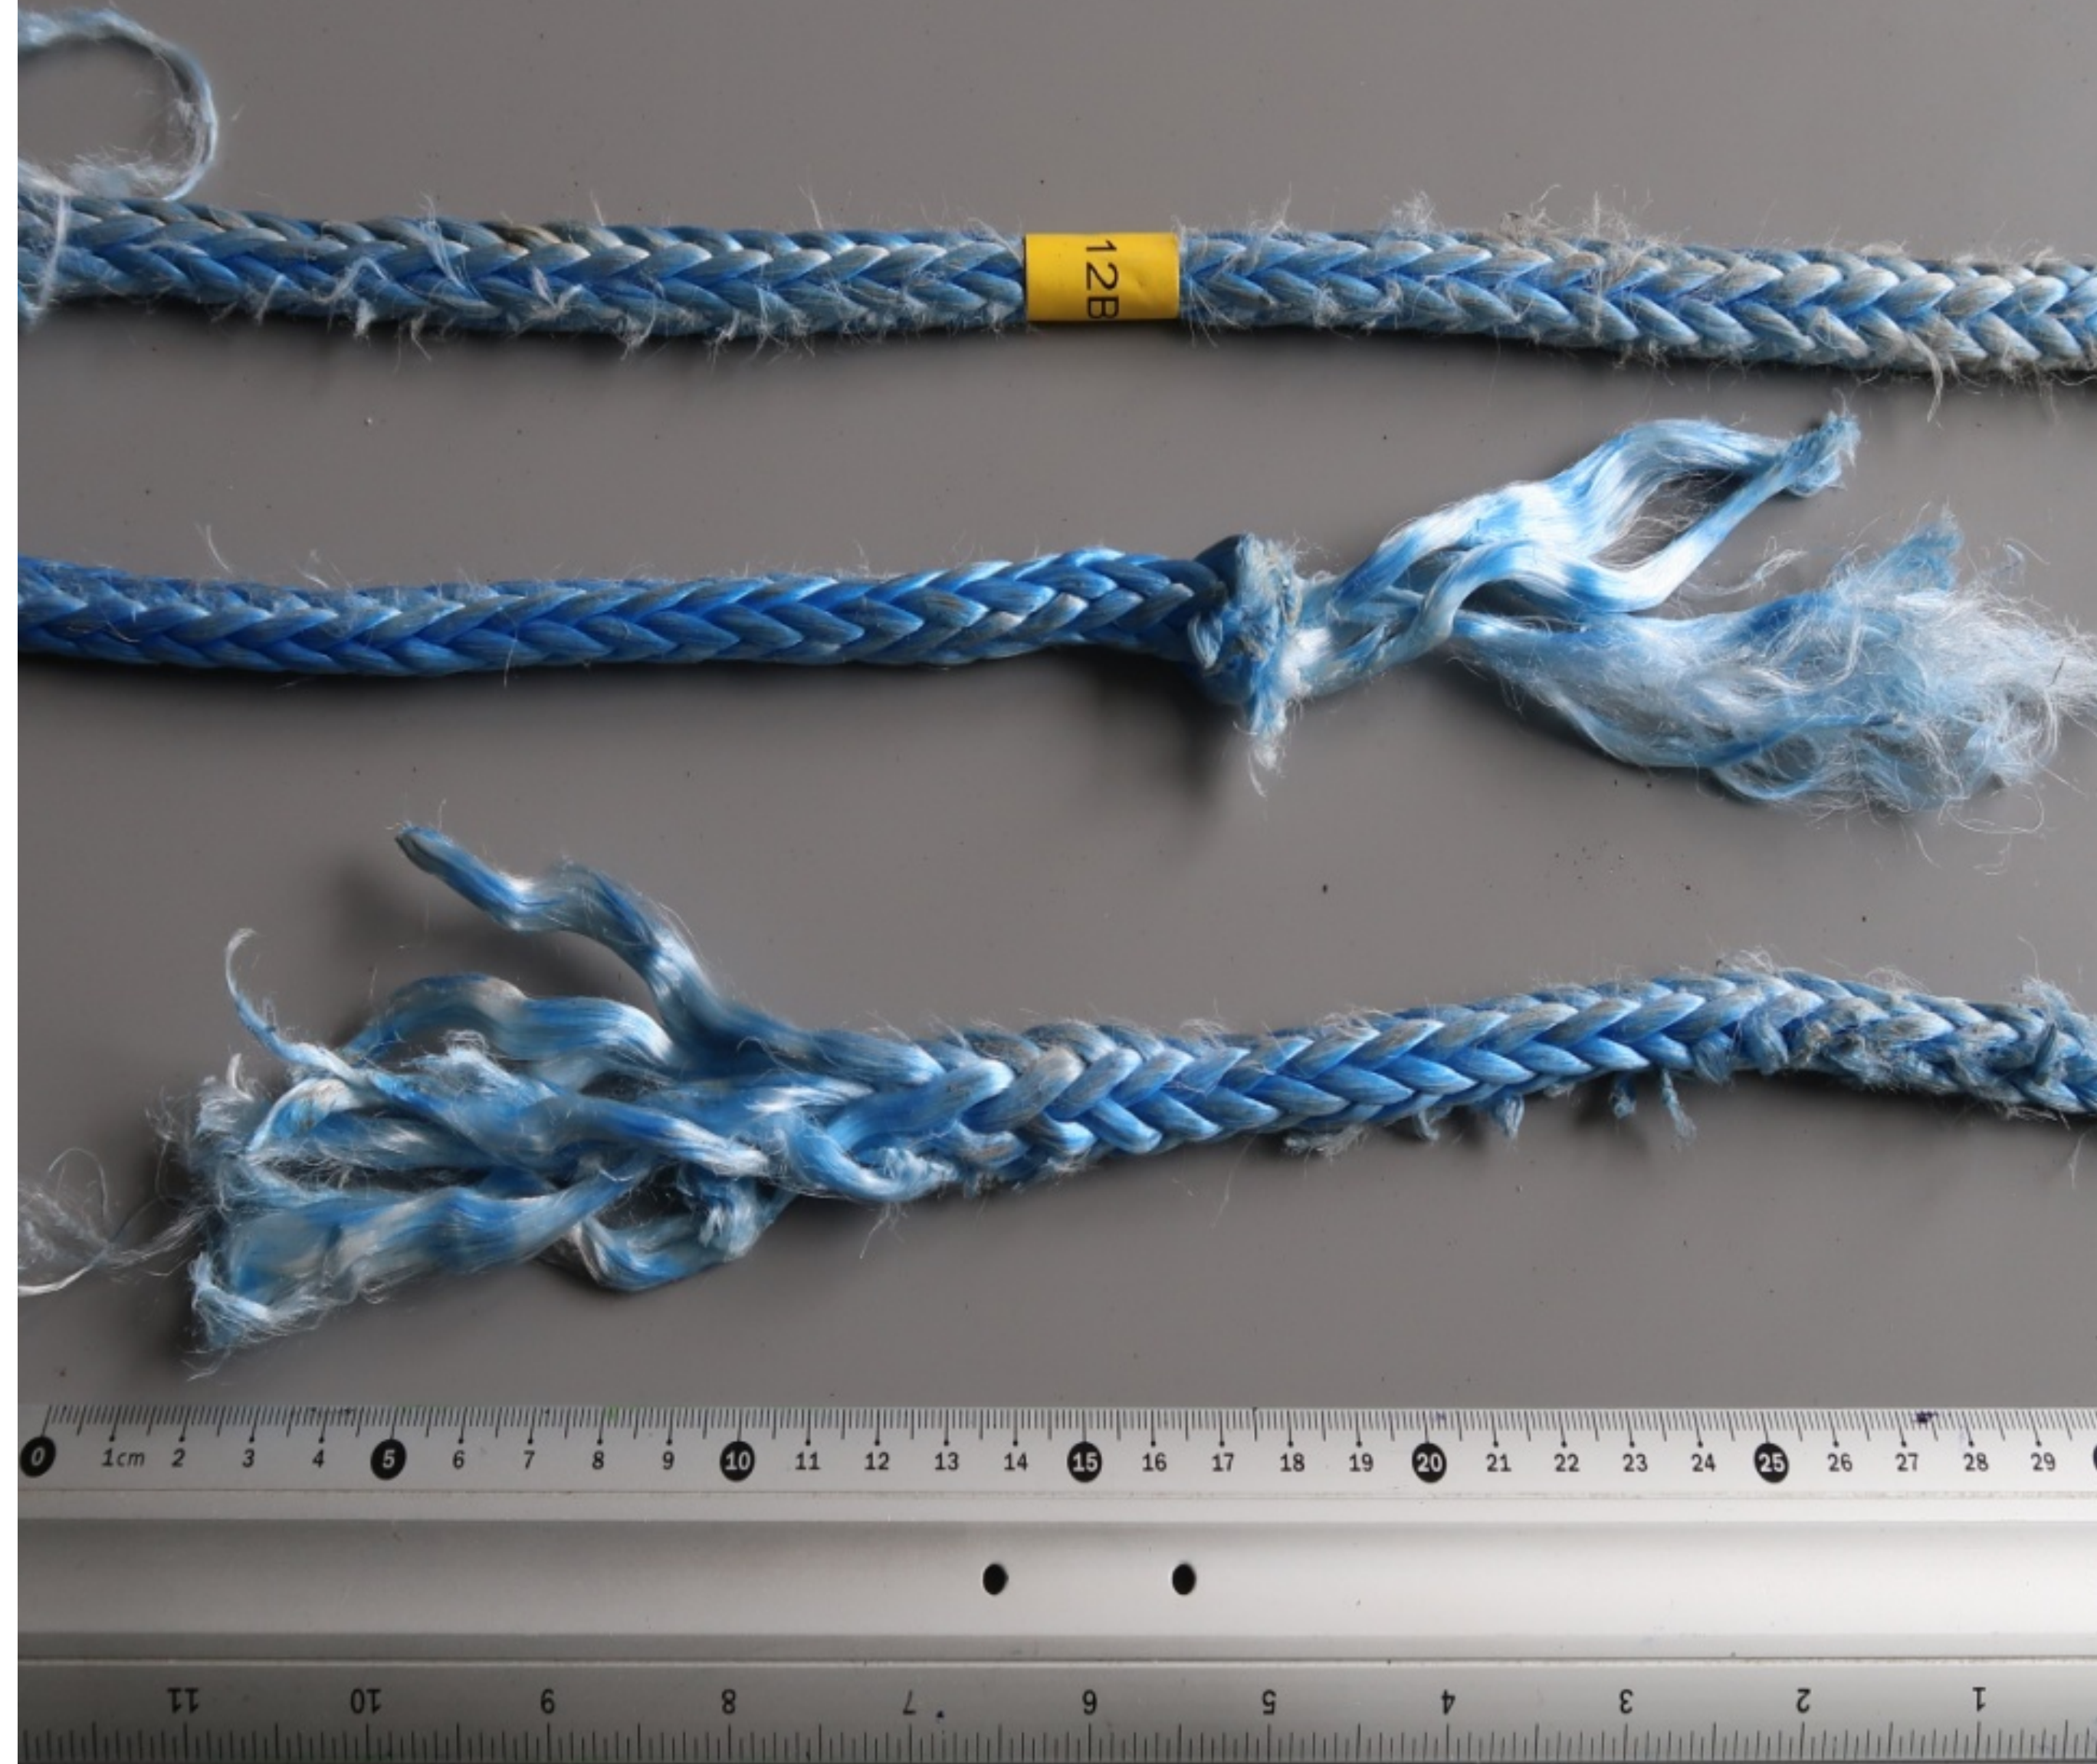
Sharp edge test with a pendulum - rope 12B 8 mm Dyneema - 140 kg load

- **THE ROPE WAS CUT!**
- **Rapid melting of material with very low force compared to other Dyneema ropes!**

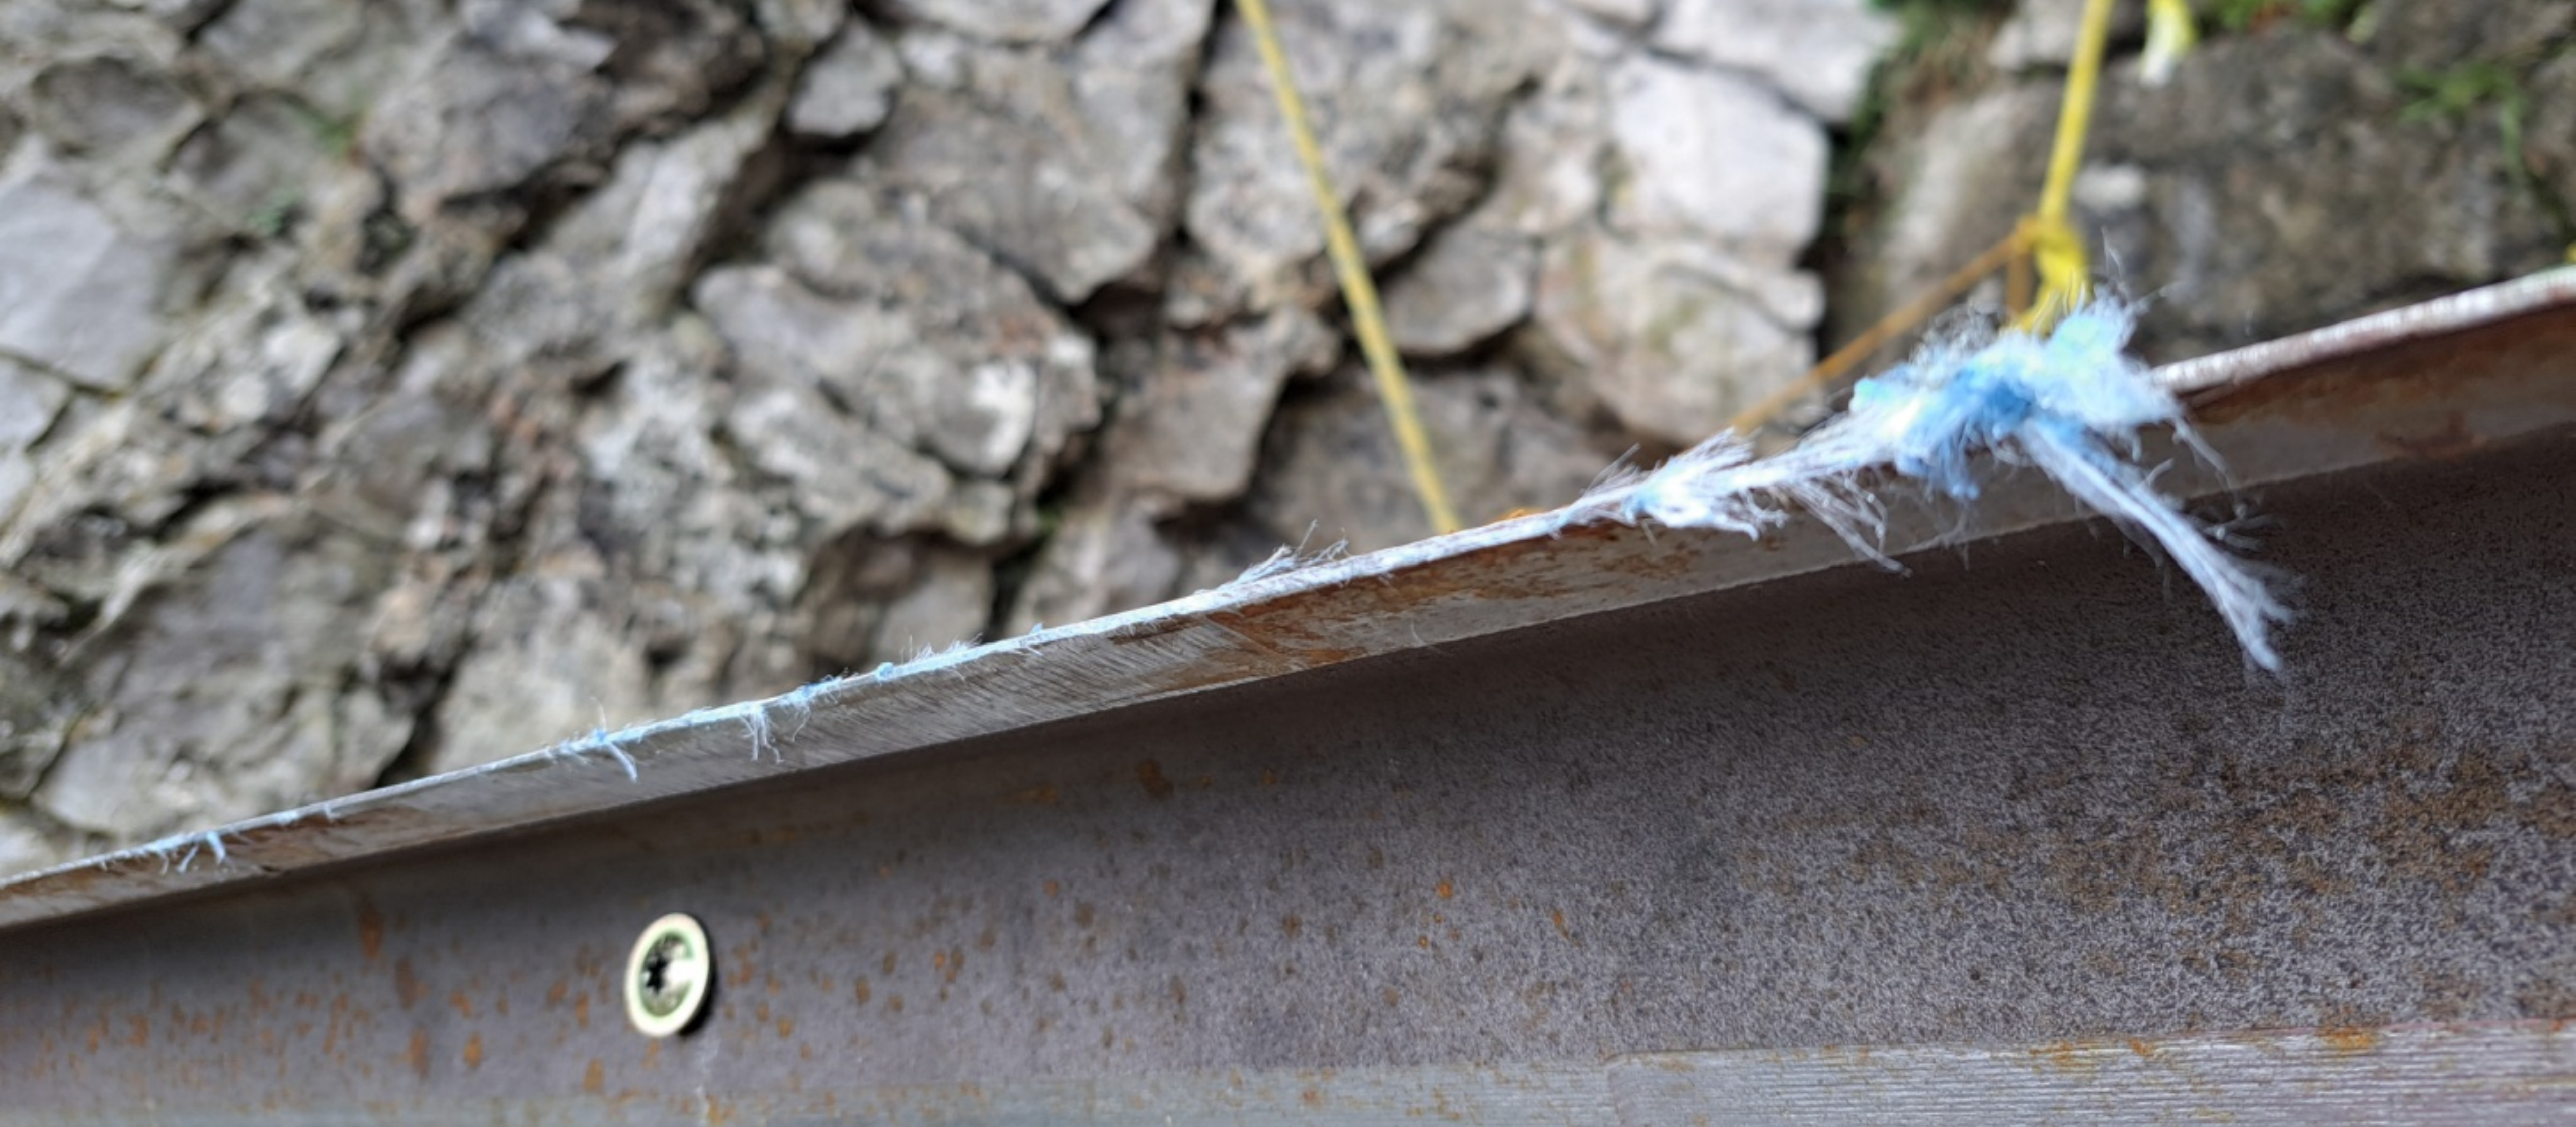
rope 12B, 8 mm Dyneema - 140 kg load

2 mm test edge after the rope failure
