Dyneema incident on Mt. Świnica

authors: Andrzej Marasek, Witold Cikowski, Marcin Józefowicz, prof. dr hab. inż. Jerzy Zych, mgr inż. Tomasz Snopkiewicz, PhD
Eng. Michał Ciszewski, Andrzej Górka

causes of rope failure

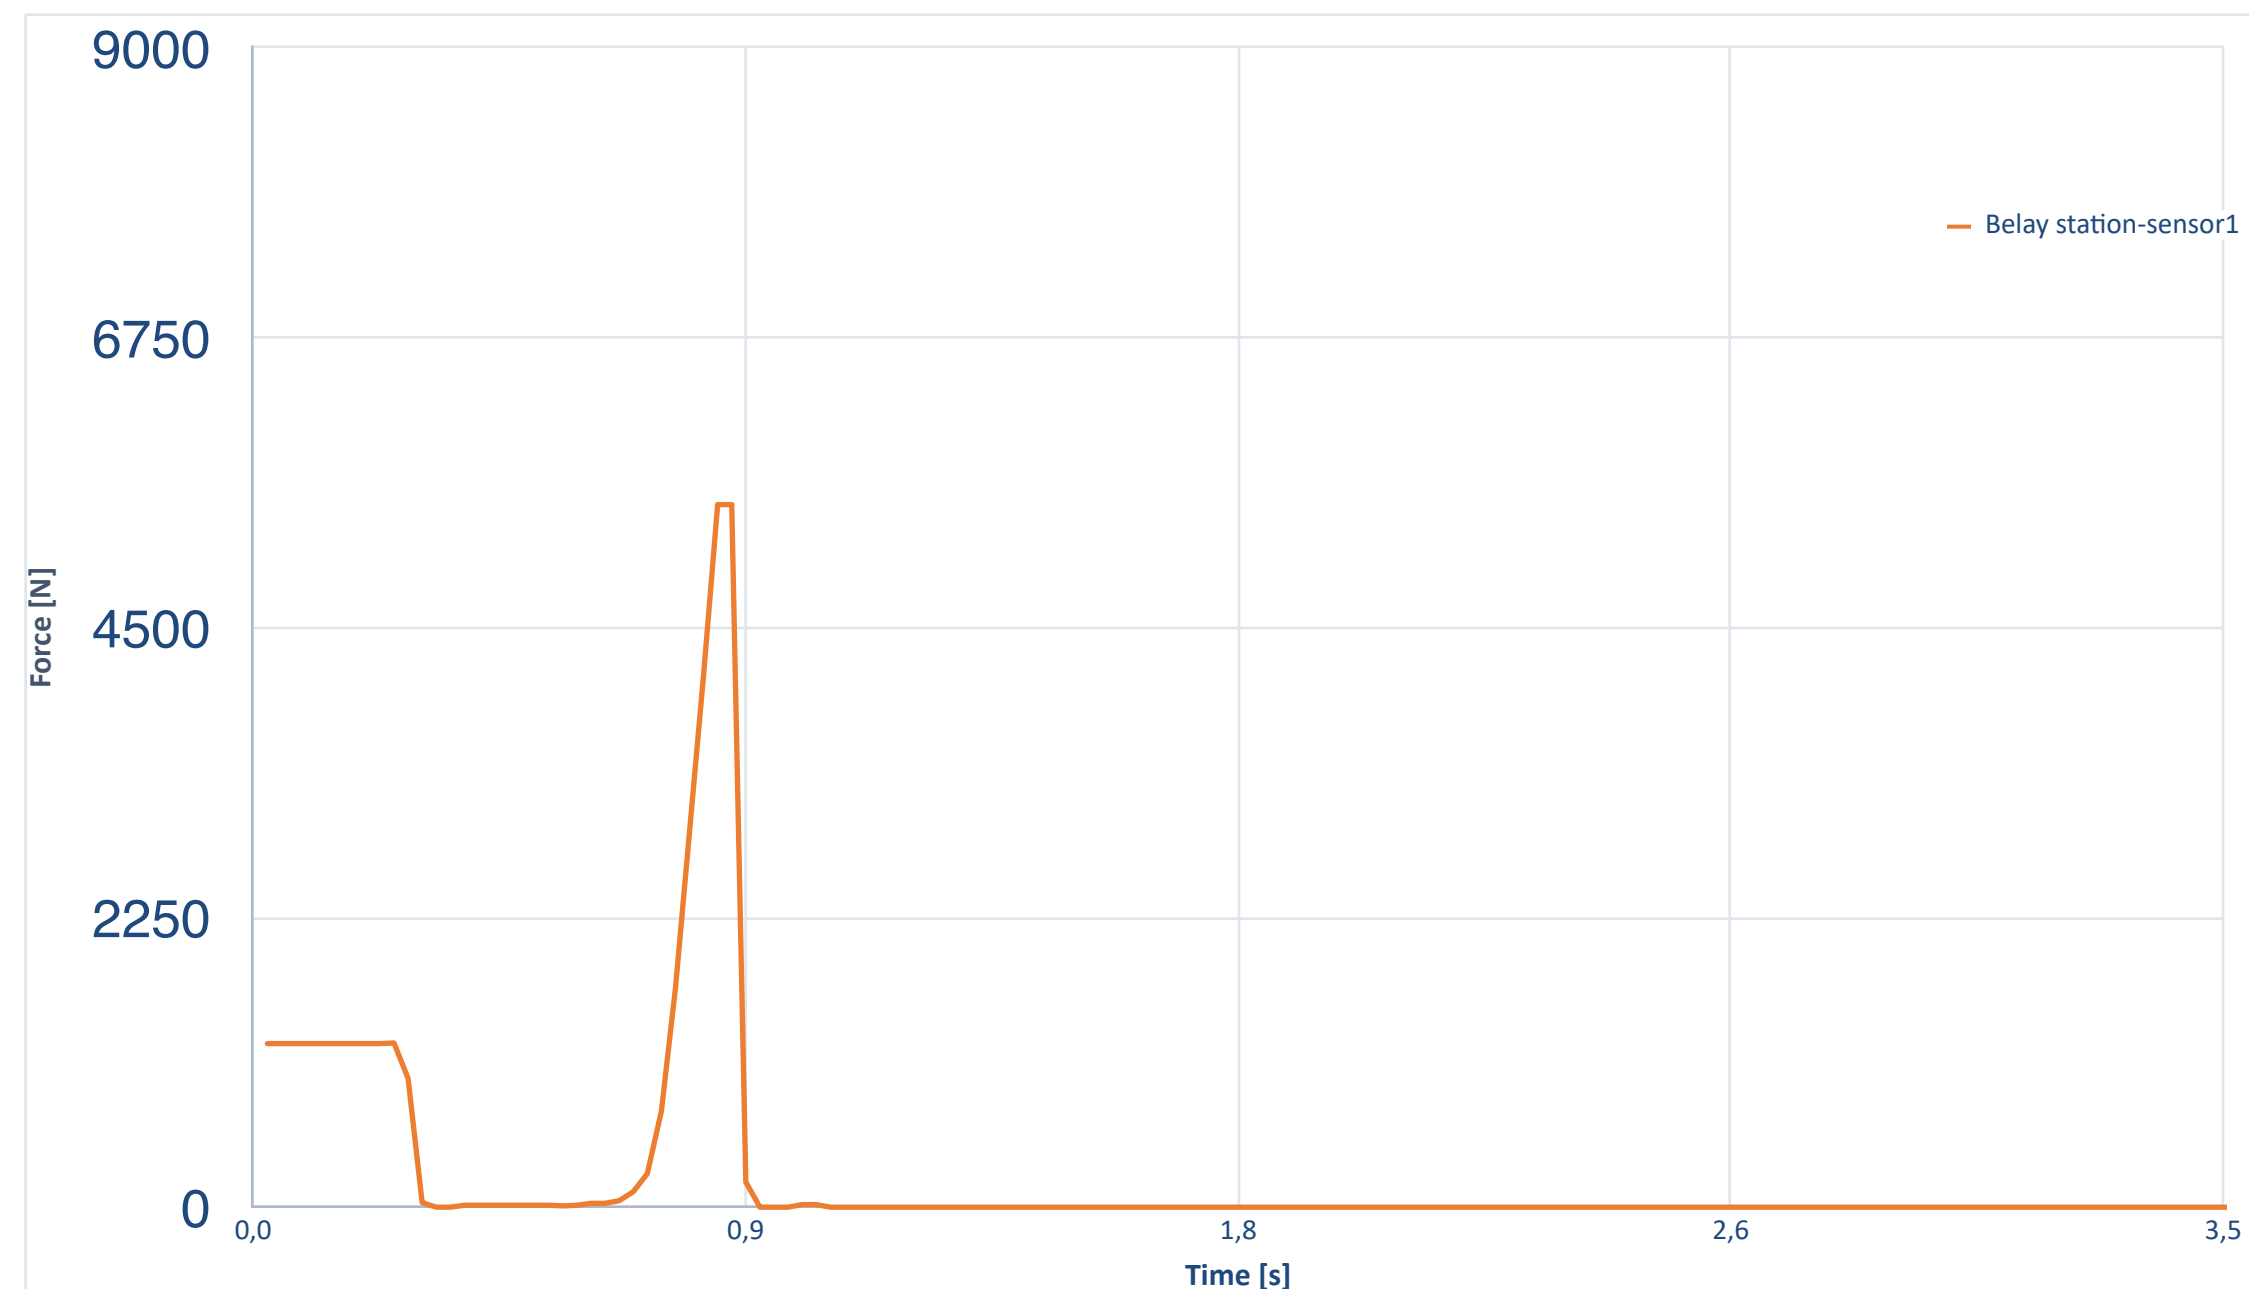
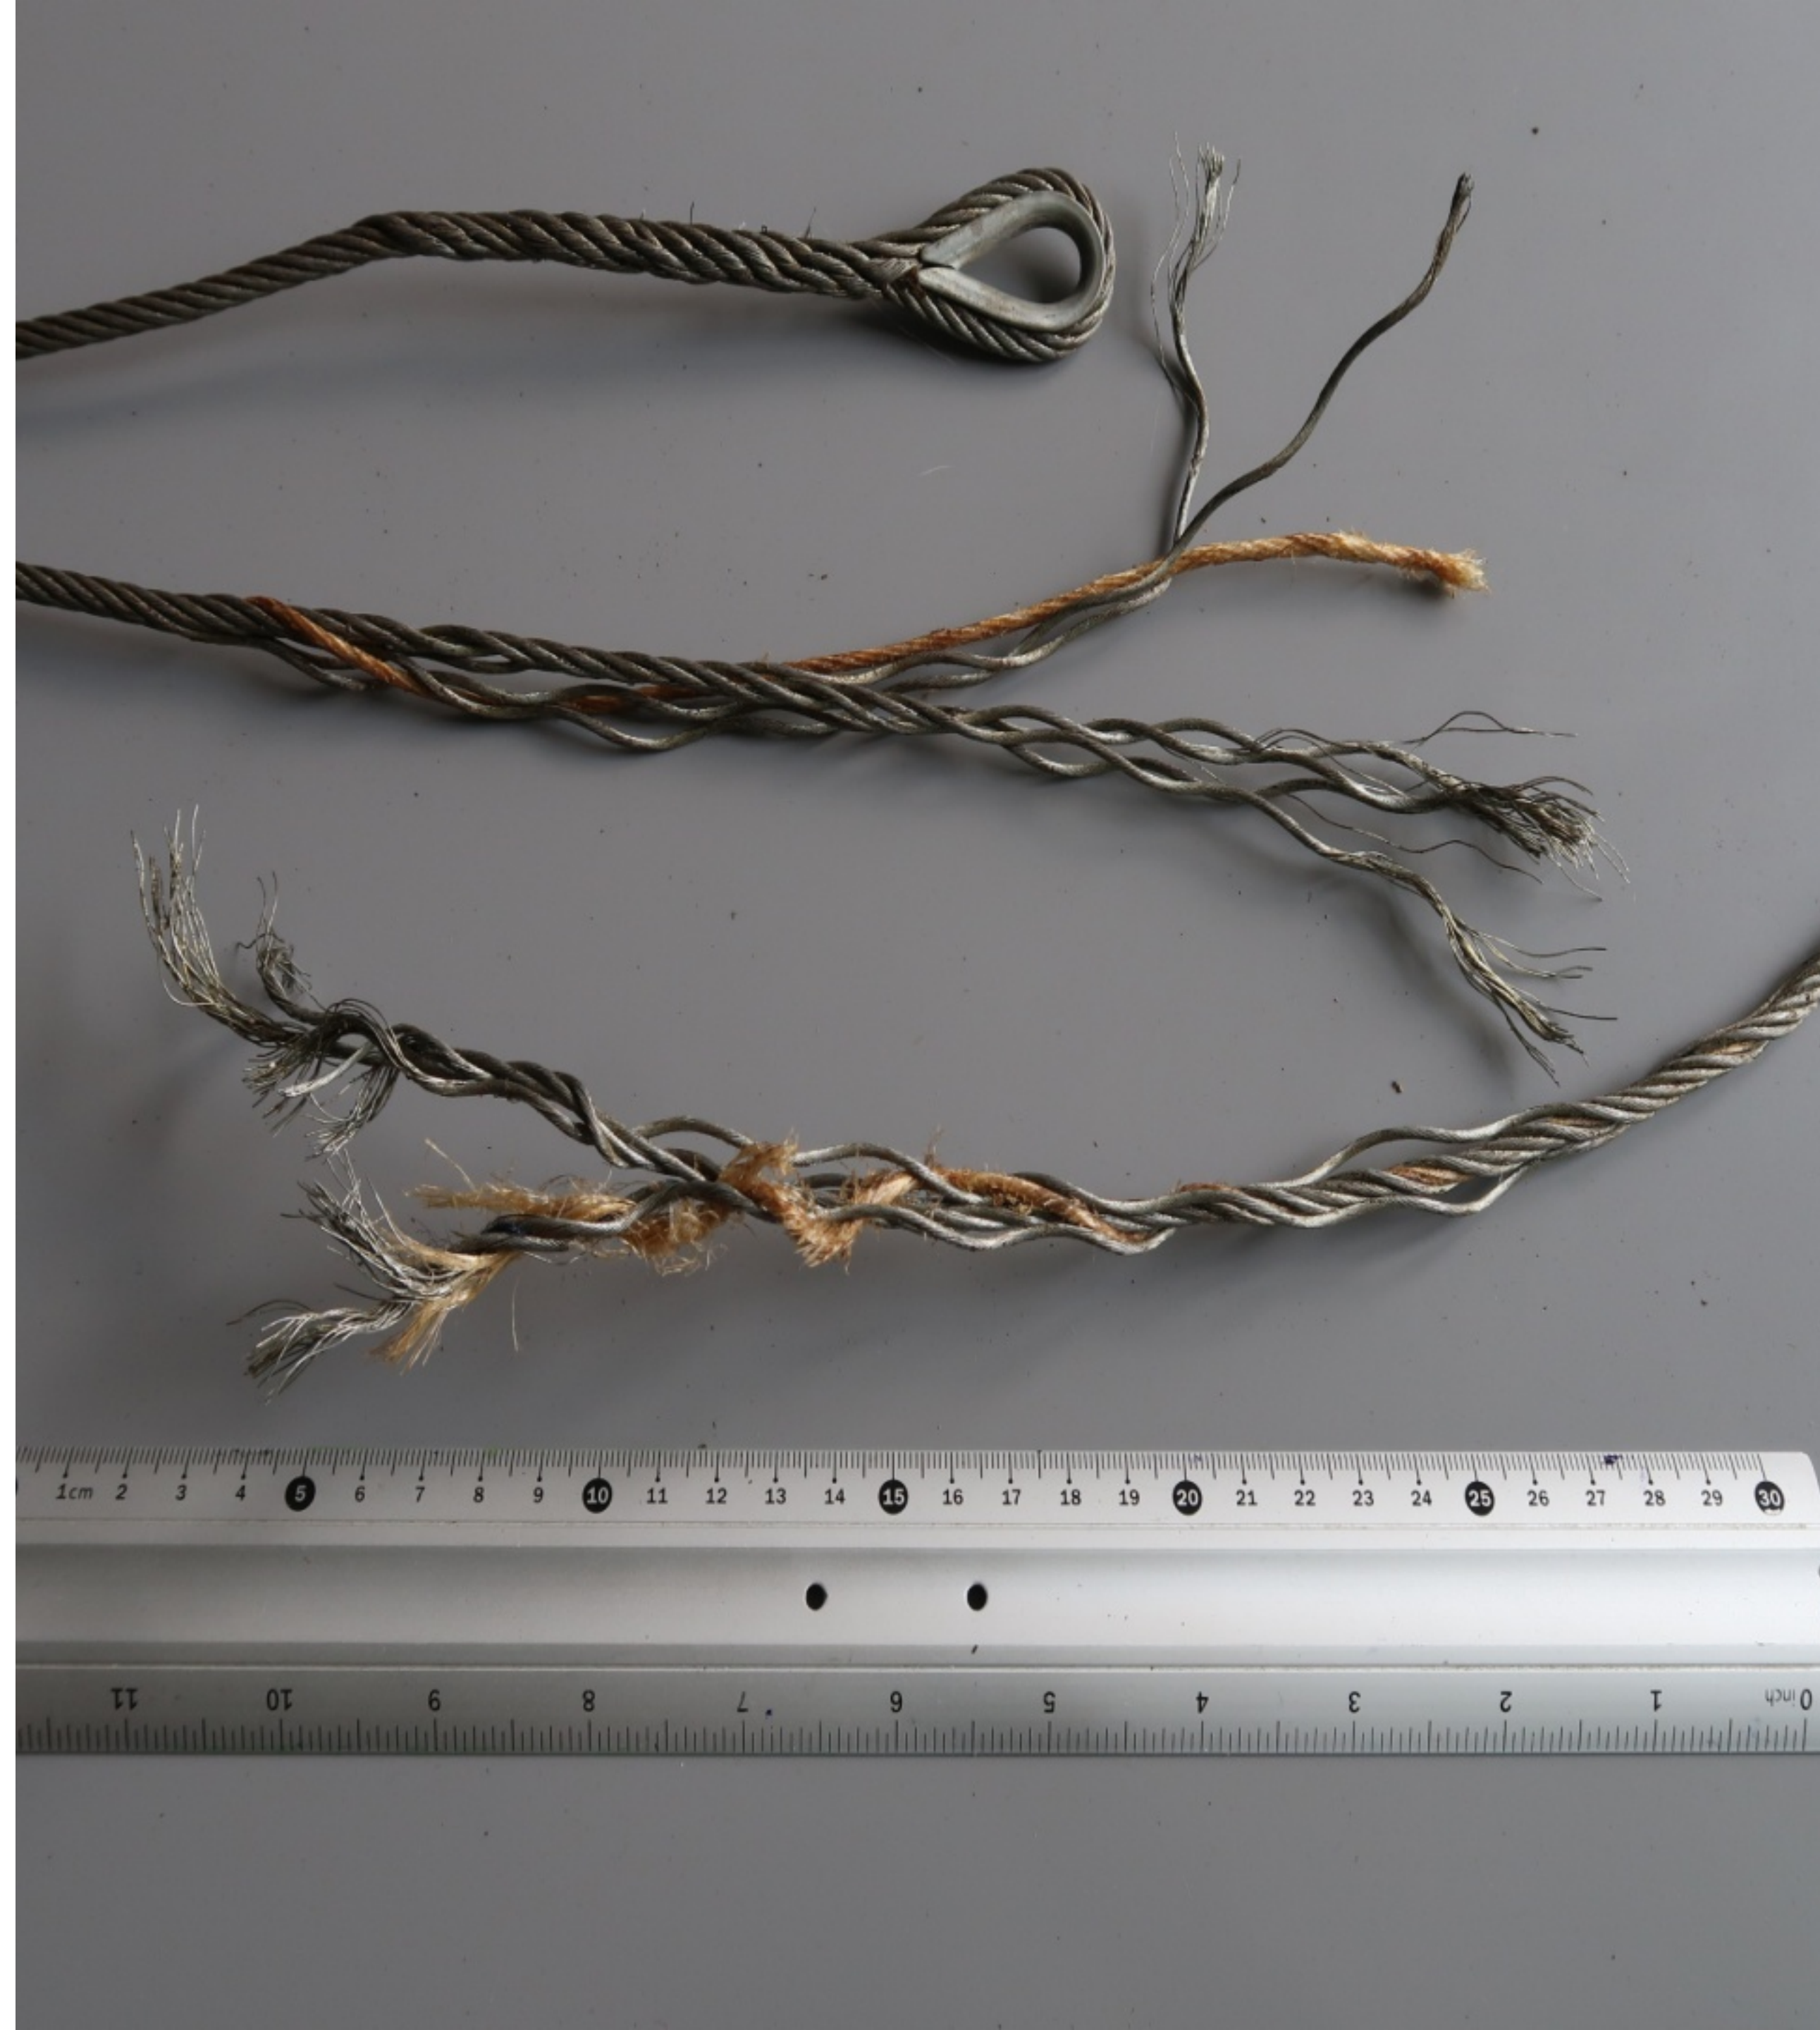
Sharp edge test with a pendulum - rope 14B Steel rope 5,6 mm - 200 kg load

- **THE ROPE WAS CUT!**
- **Breakage of the rope structure after the first touch of the sharp edge**
- **Time: 0.2 s from the contact of the edge to the complete breakage**

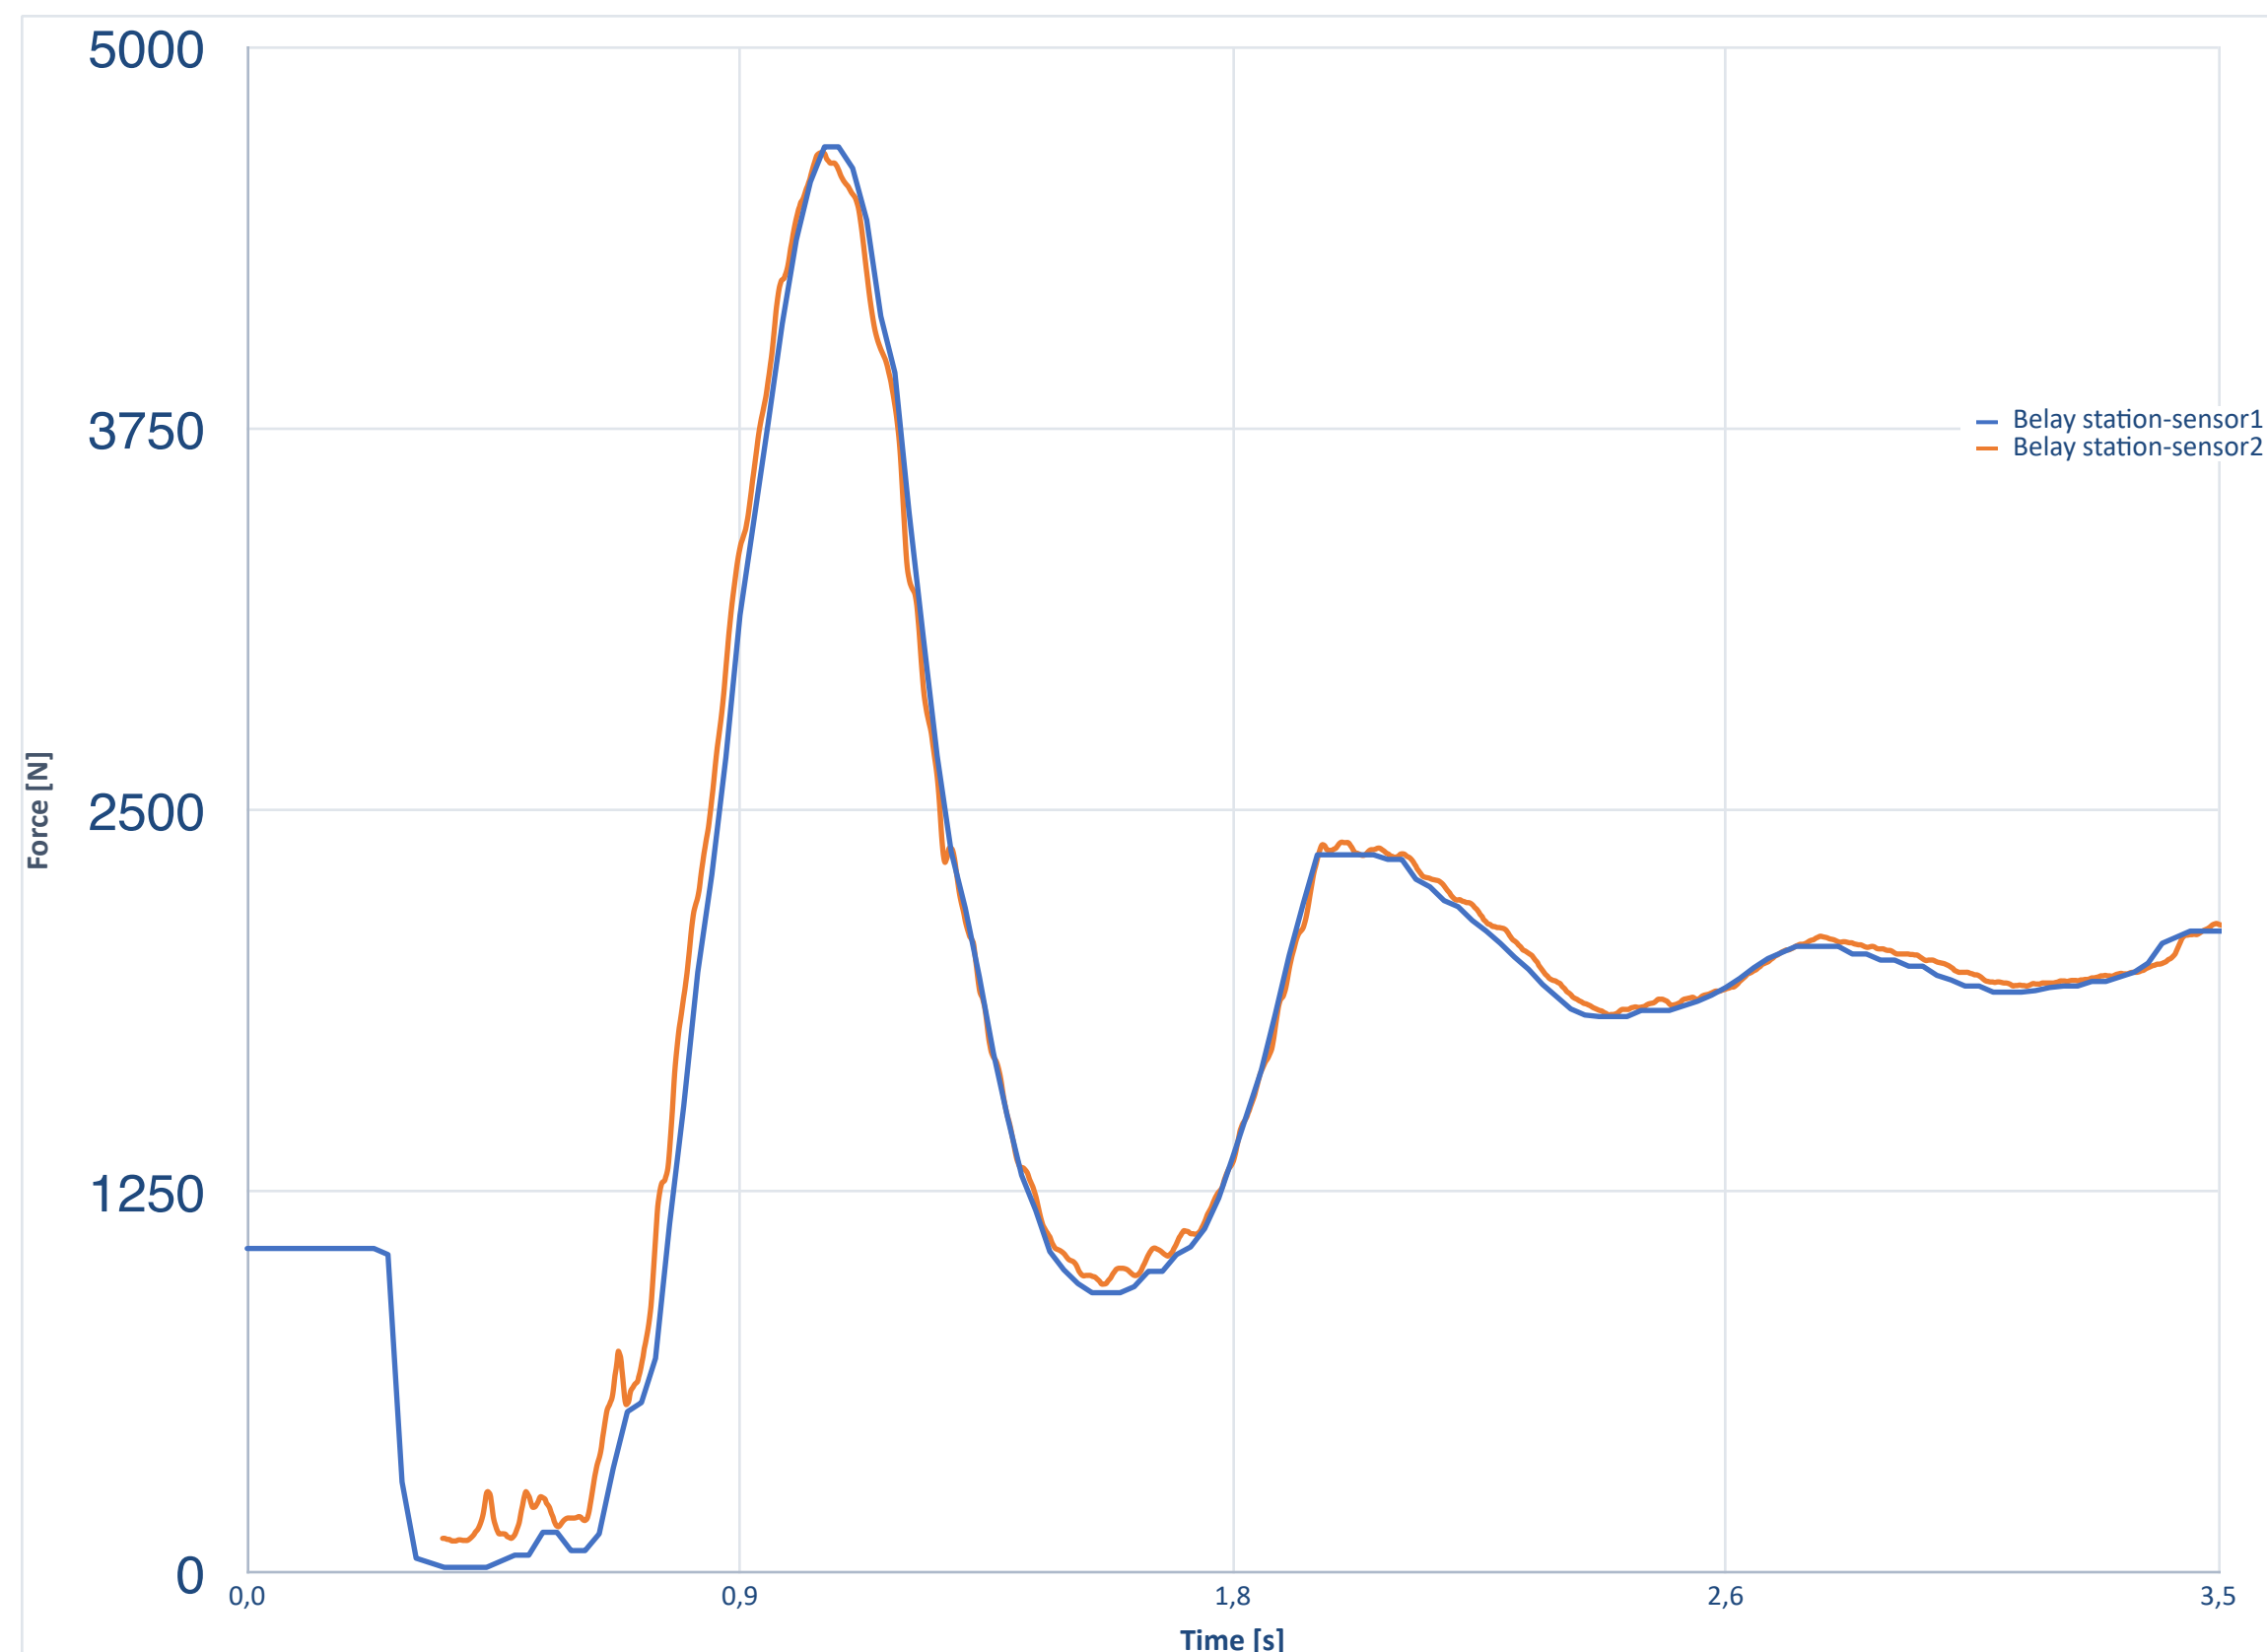
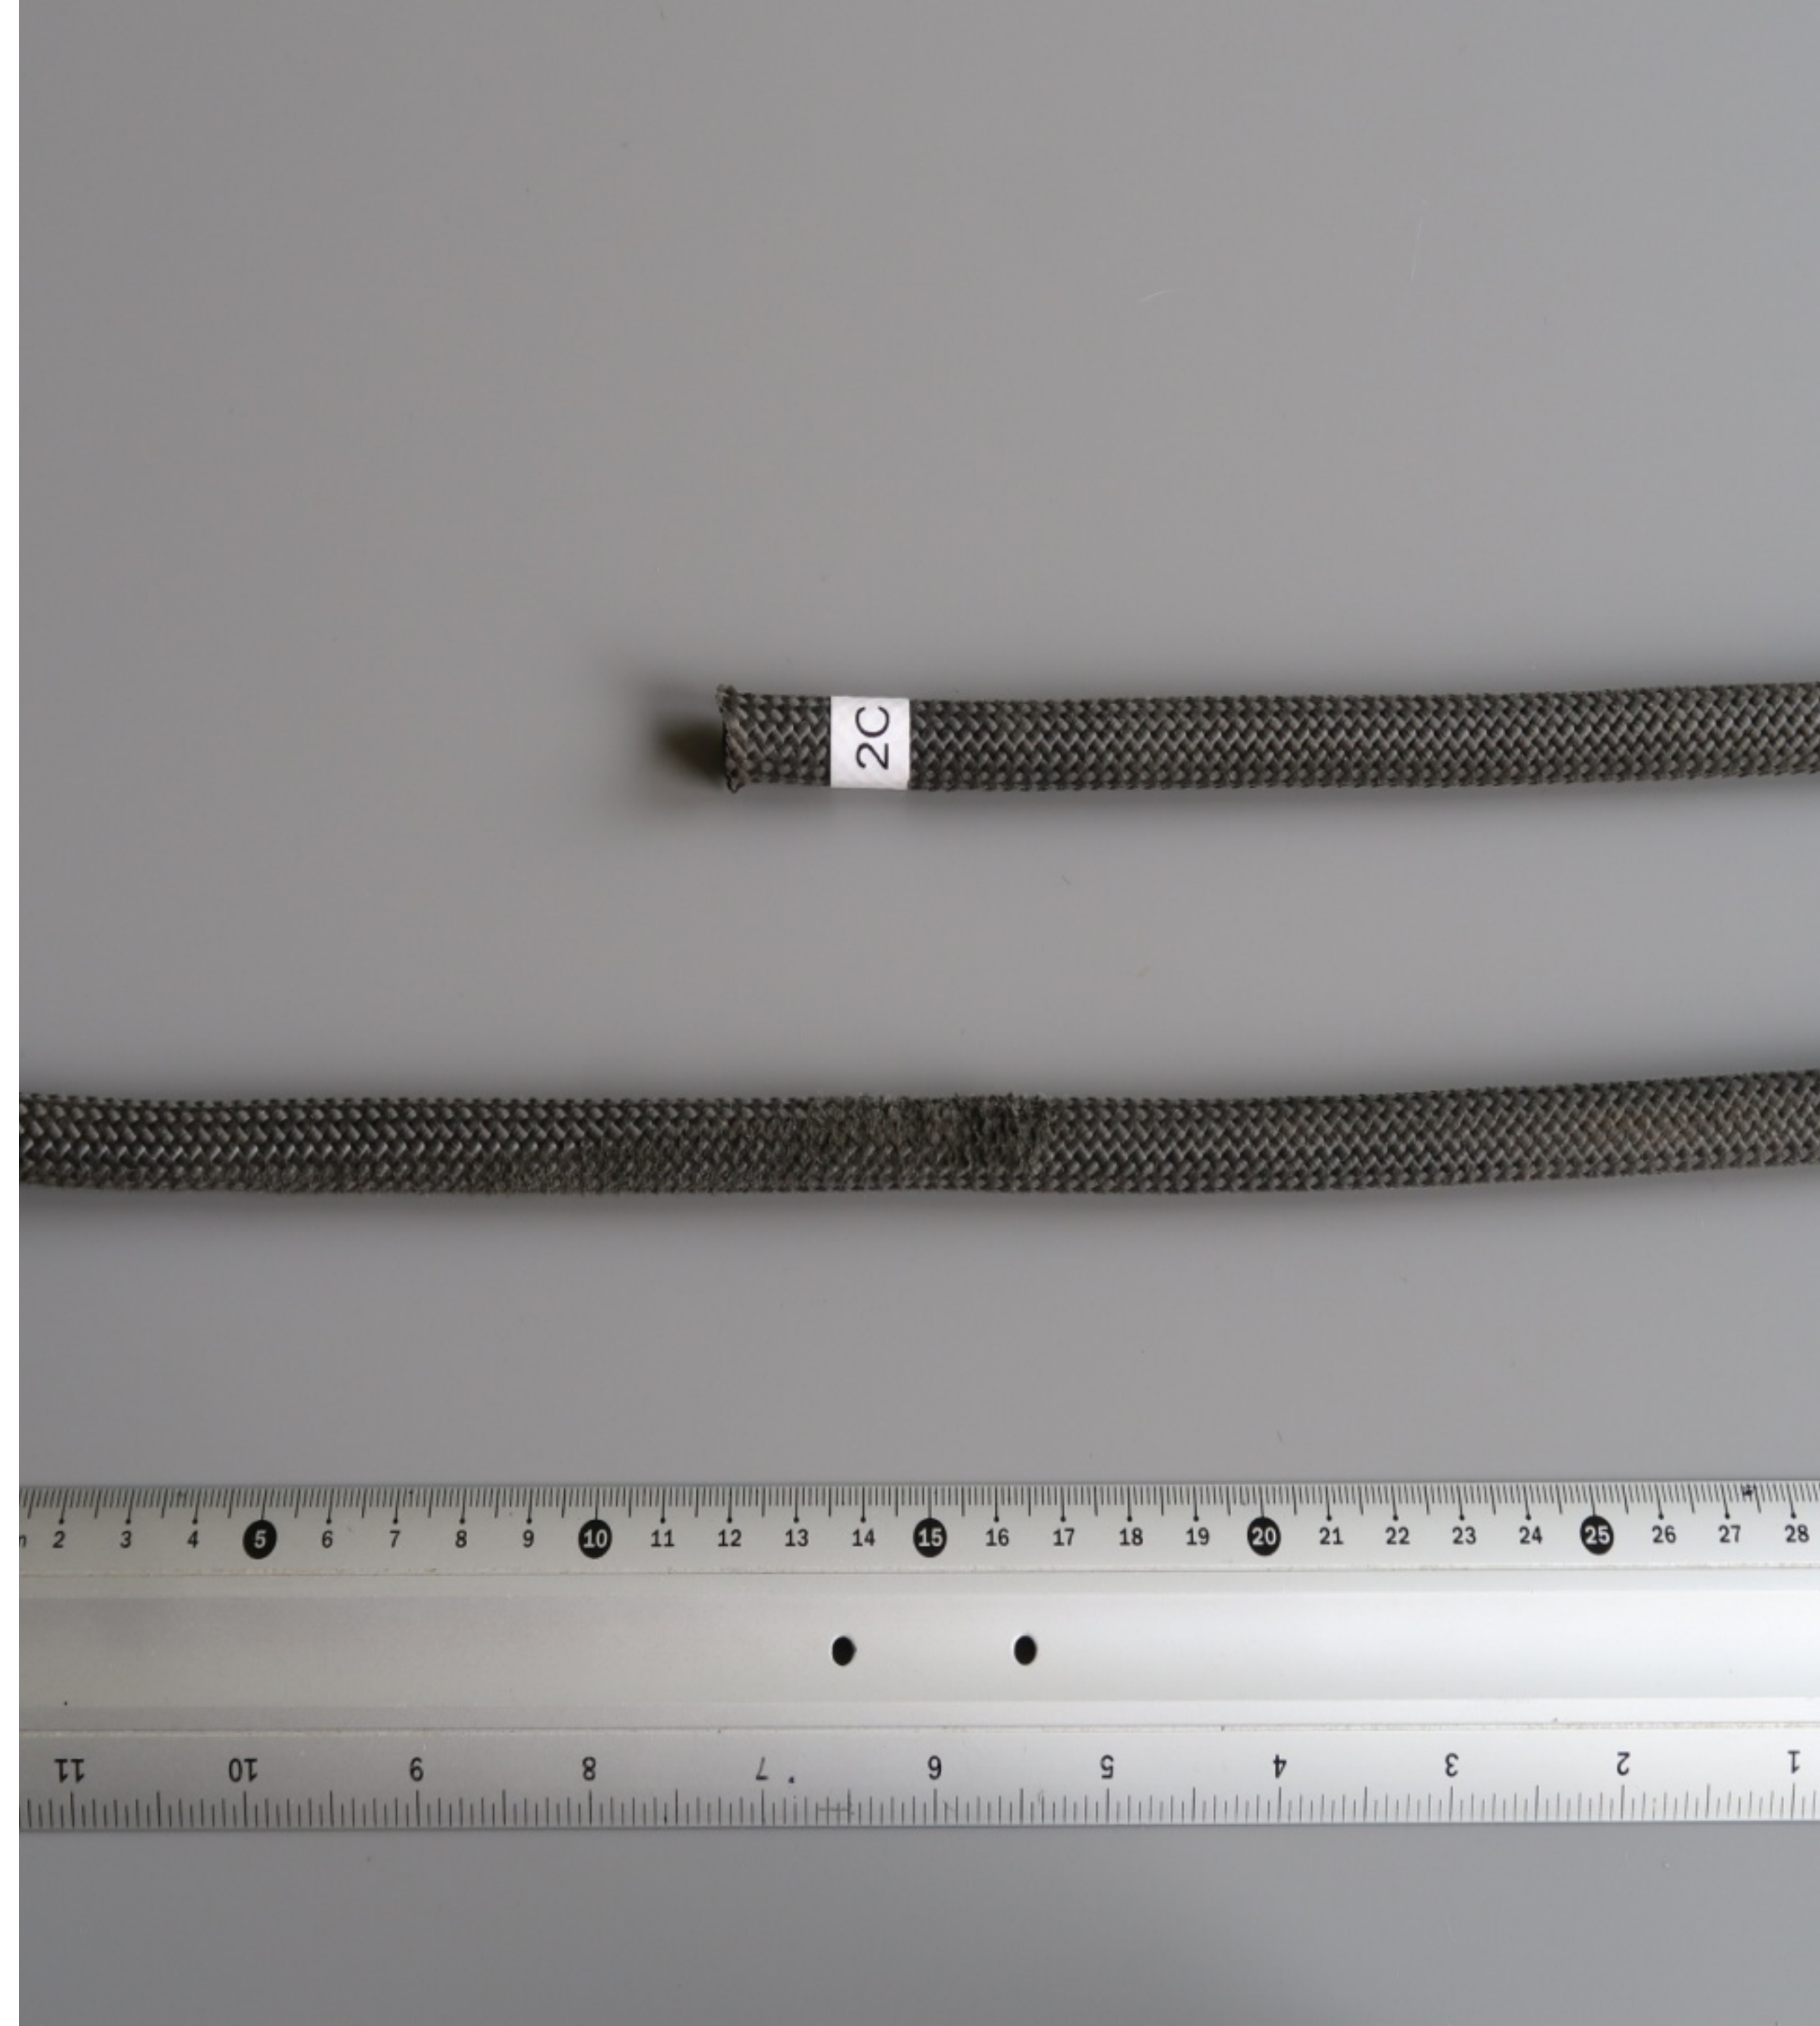
- rope 2C
- Aramid/polyamide 10,5 mm - 200 kg load

- **THE ROPE DID NOT BREAK - sheath damage is very small**

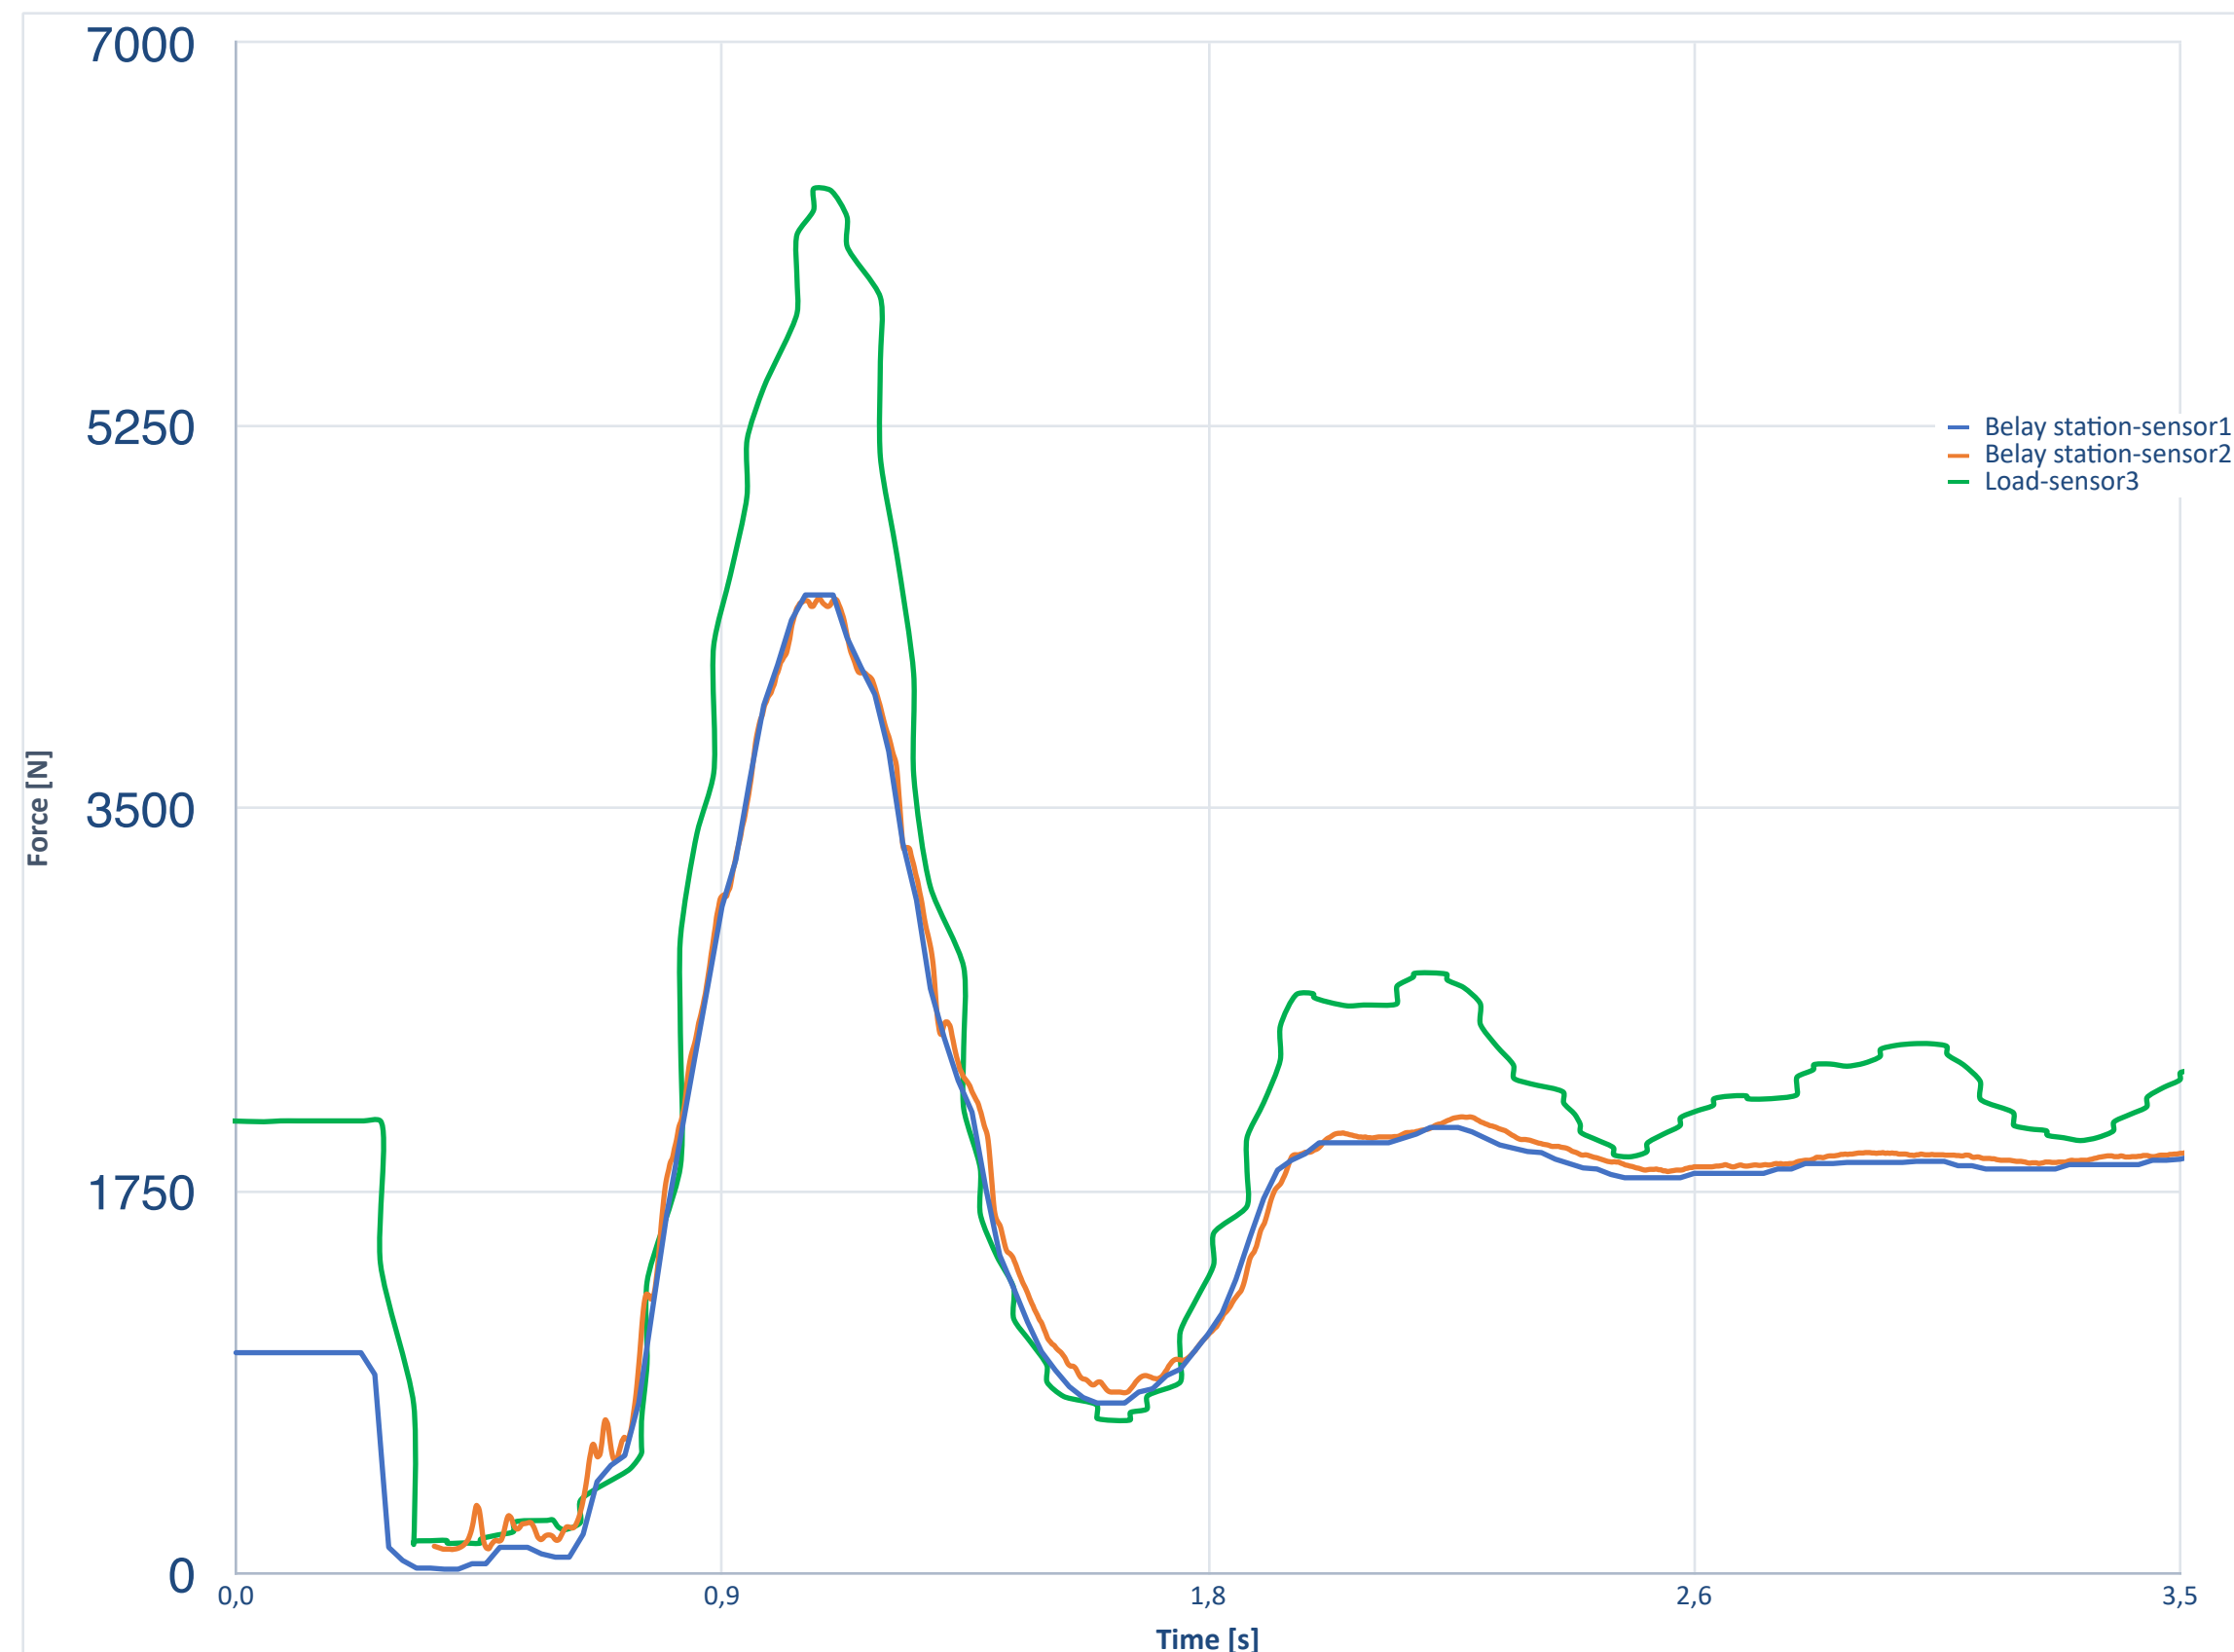
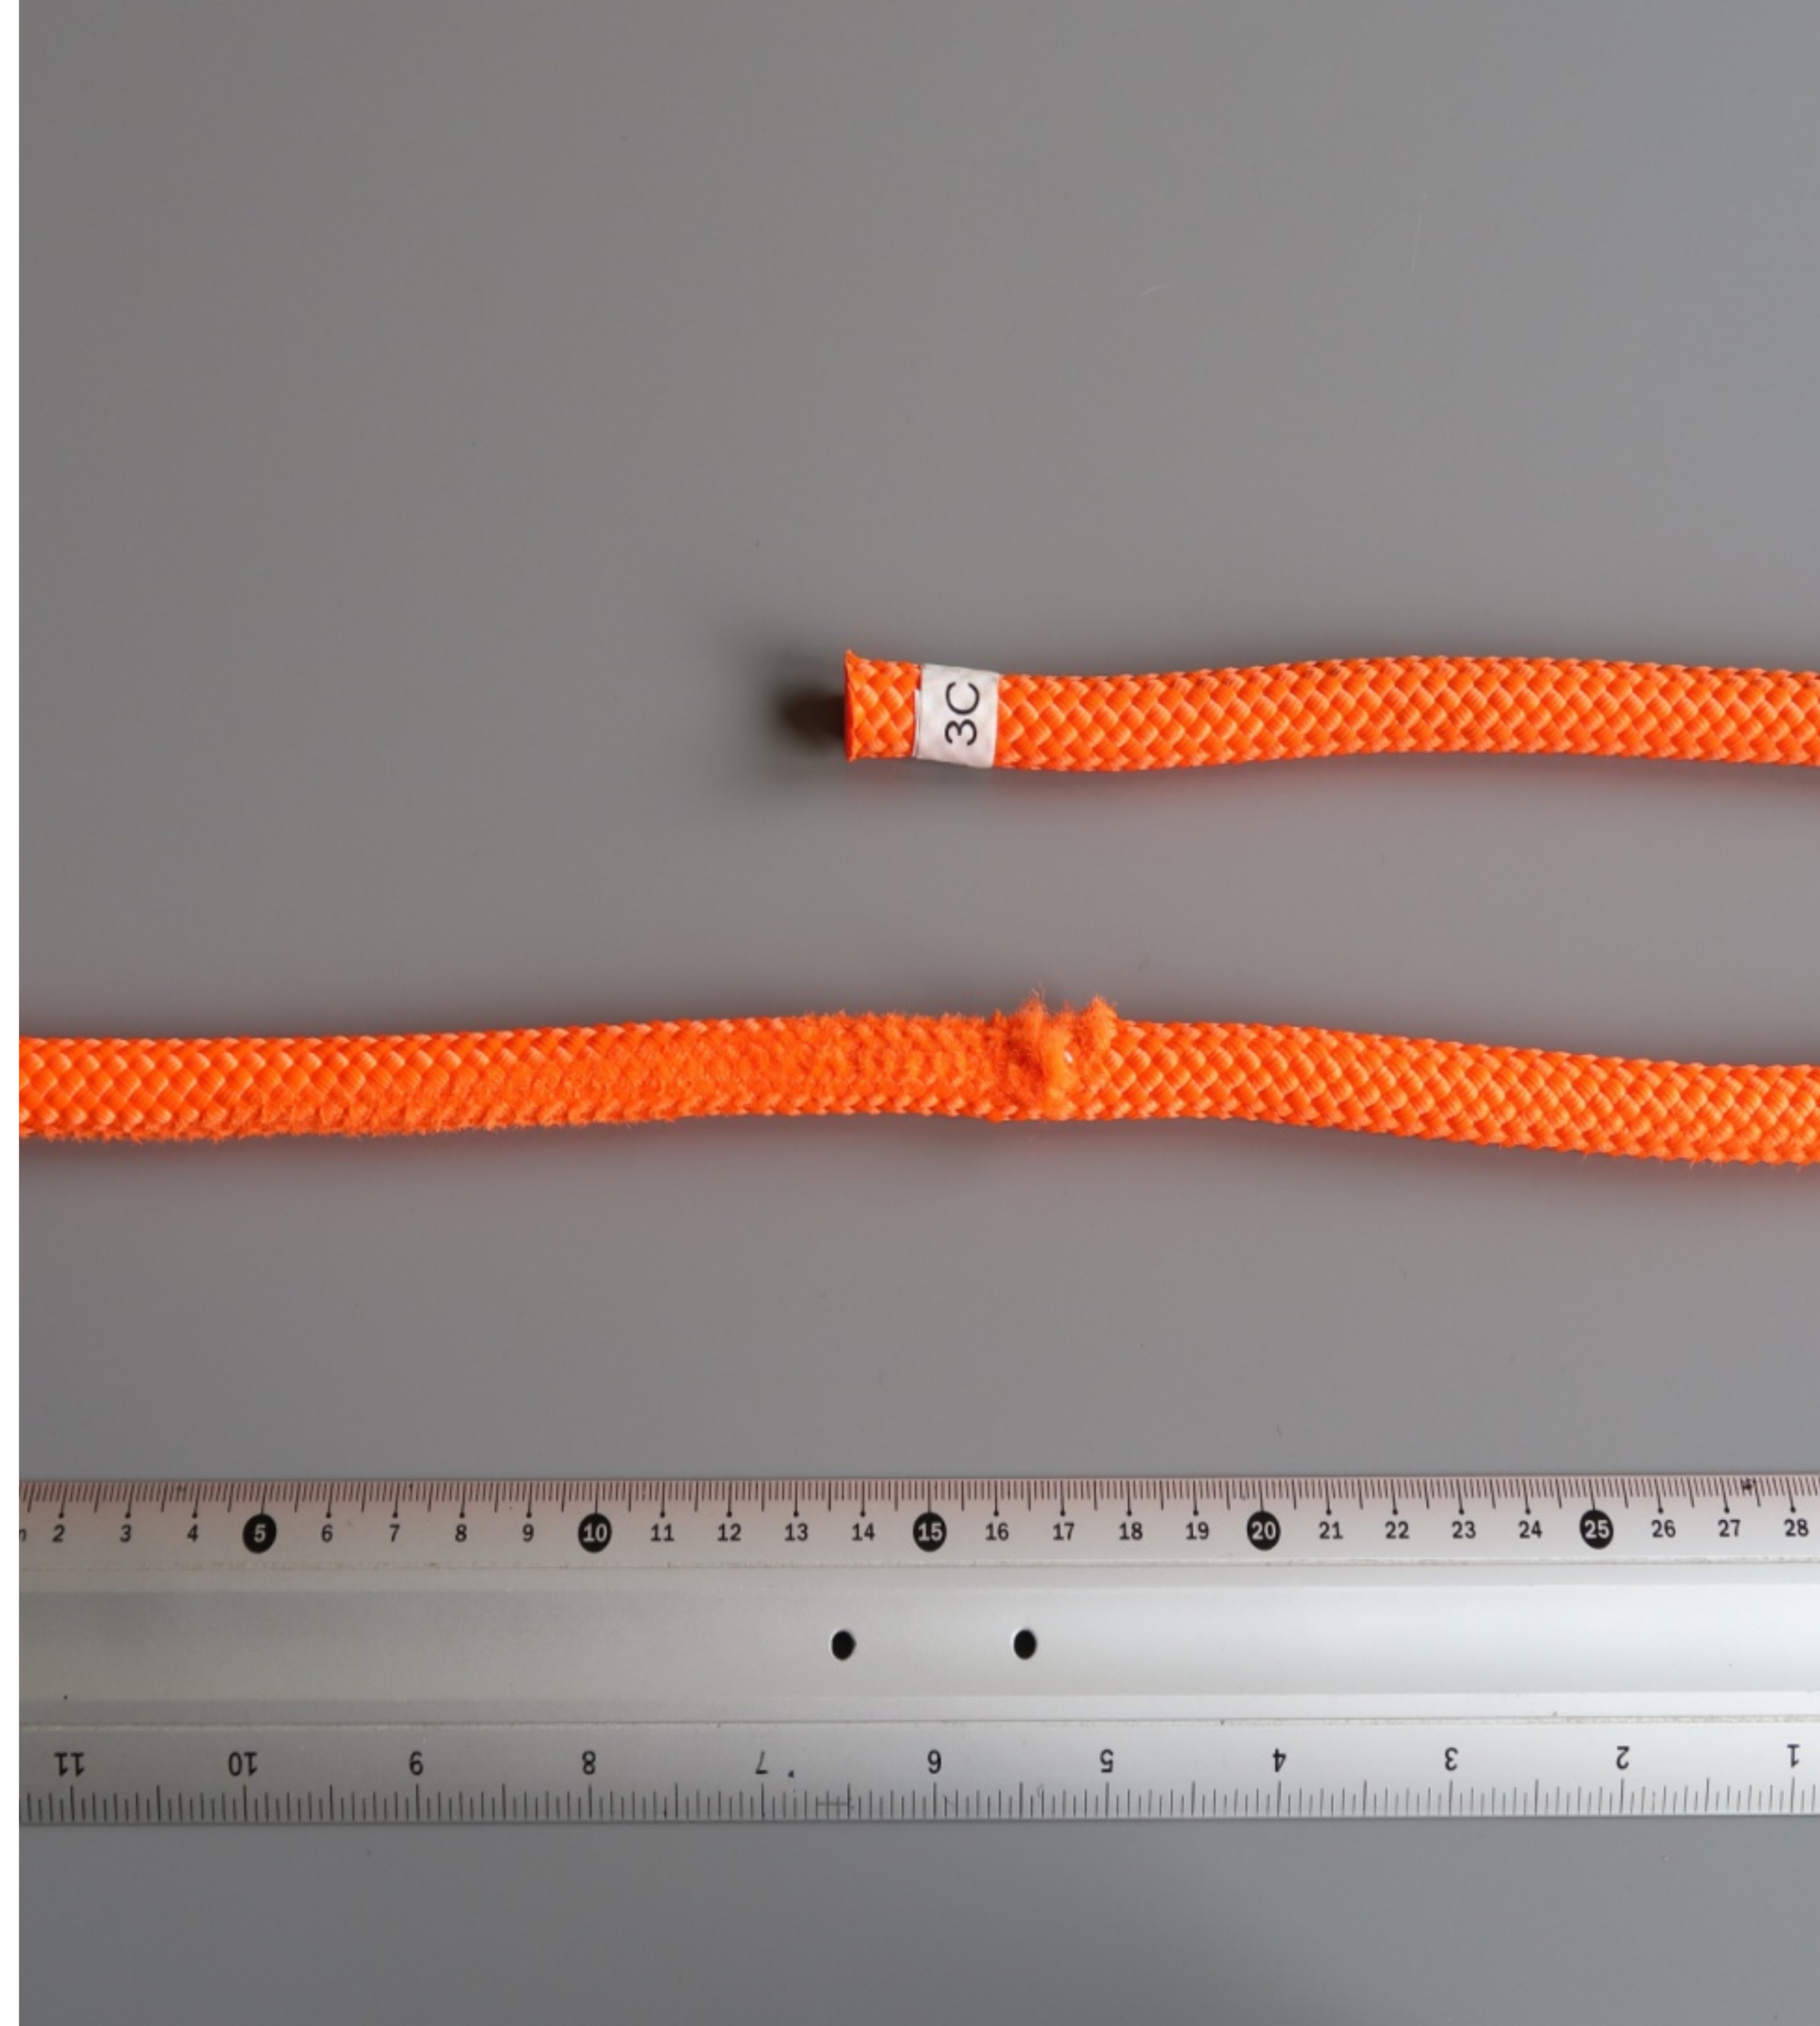
- rope 3C
- Polyester/polyamid 10,5 mm - 200 kg load

- **THE ROPE DID NOT BREAK – medium sheath damage**
