Dyneema incident on Mt. Świnica

authors: Andrzej Marasek, Witold Cikowski, Marcin Józefowicz, prof. dr hab. inż. Jerzy Zych, mgr inż. Tomasz Snopkiewicz, PhD
Eng. Michał Ciszewski, Andrzej Górka

causes of rope failure

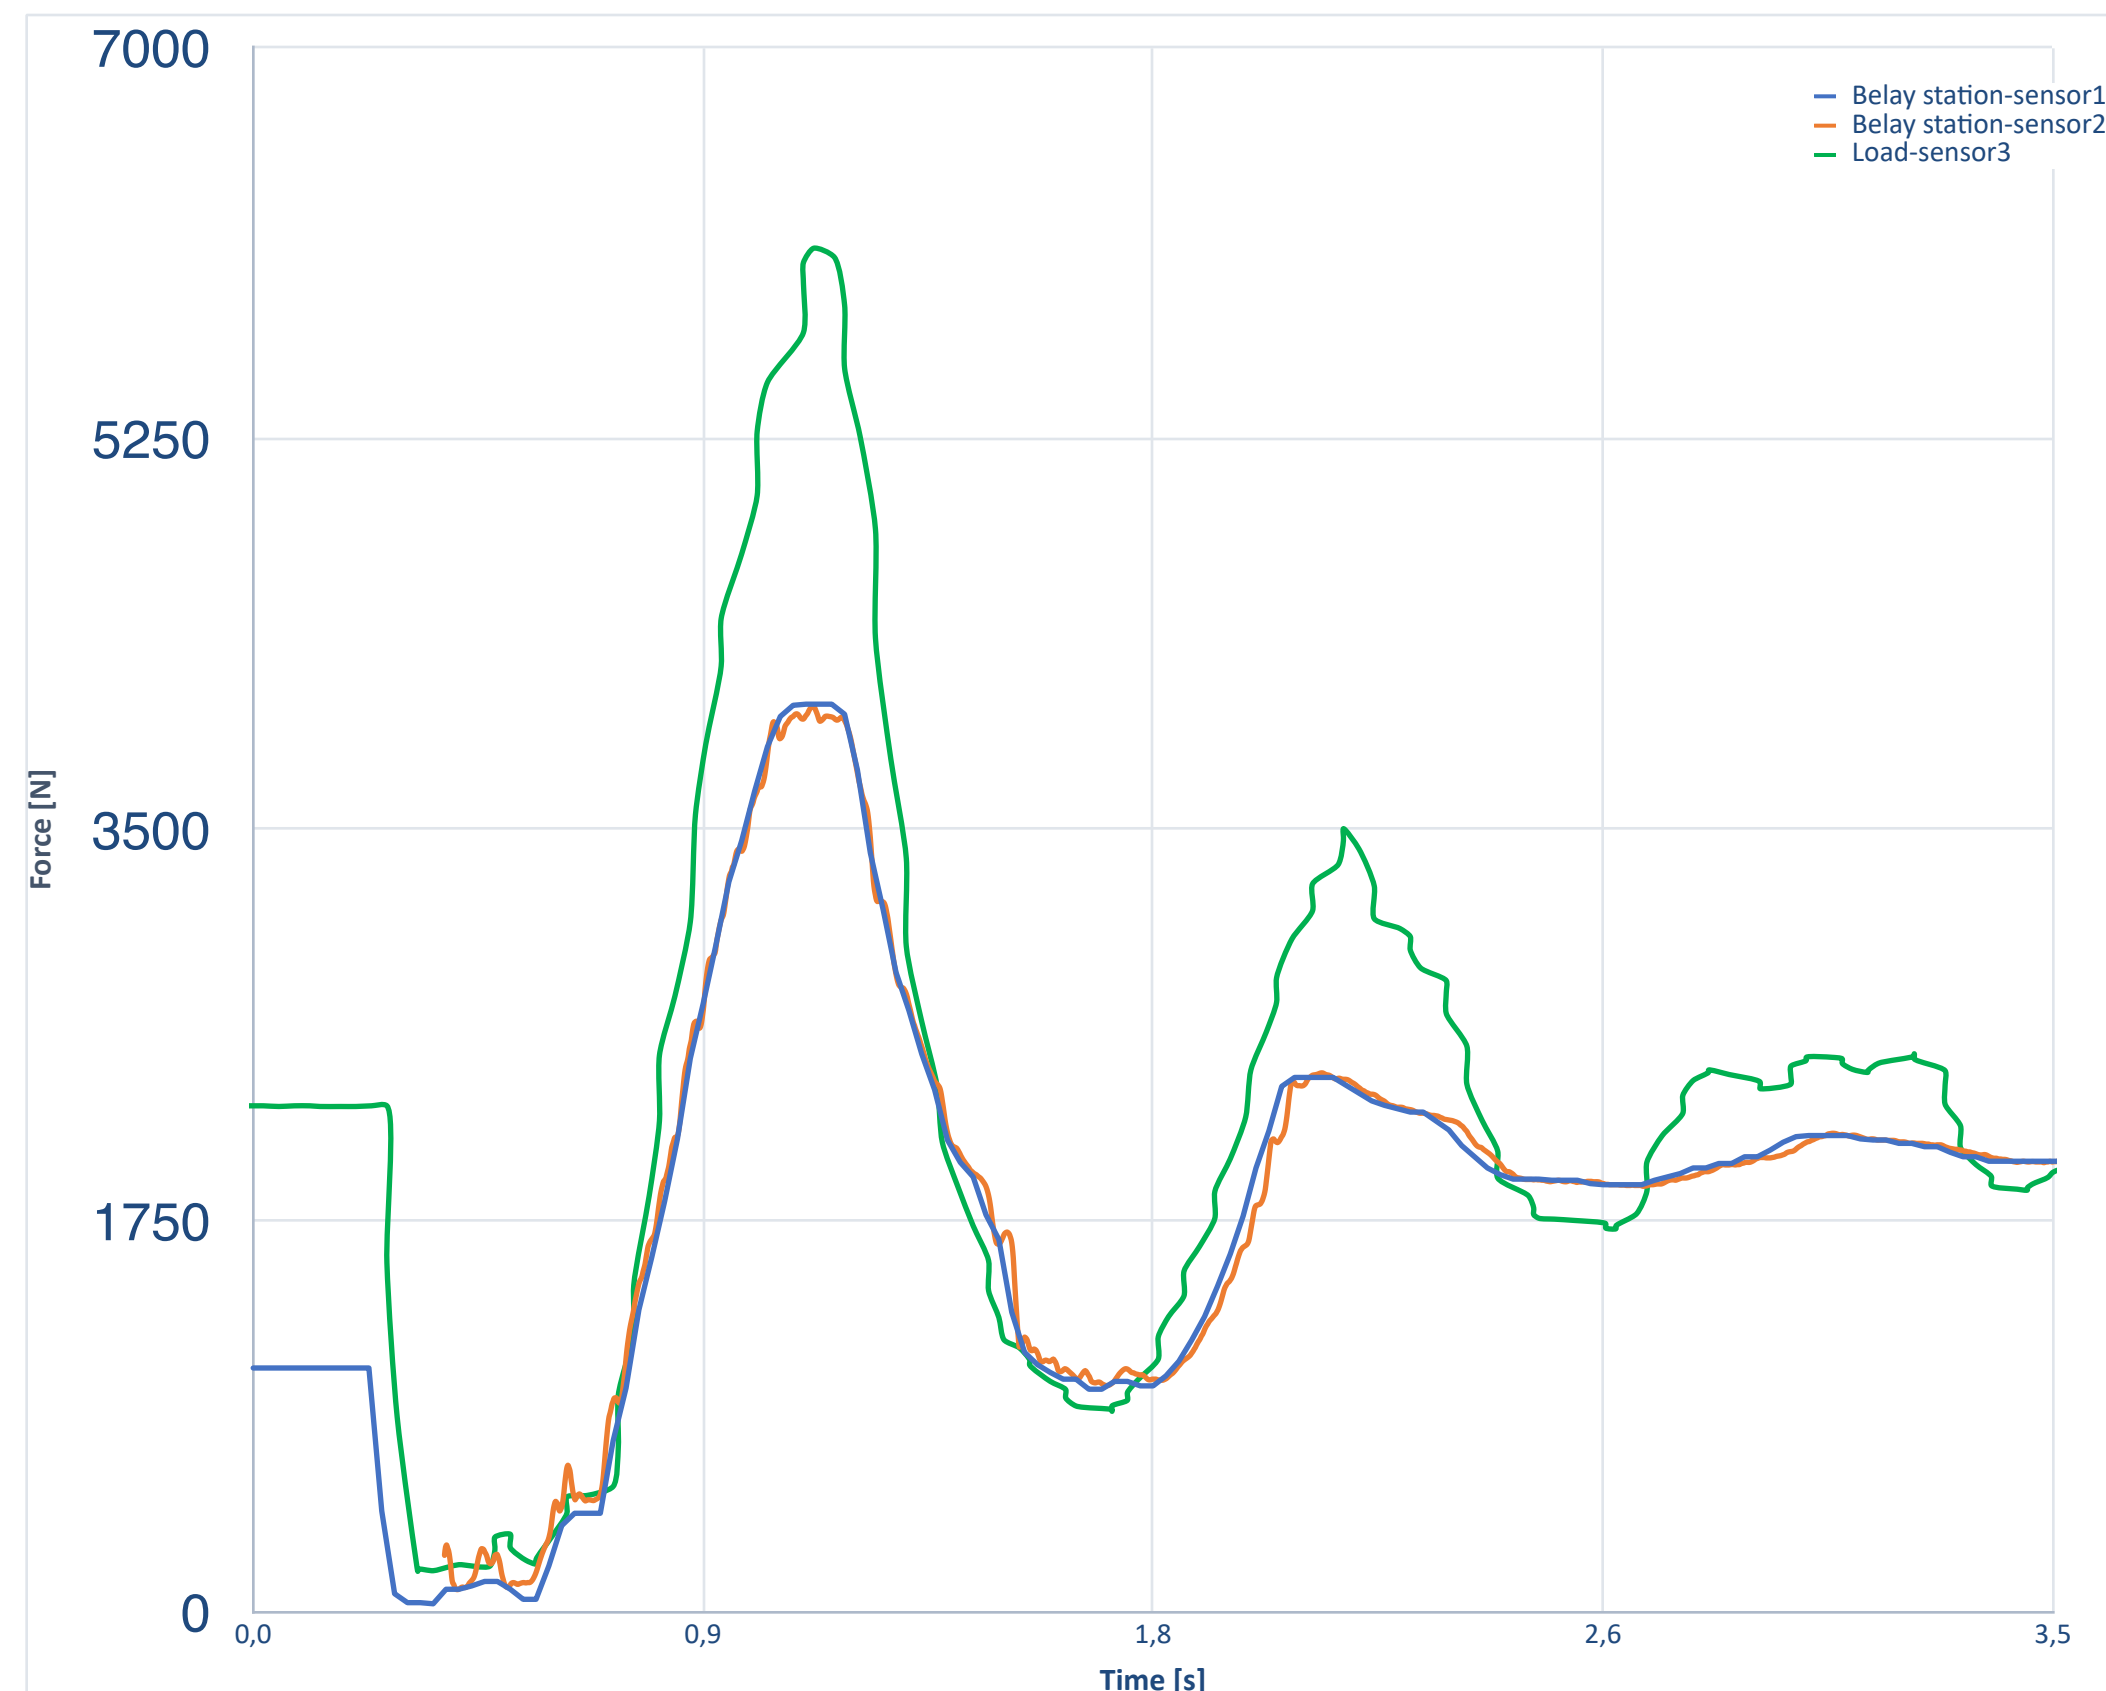
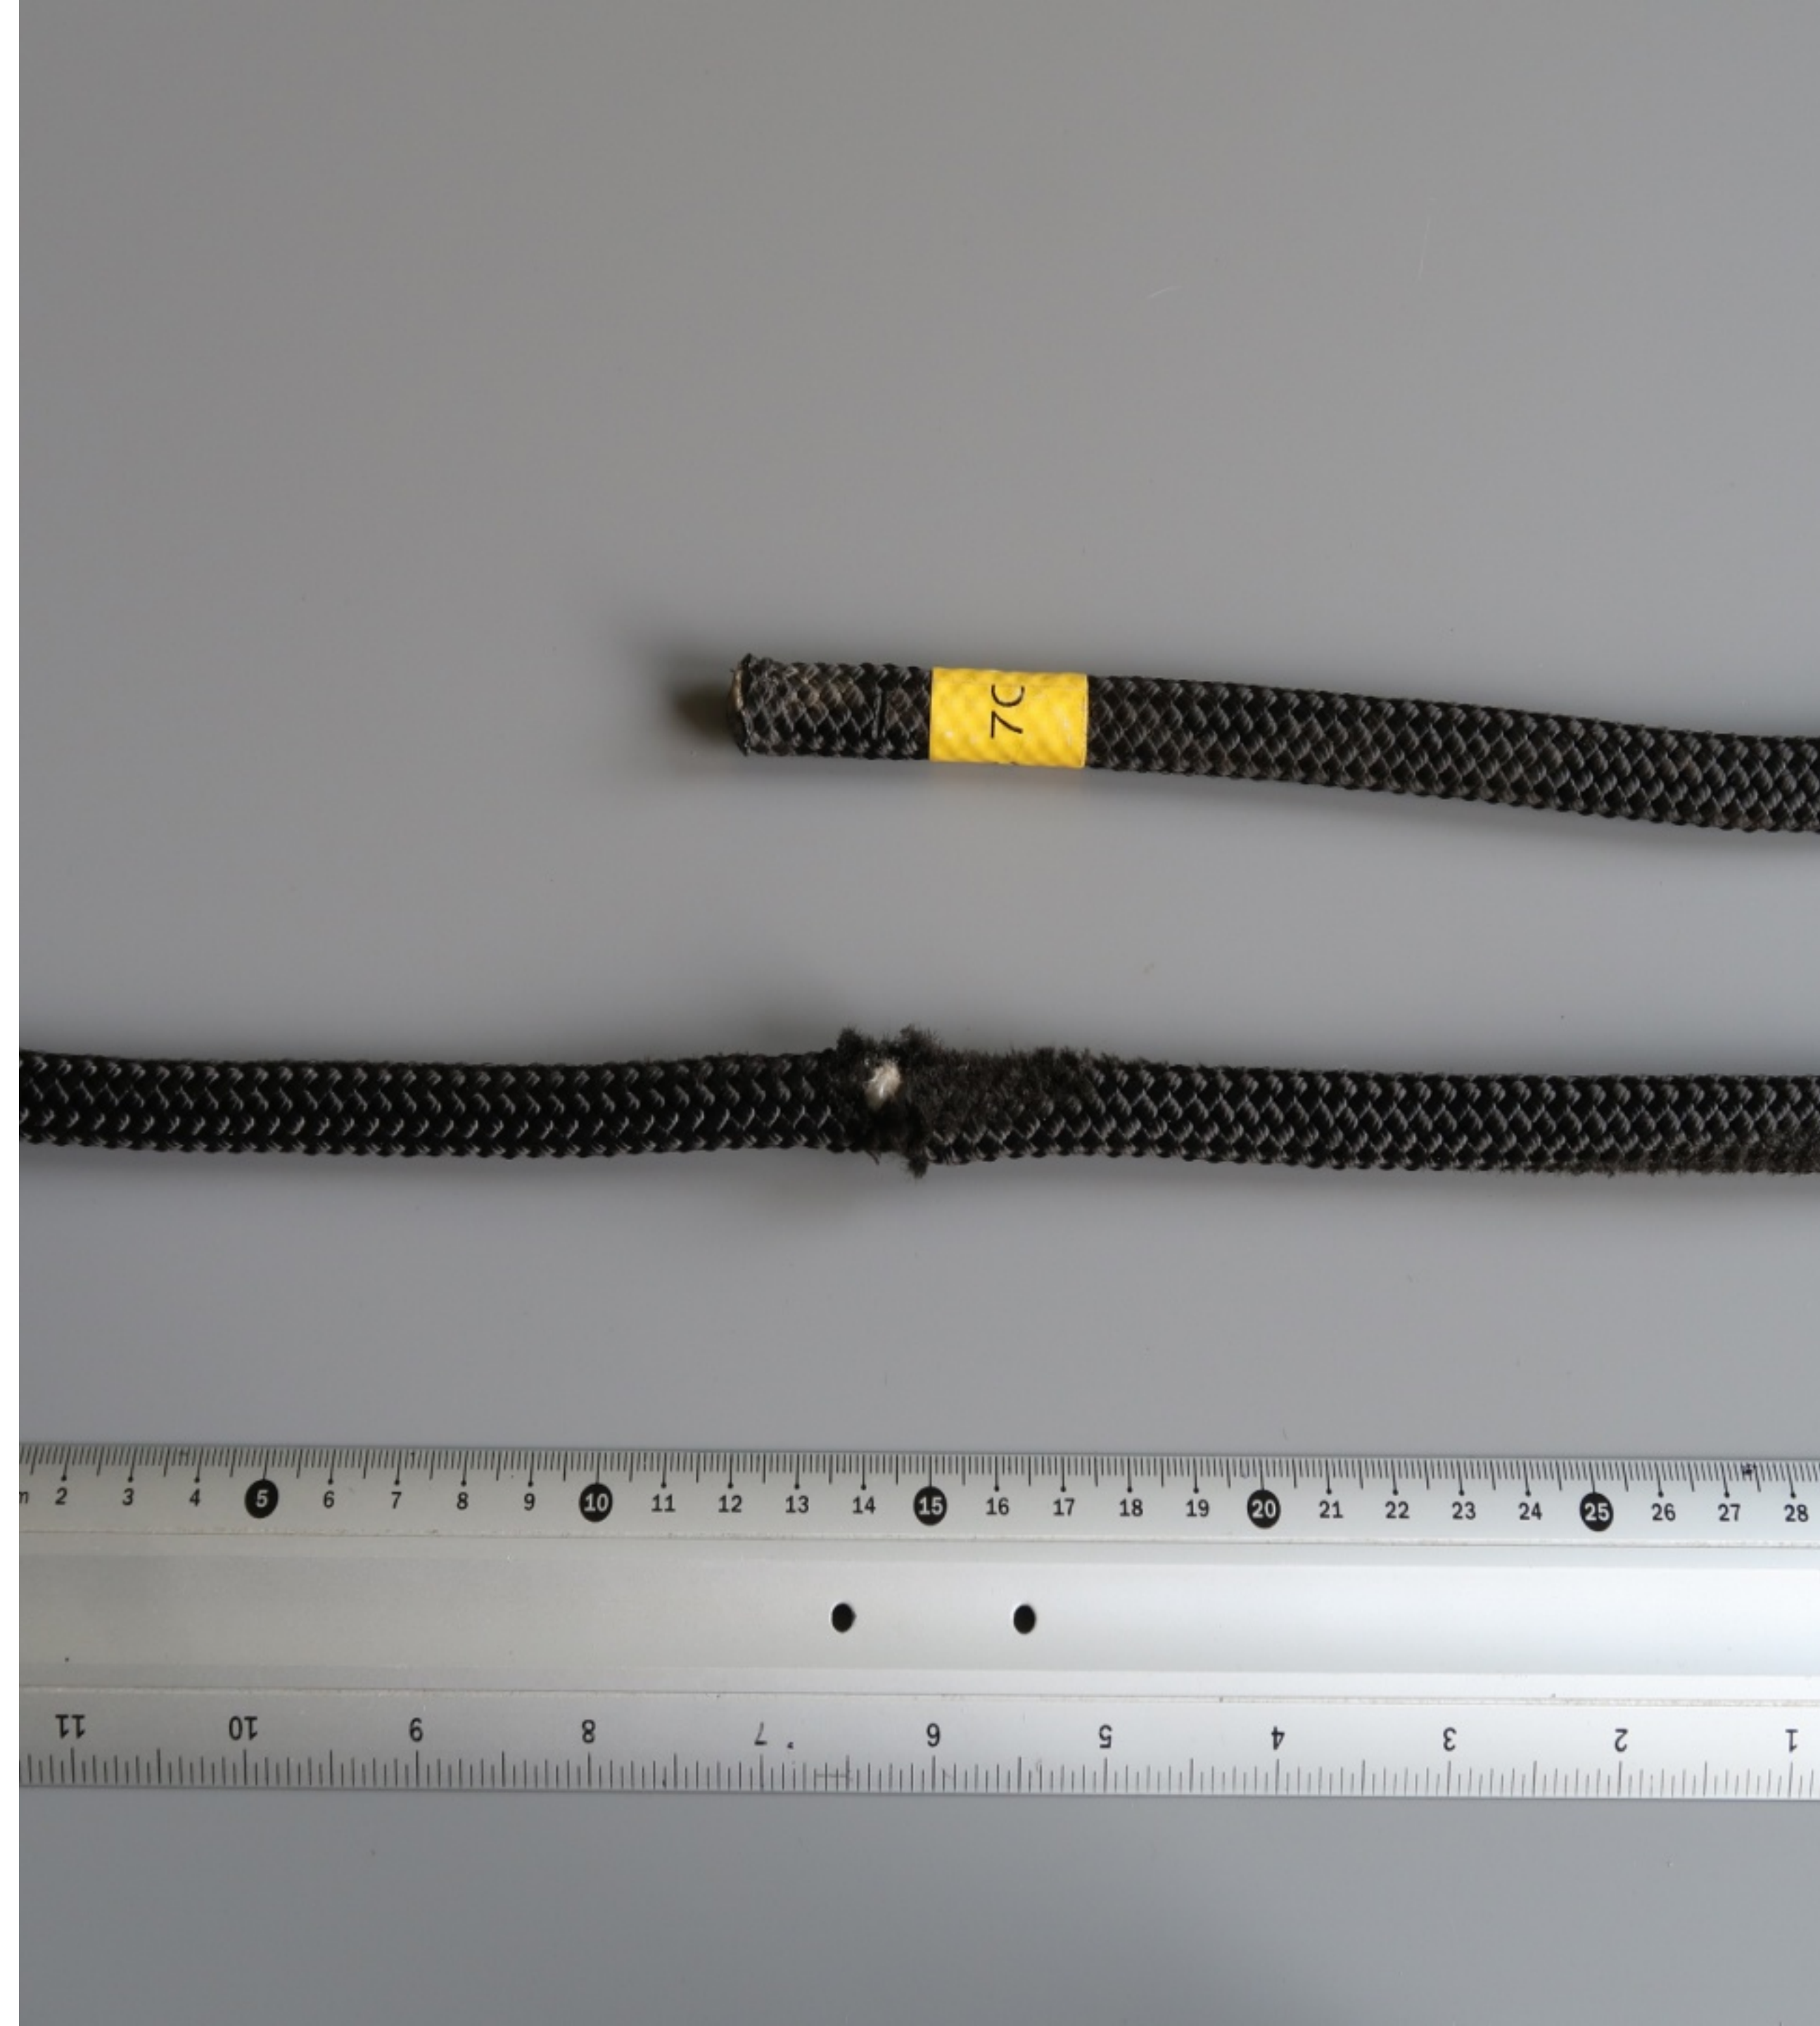
Sharp edge test with a pendulum - rope 7C Polyamid/steel/polyamid 10 mm 200 kg load

- **THE ROPE DID NOT BREAK – medium sheath damage**

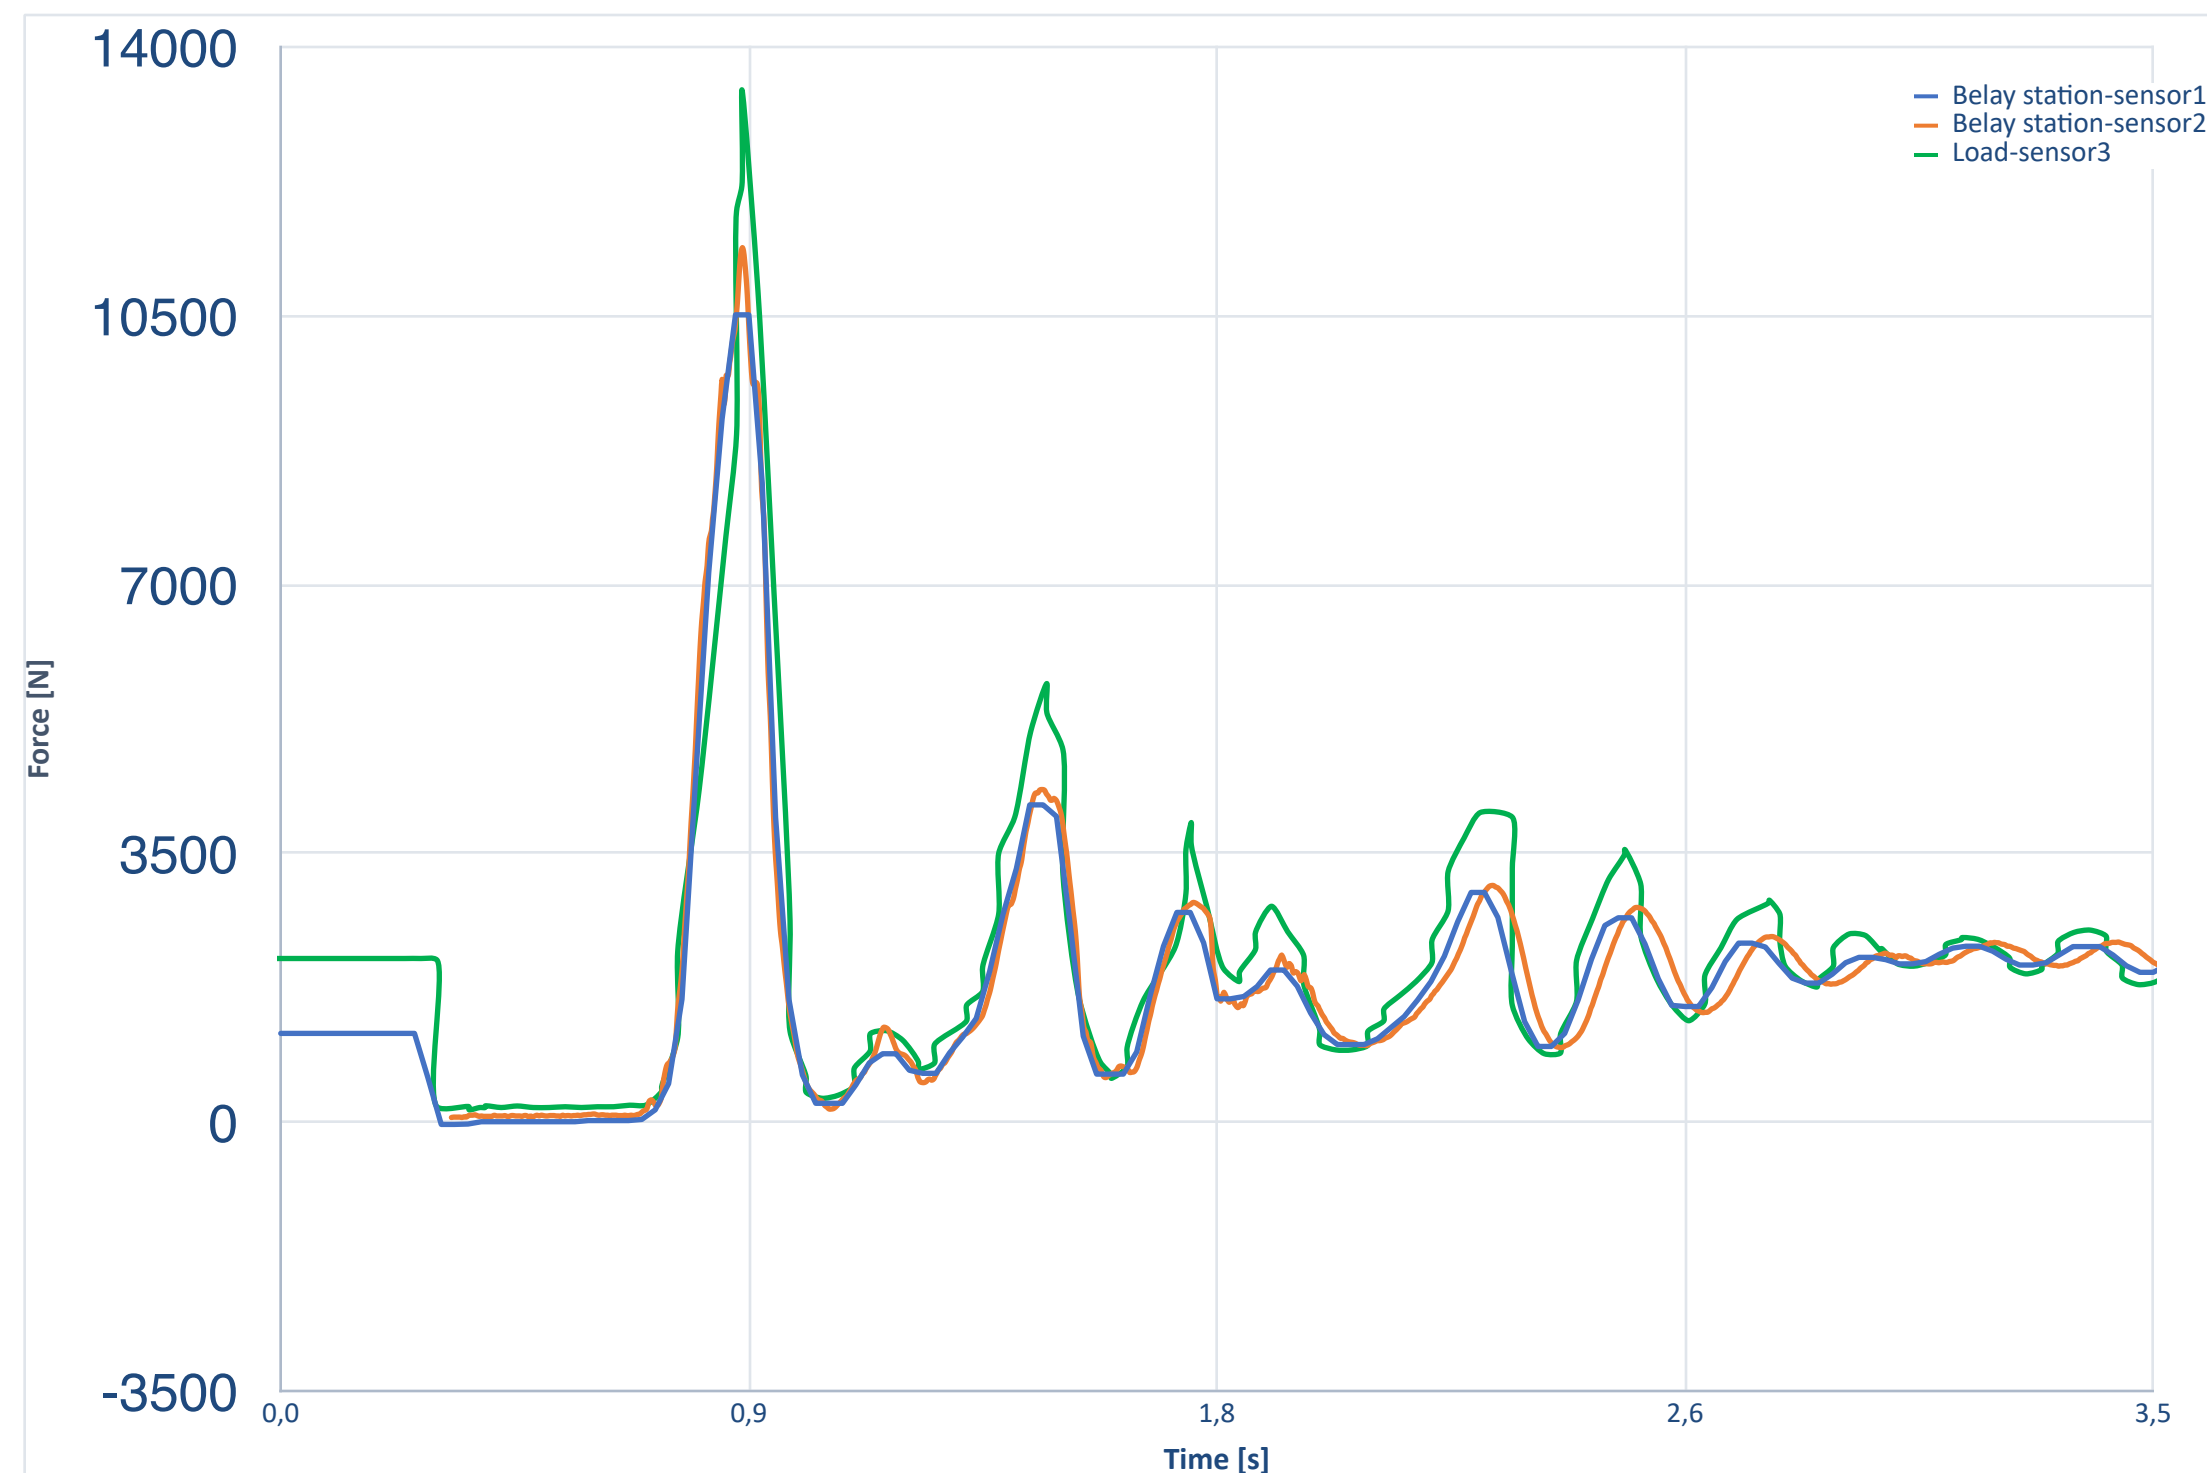
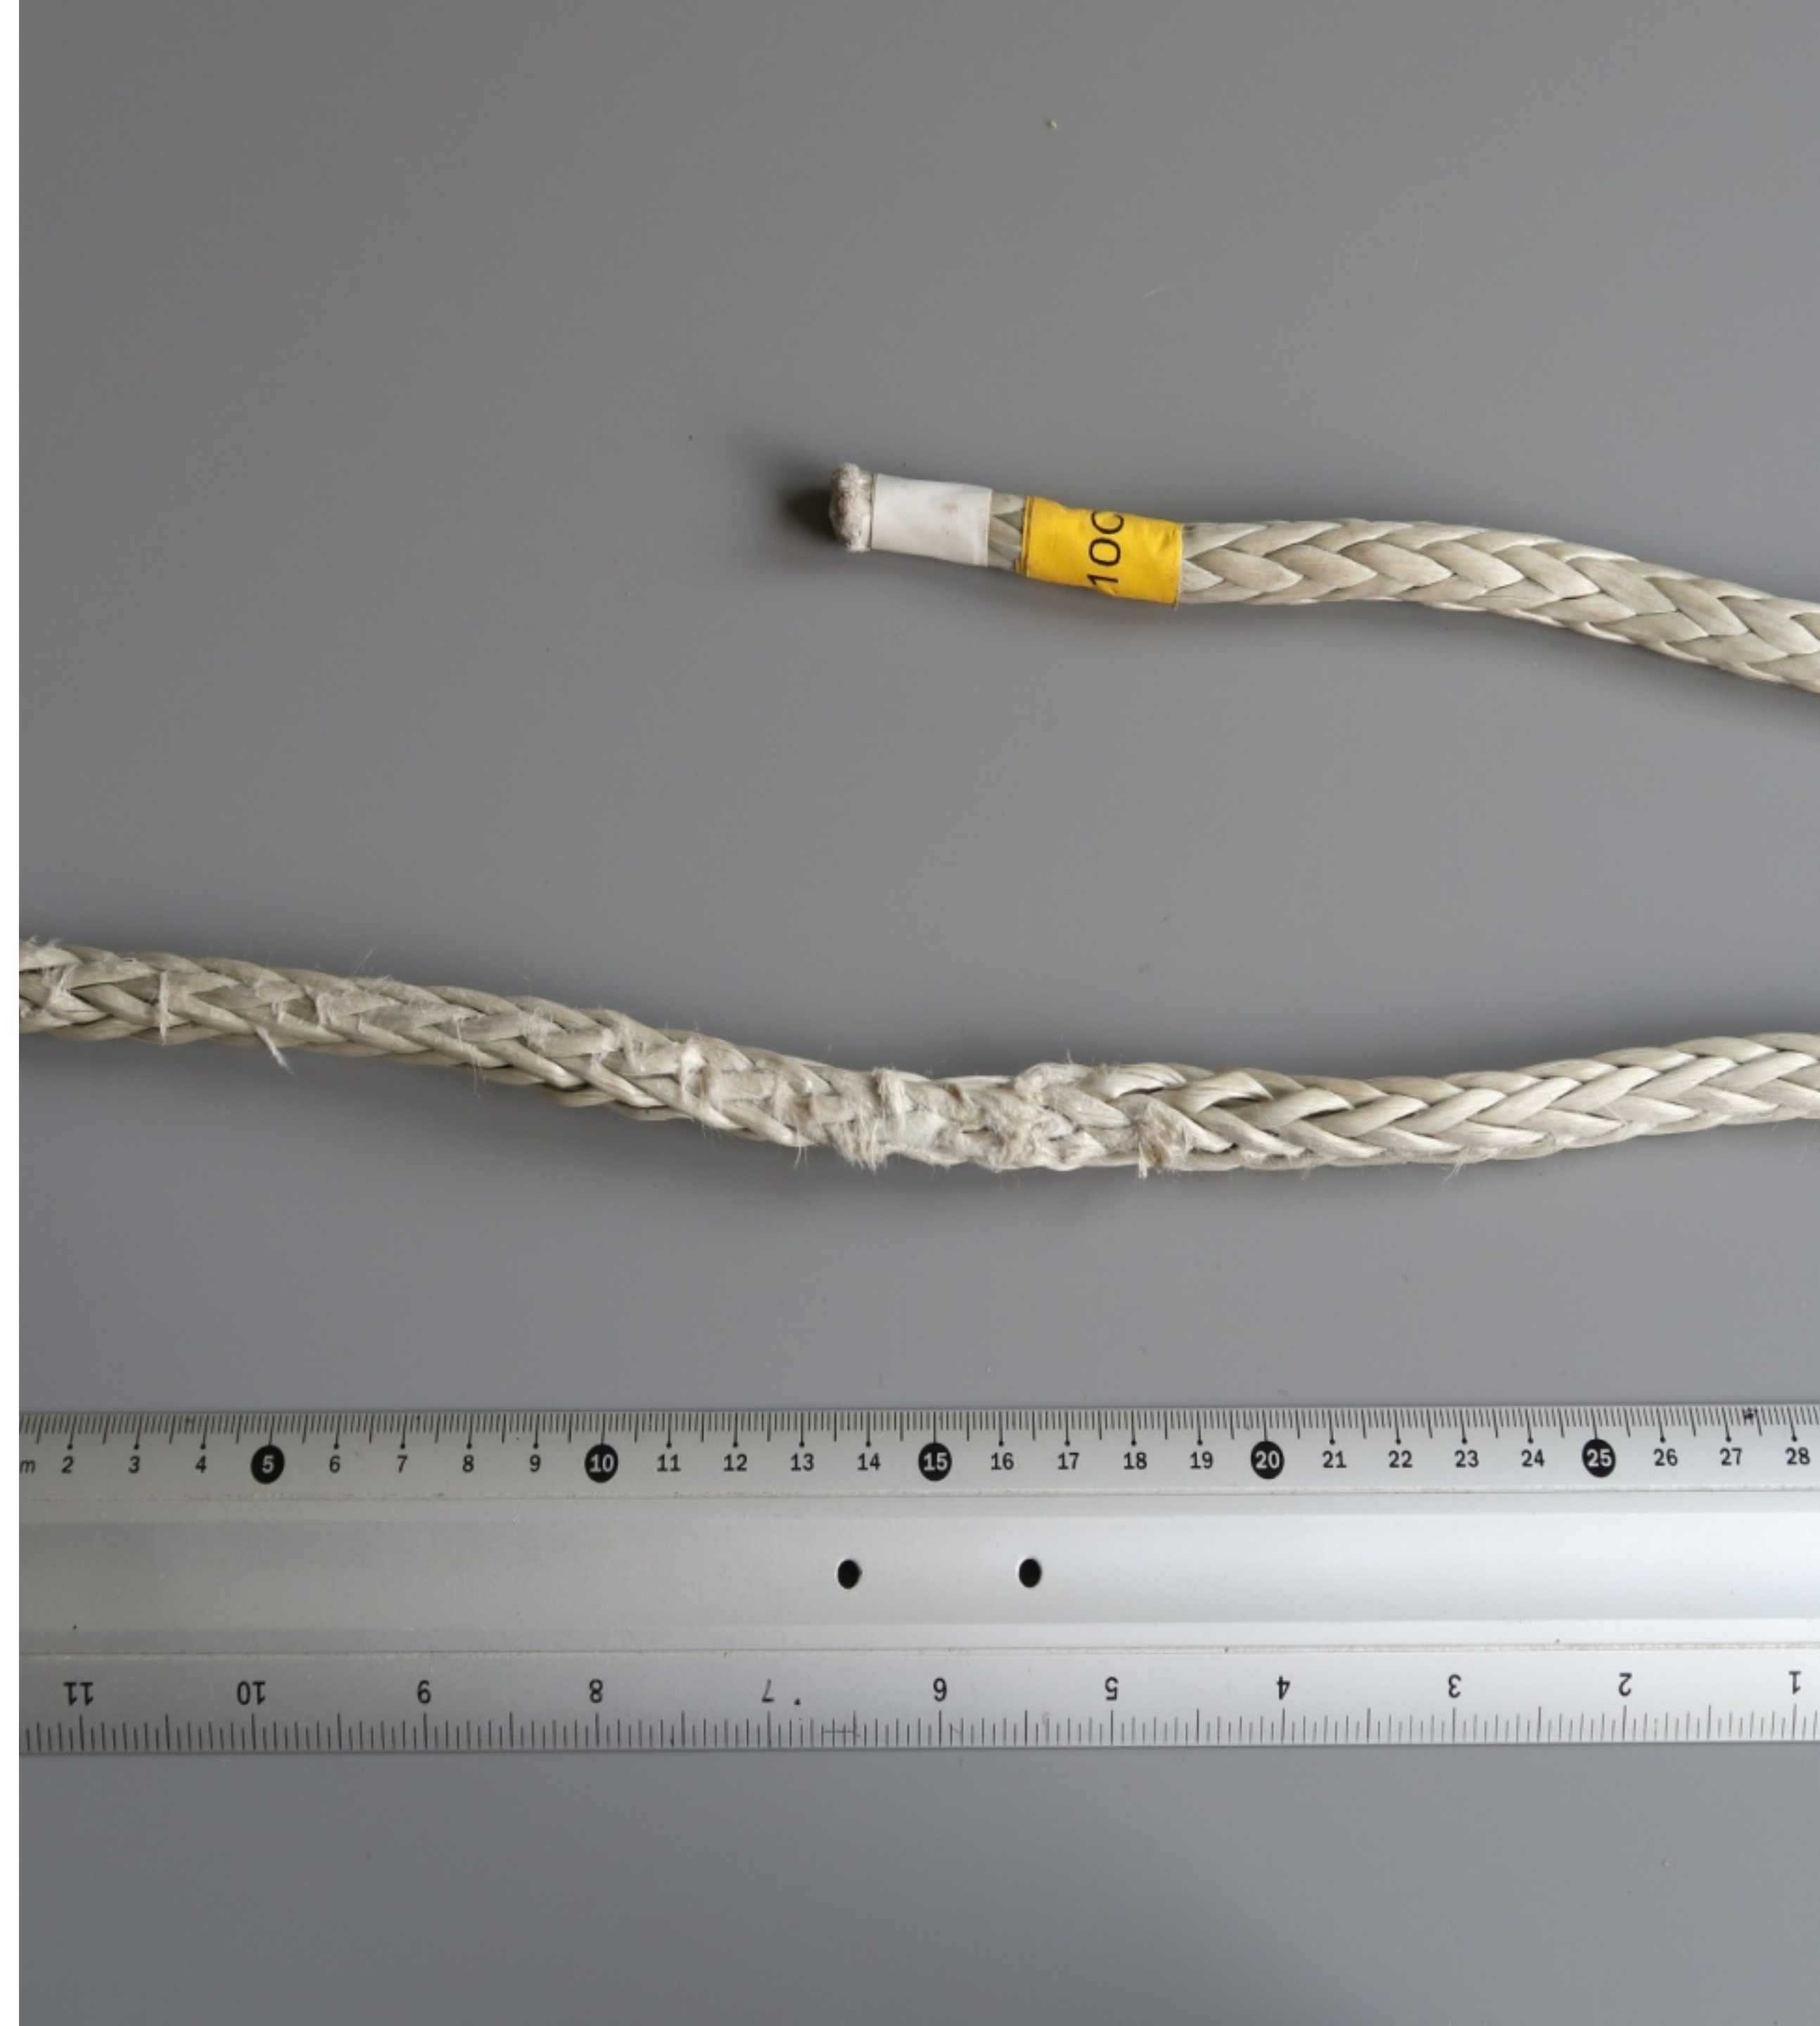
Sharp edge test with a pendulum - rope 10C UHMWPE 8 mm additionally heat treated 200 kg load

- **THE ROPE DID NOT BREAK – sheath damage is very small**
- **Very high impact force!**

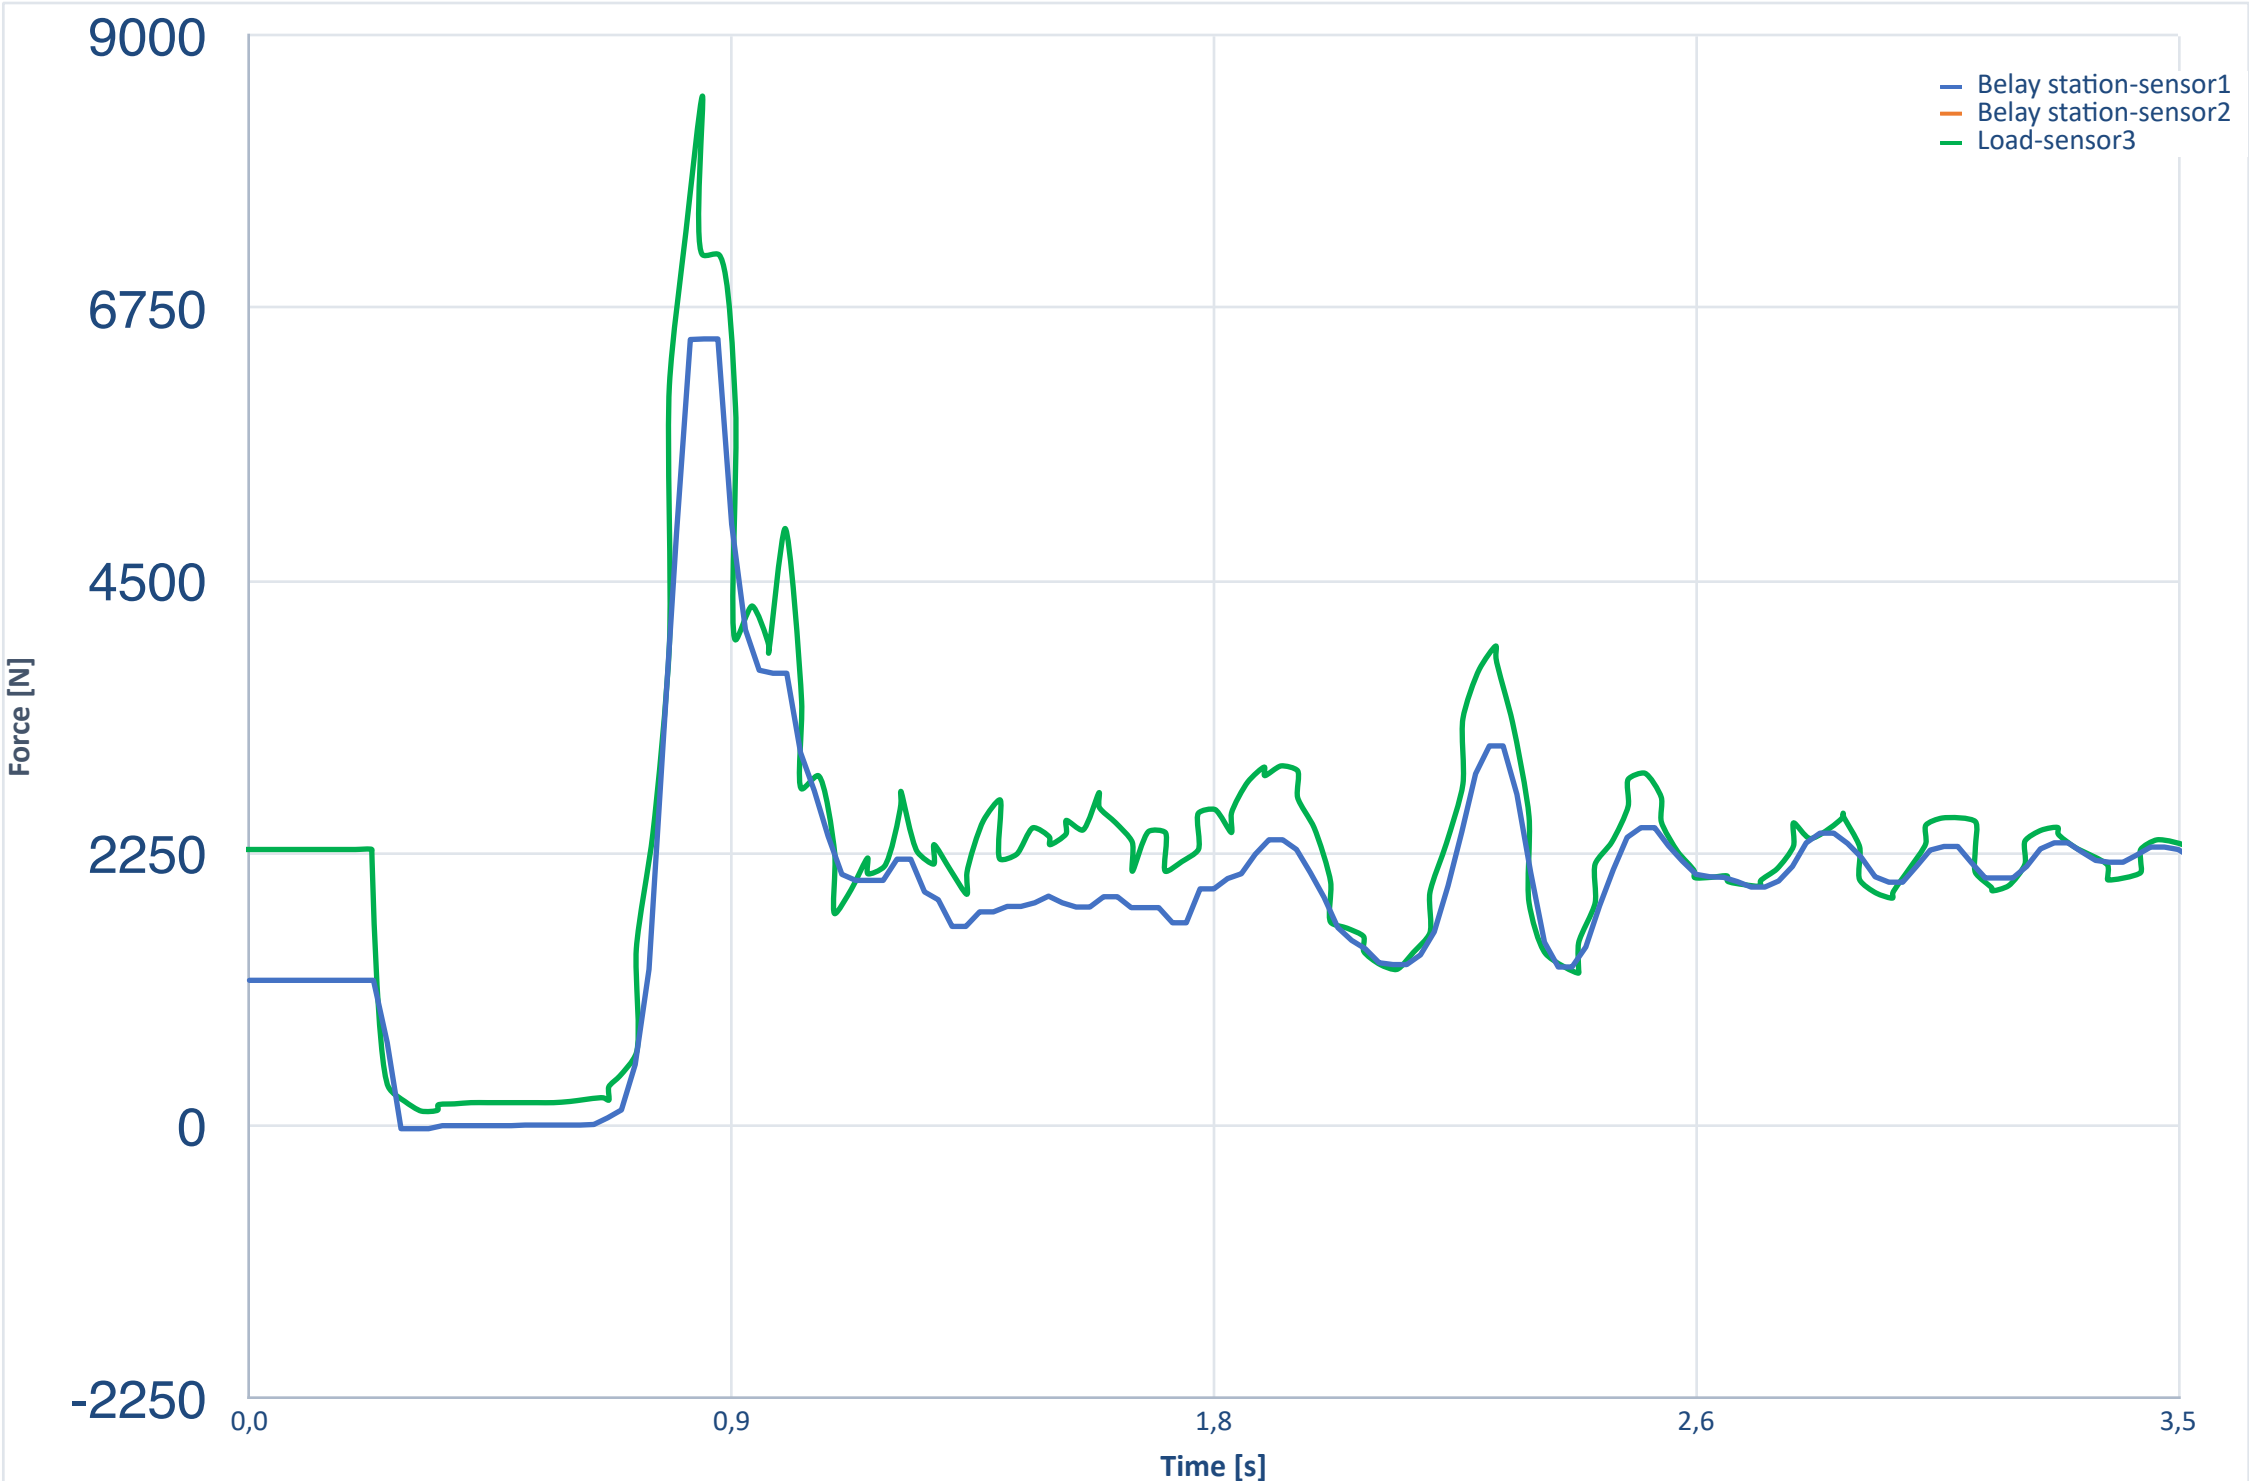
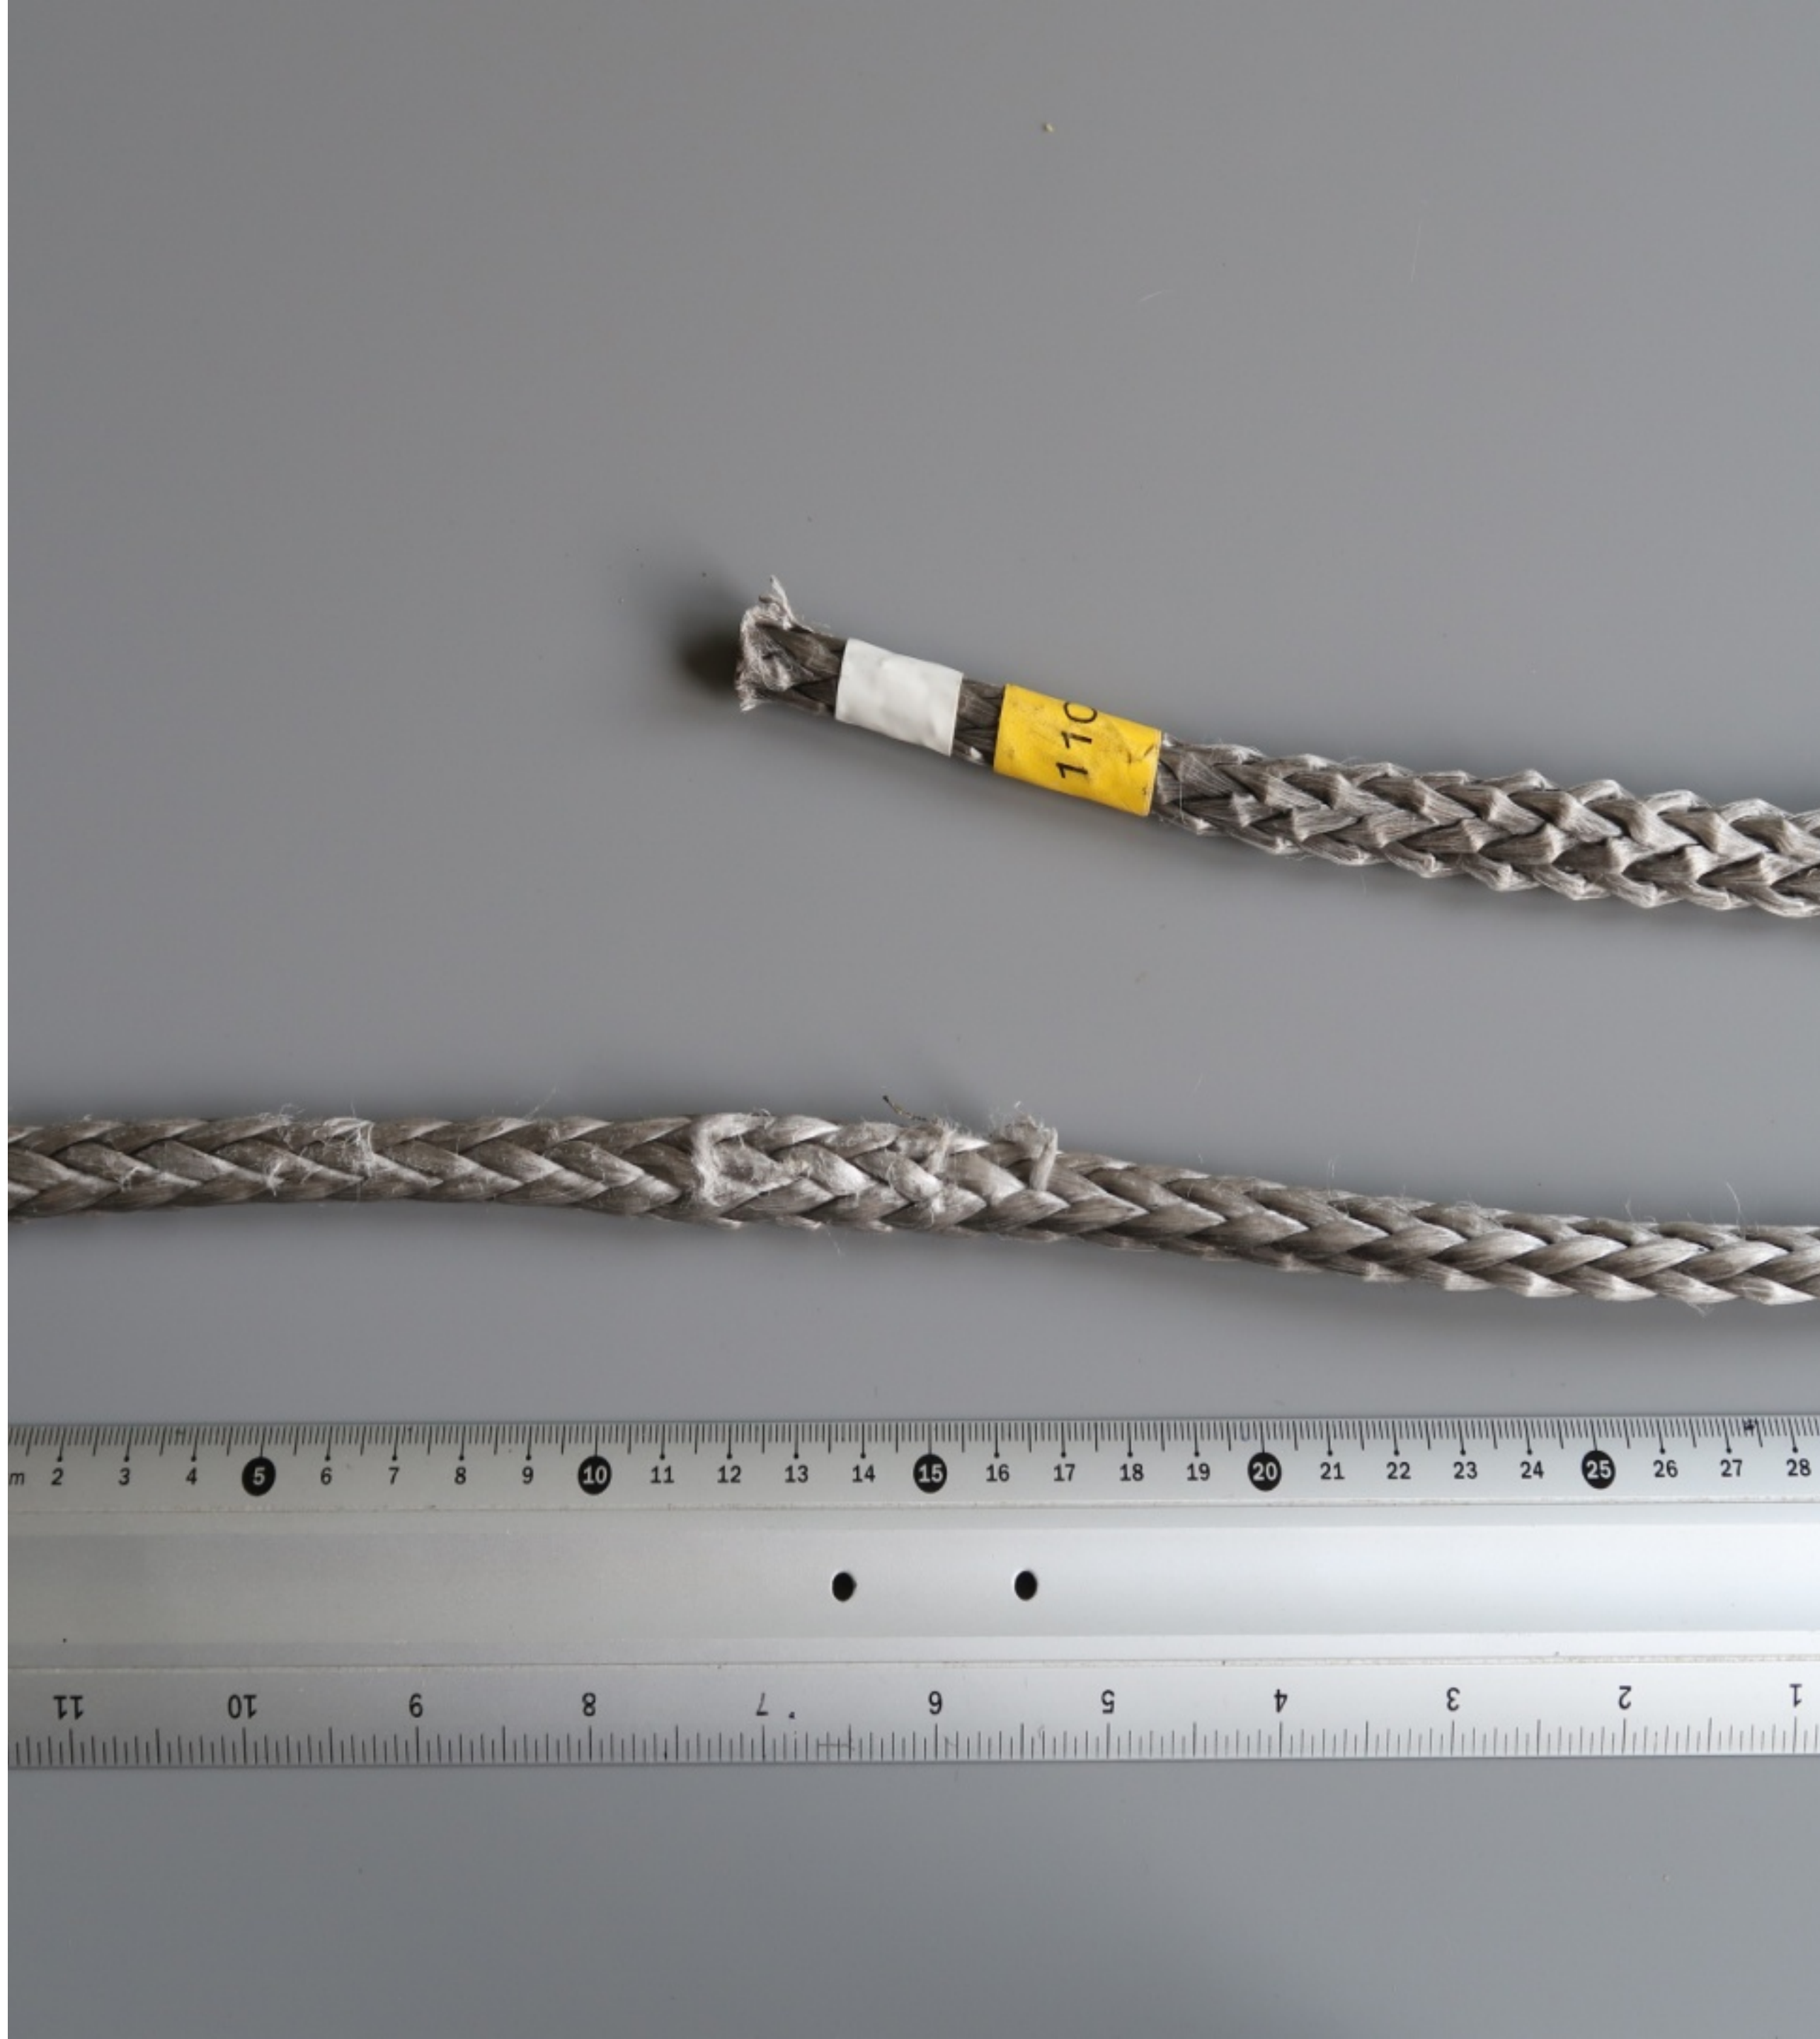
**Sharp edge test with a pendulum - rope 11C
8 mm Dyneema additionally heat treated
200 kg load**

- **THE ROPE DID NOT BREAK – sheath damage is very small**
- **Very high impact force!**
