Dyneema incident on Mt. Świnica

authors: Andrzej Marasek, Witold Cikowski, Marcin Józefowicz, prof. dr hab. inż. Jerzy Zych, mgr inż. Tomasz Snopkiewicz, PhD
Eng. Michał Ciszewski, Andrzej Górka

causes of rope failure

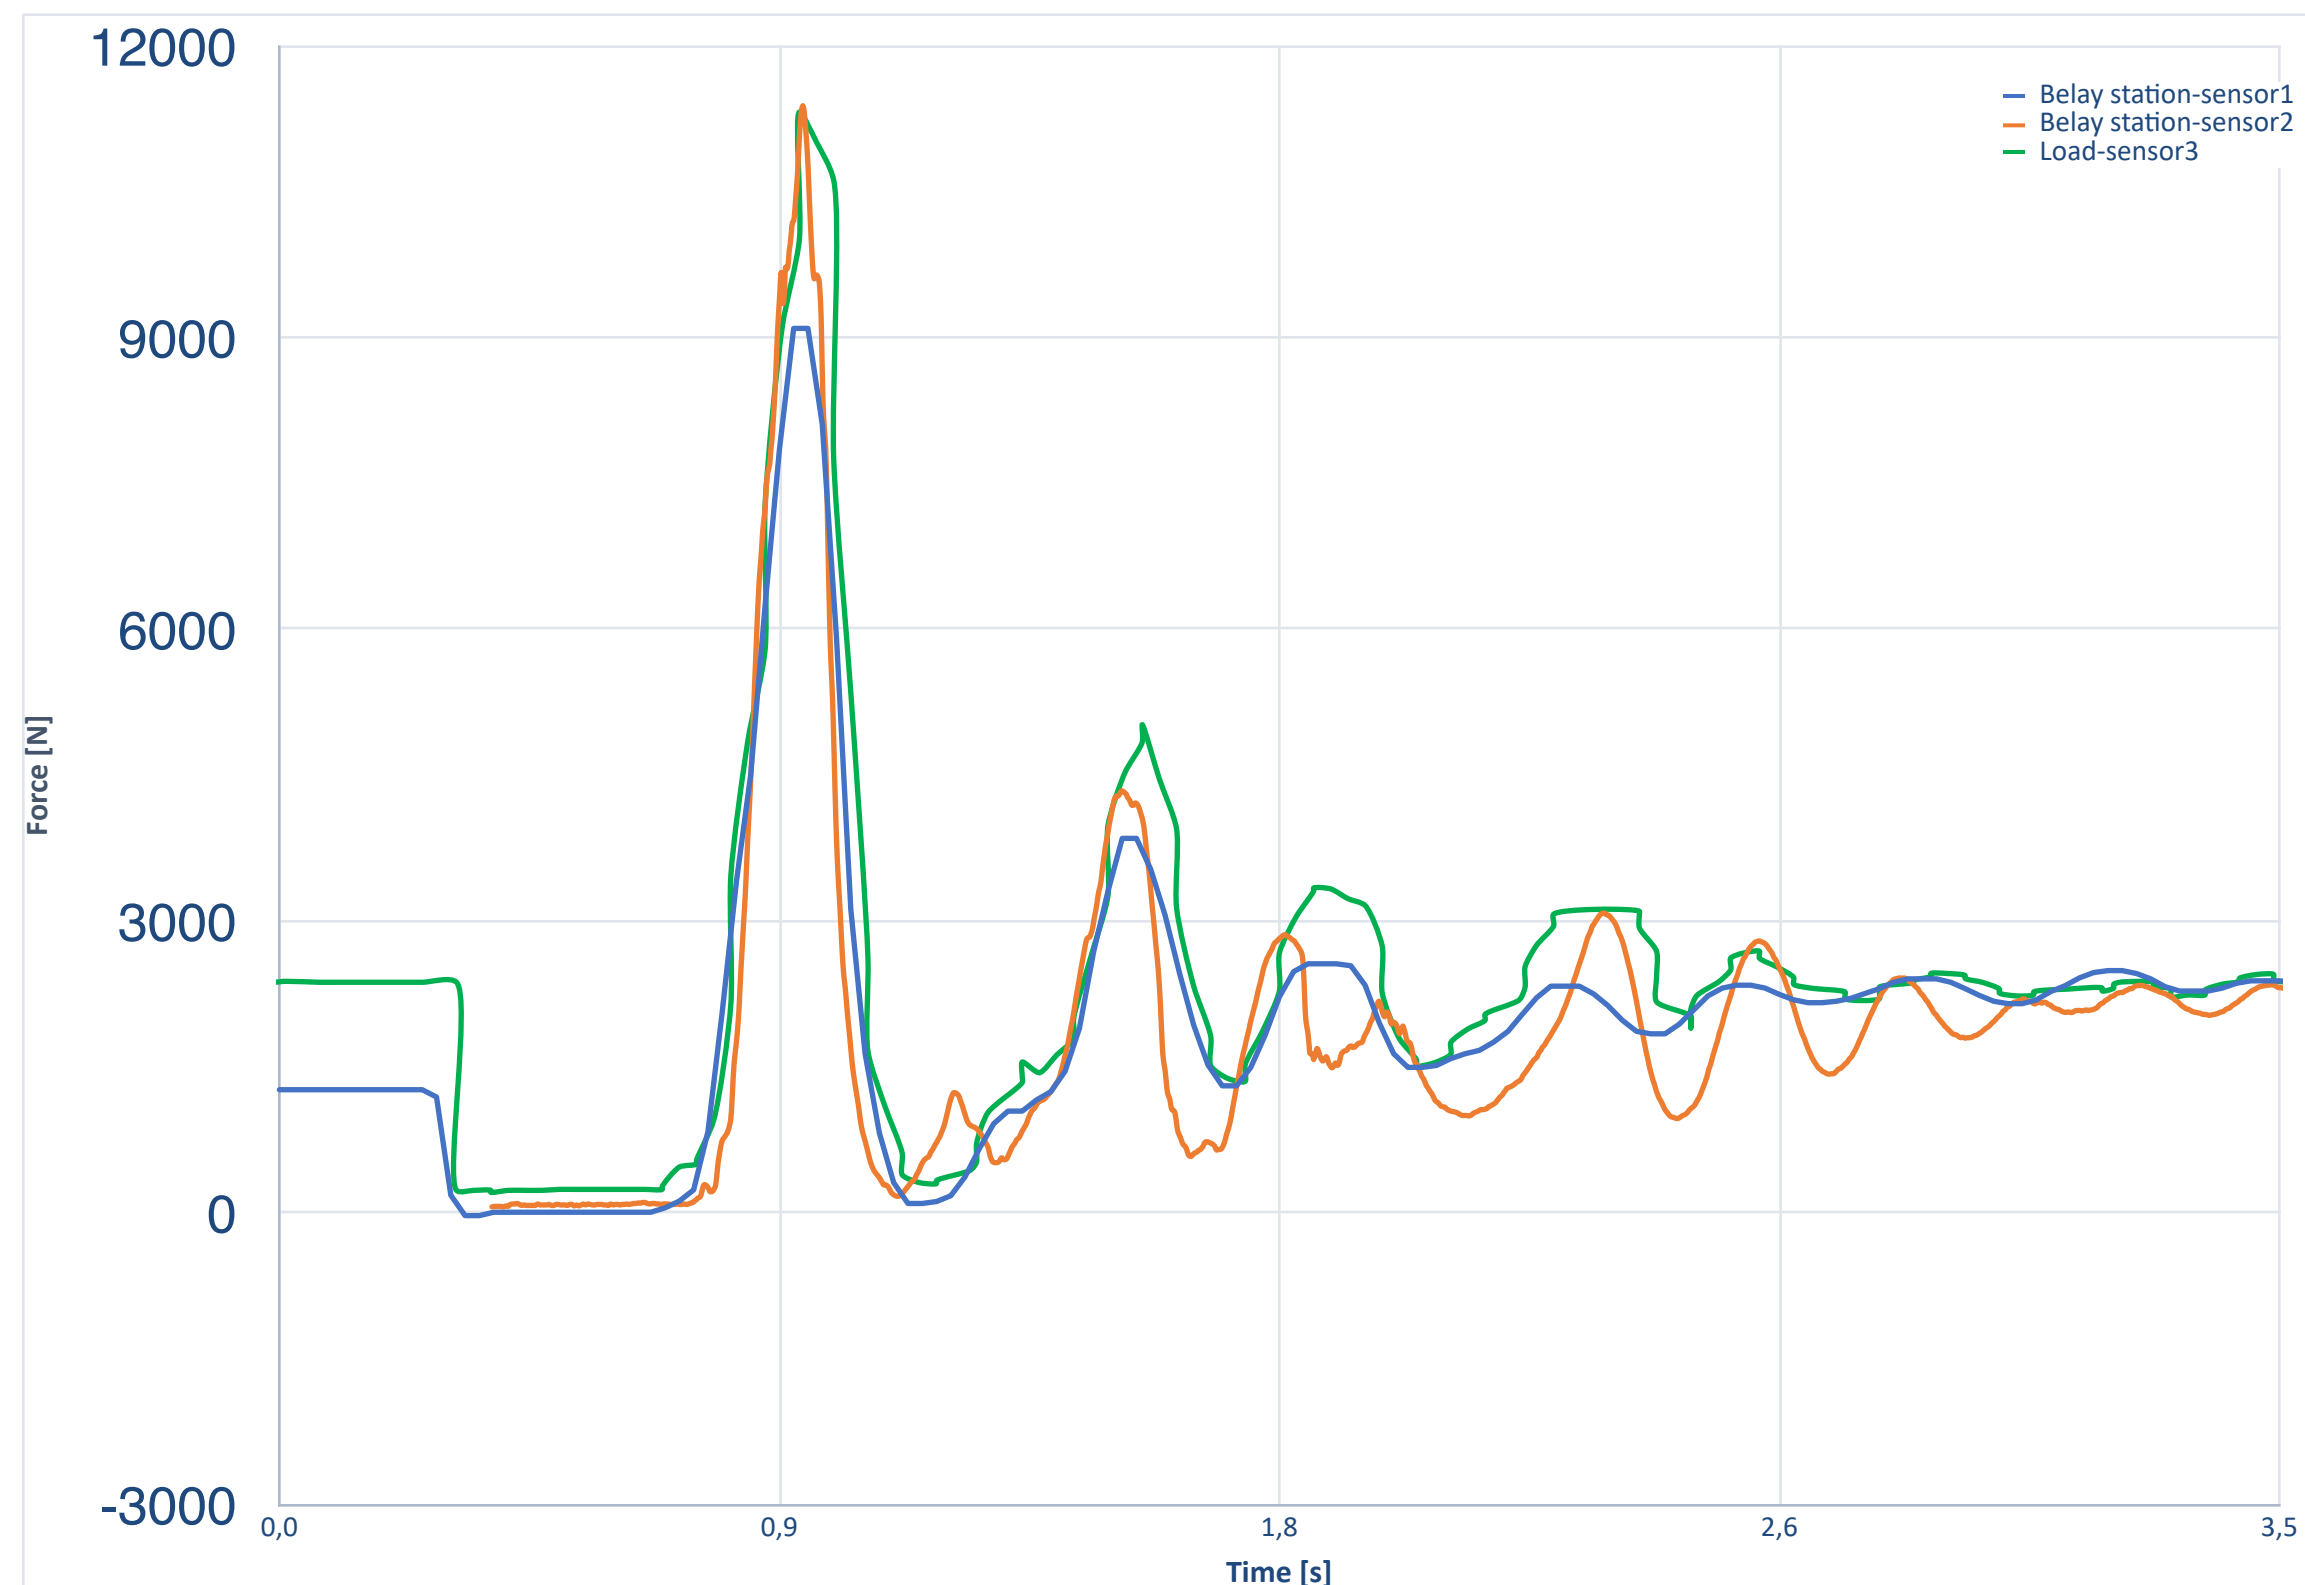
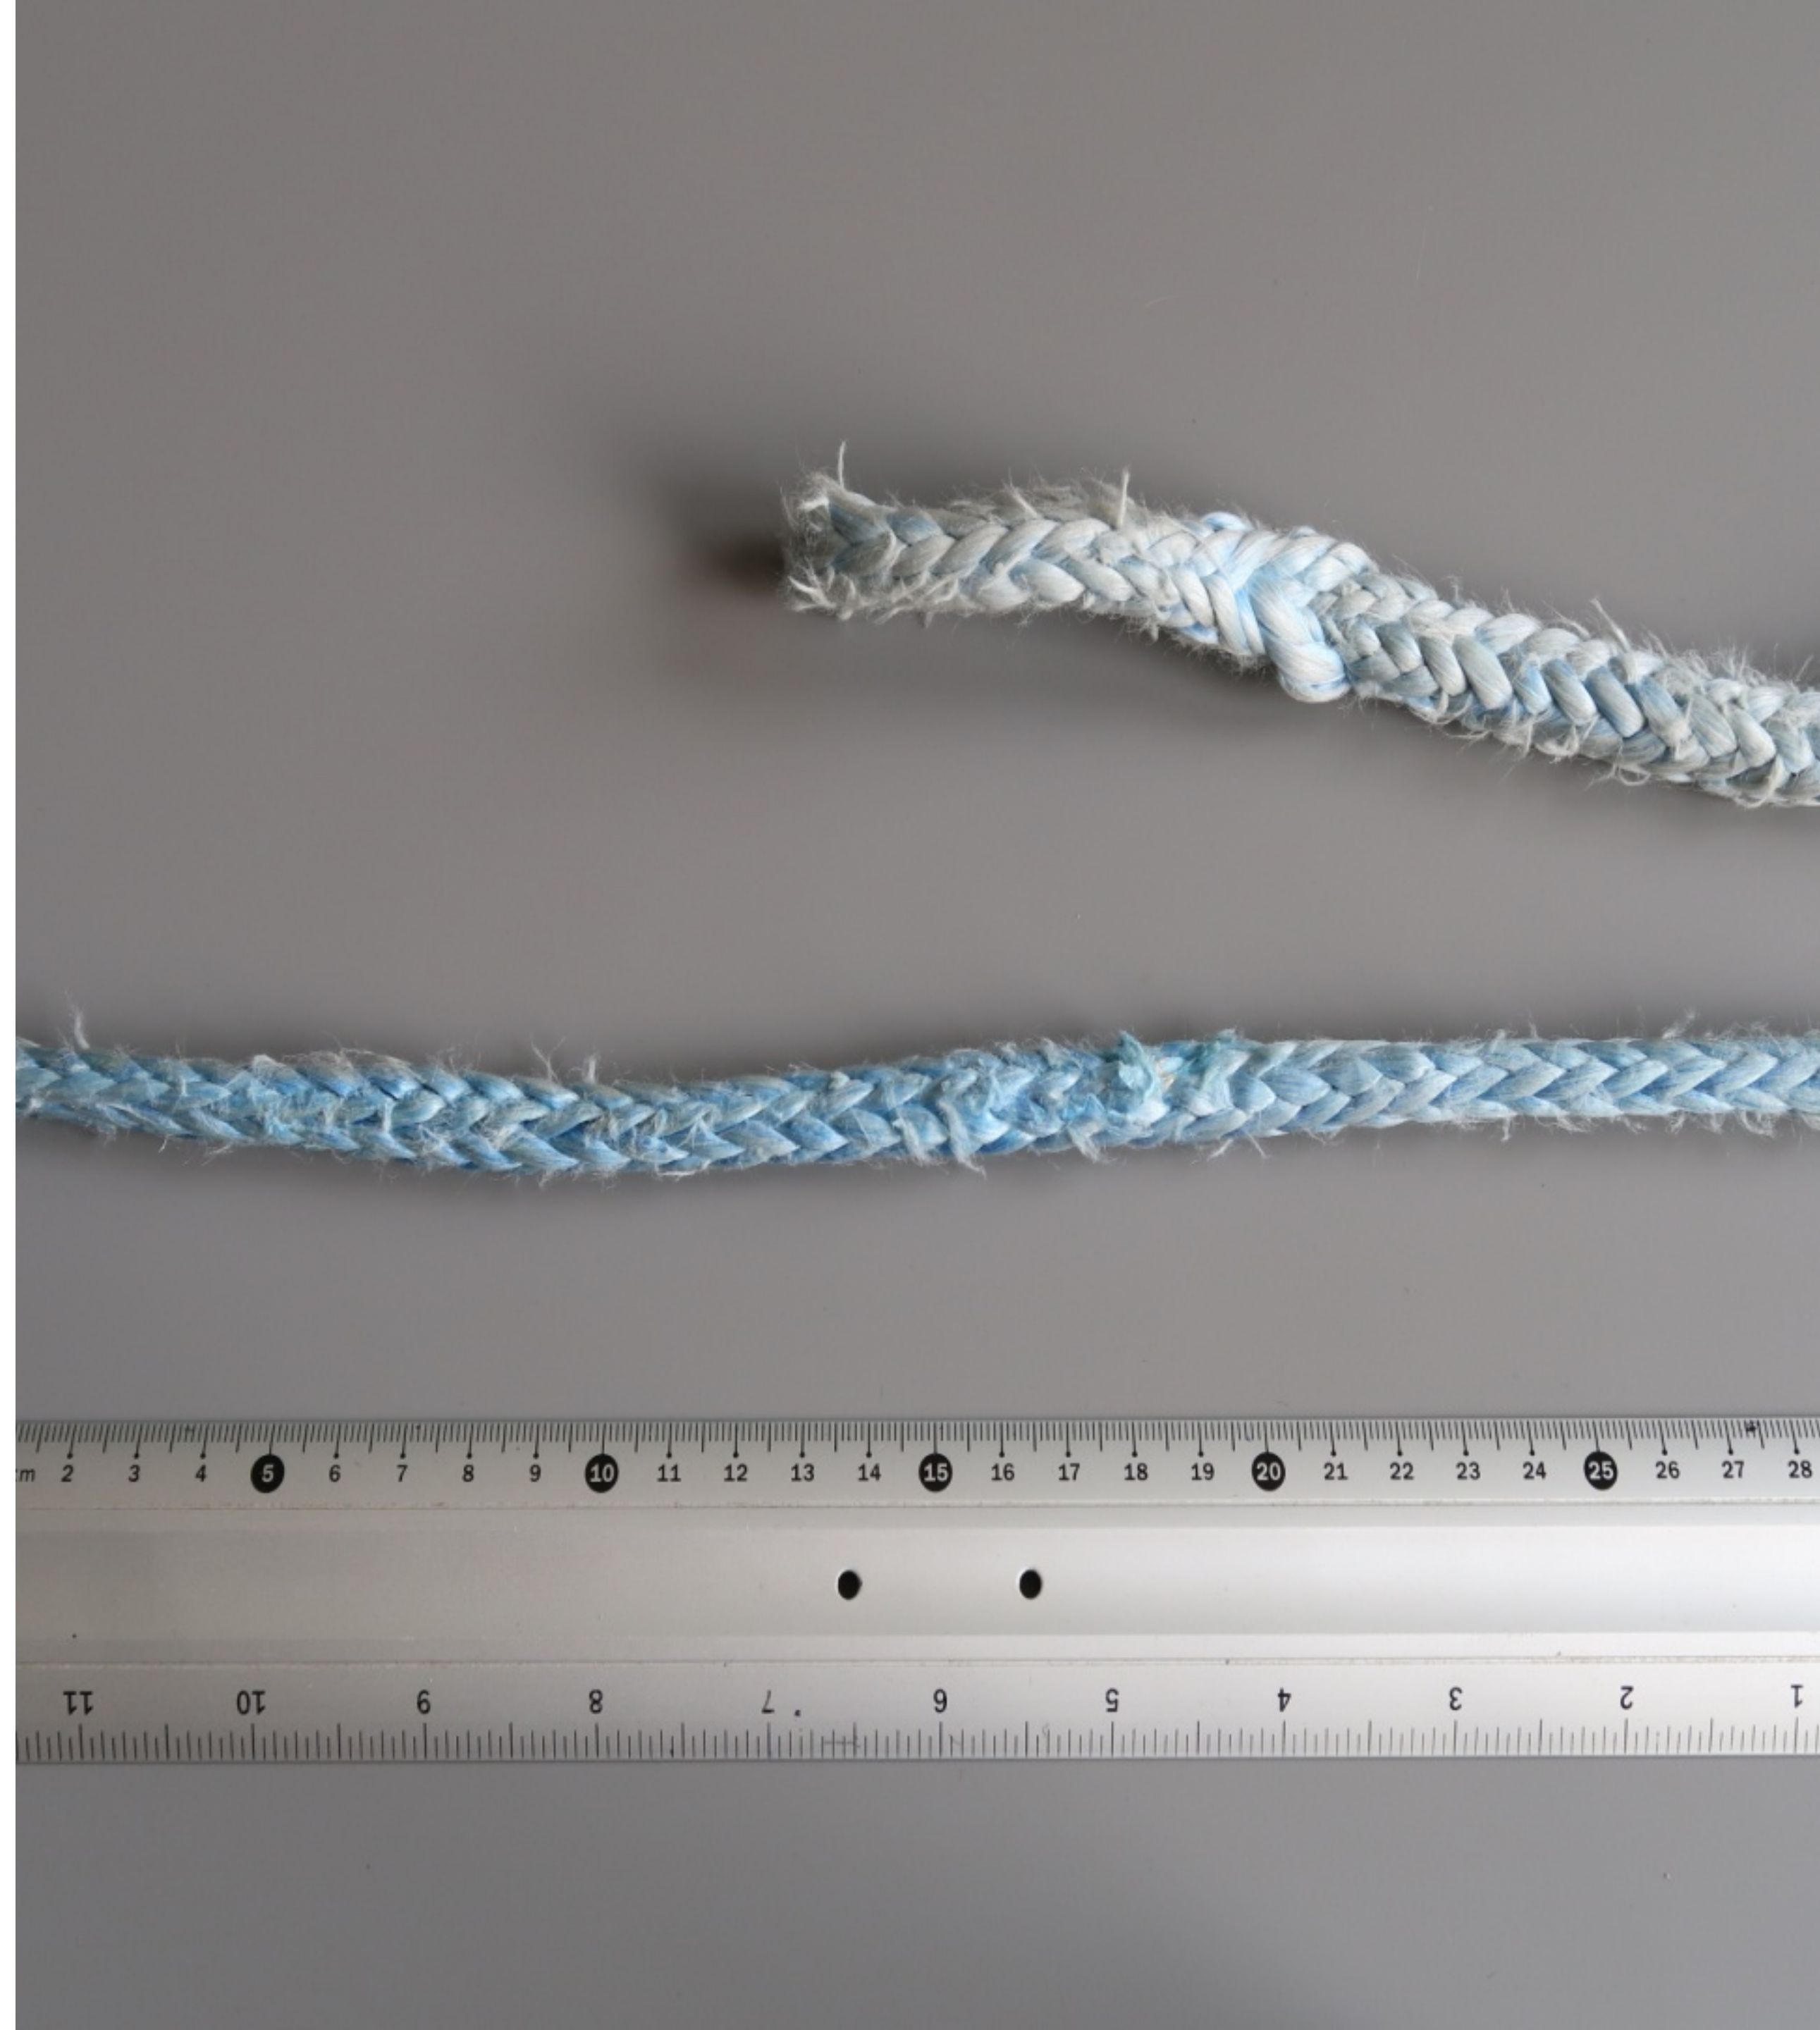
Sharp edge test with a pendulum - rope 12C 8 mm Dyneema - 200 kg load

- **THE ROPE DID NOT BREAK – sheath damage is very small**
- **Very high impact force!**

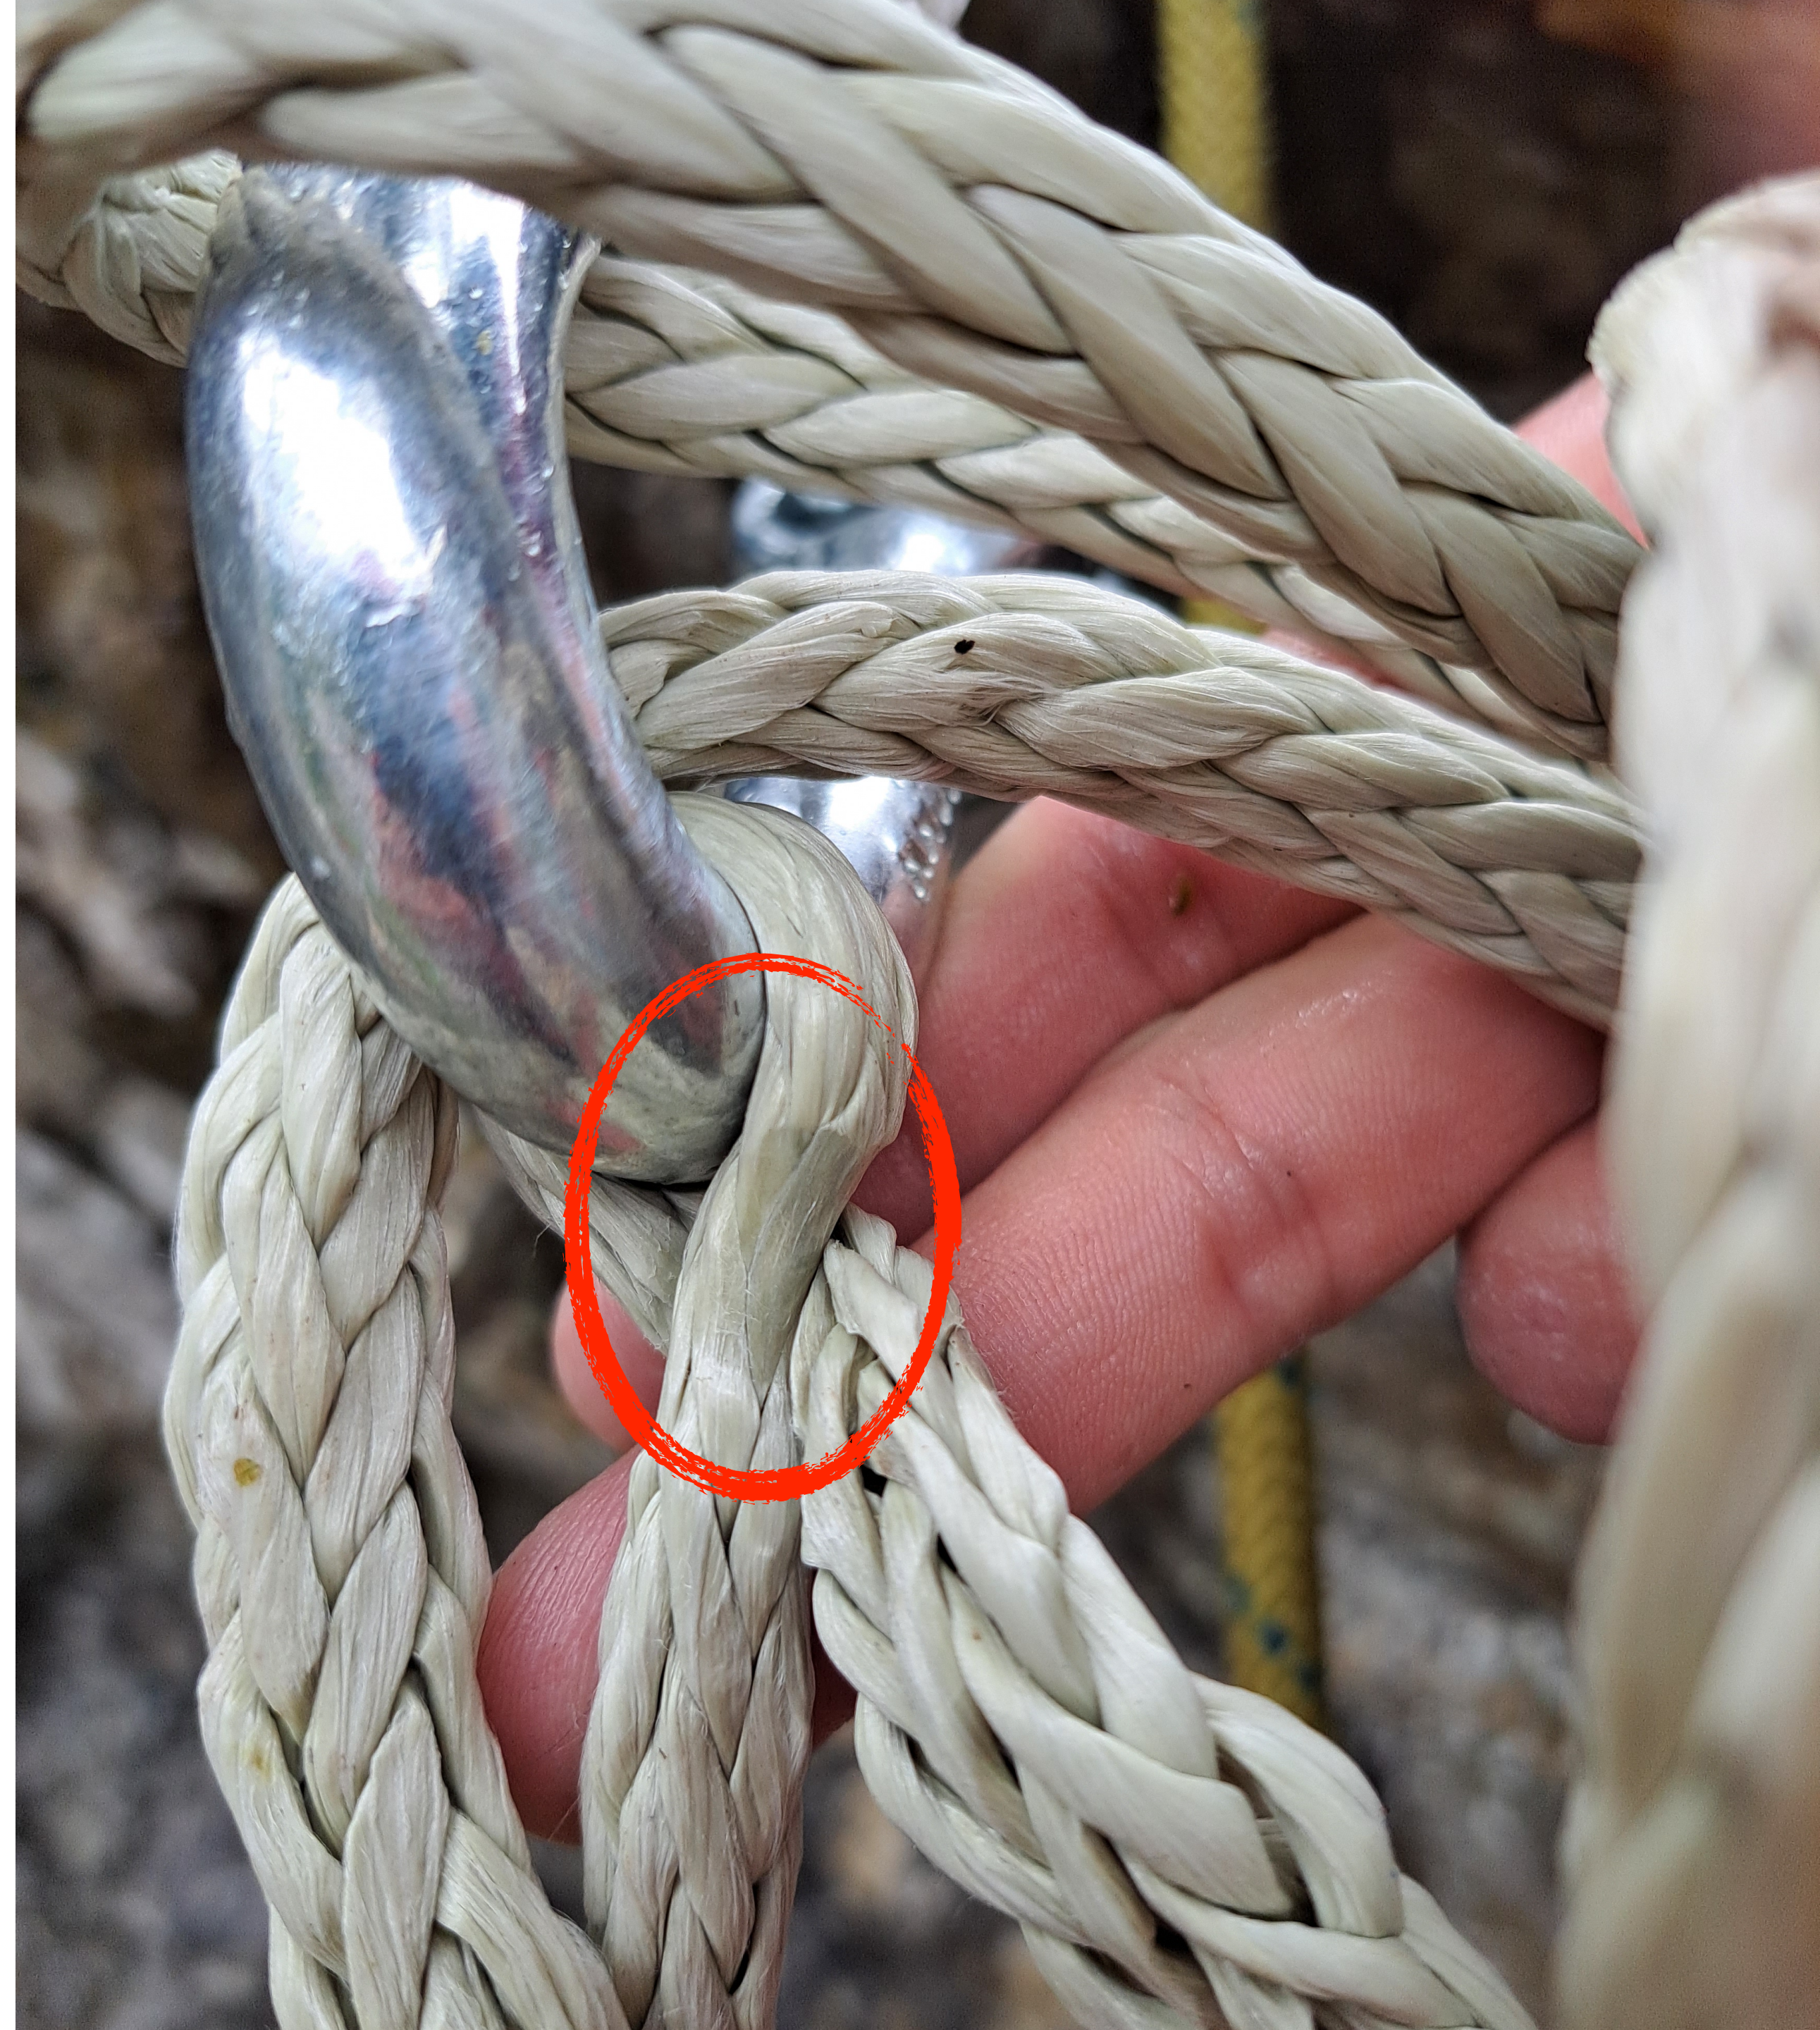
- high impact force causes heat damage to the rope in belay station
