Dyneema incident on Mt. Świnica

authors: Andrzej Marasek, Witold Cikowski, Marcin Józefowicz, prof. dr hab. inż. Jerzy Zych, mgr inż. Tomasz Snopkiewicz, PhD
Eng. Michał Ciszewski, Andrzej Górka

causes of rope failure

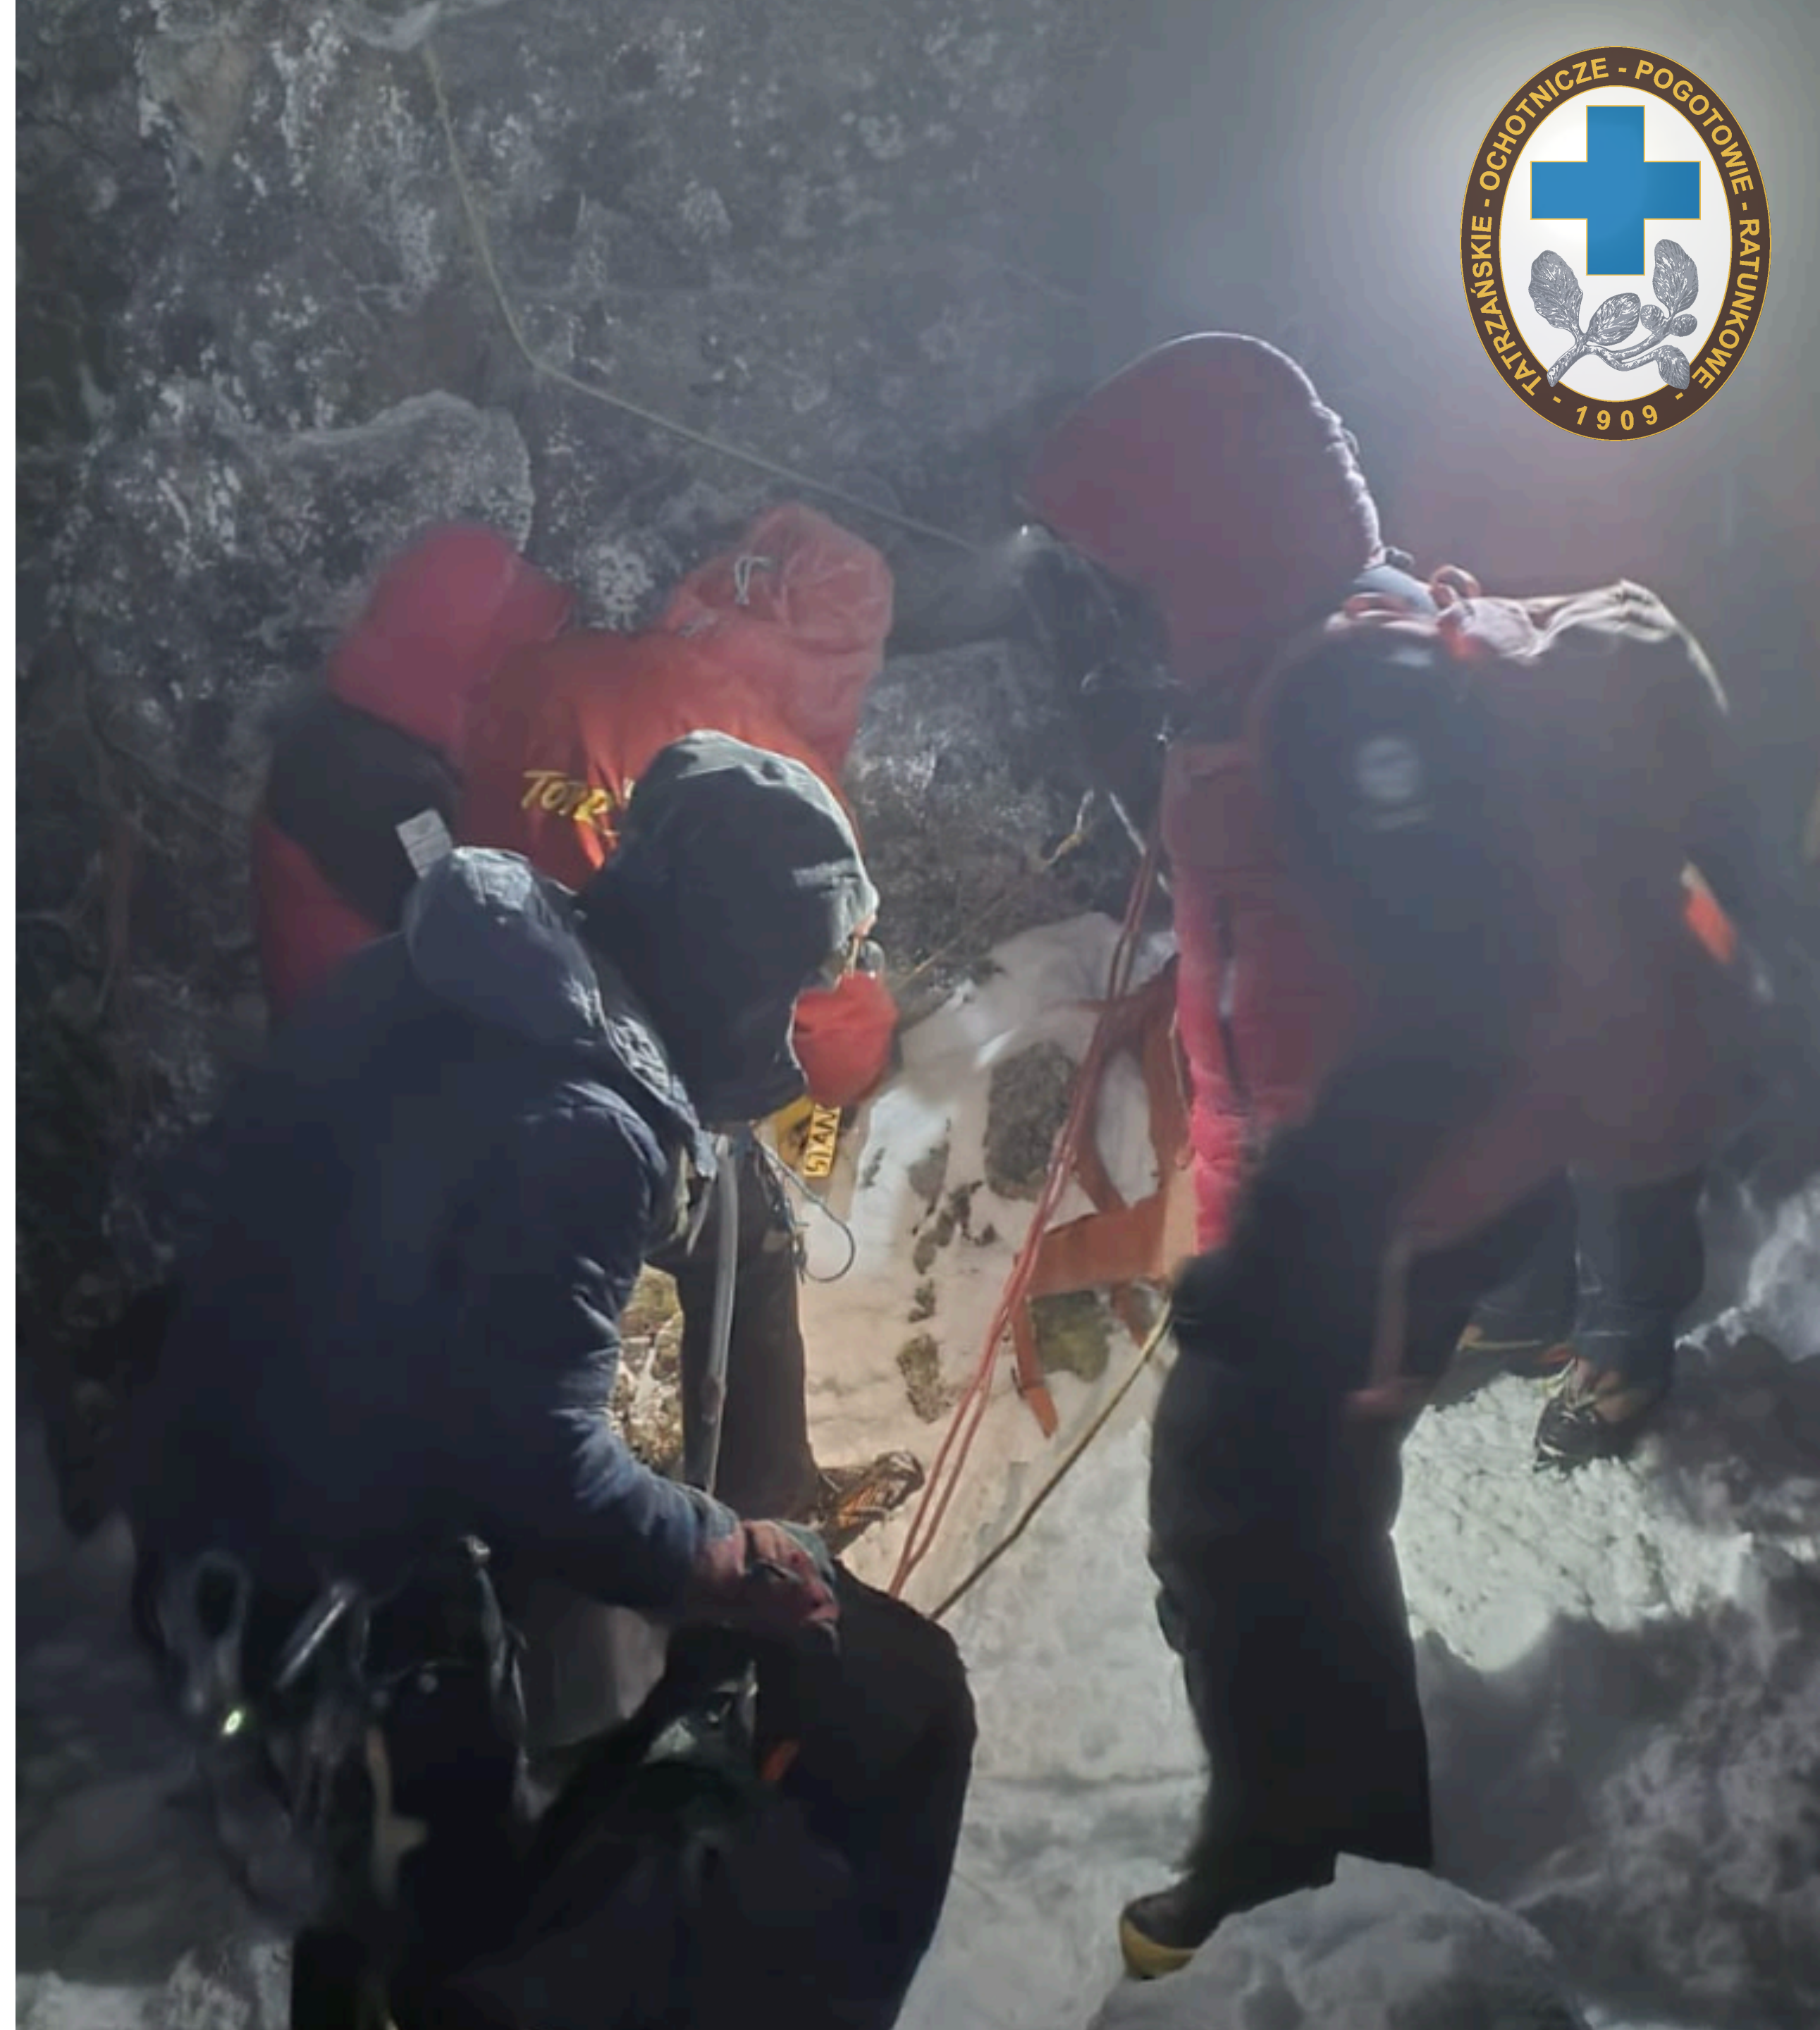
- the distance to the belay station is some 70 meters,
- the rope is being tautened,
- as the climbers are being lifted, and the rescuer is still standing on snow the rope becomes unstuck and brushes on rocks,
- suddenly the blue rope becomes loose, the rescuer reports that the climbers fell some 50 cms,

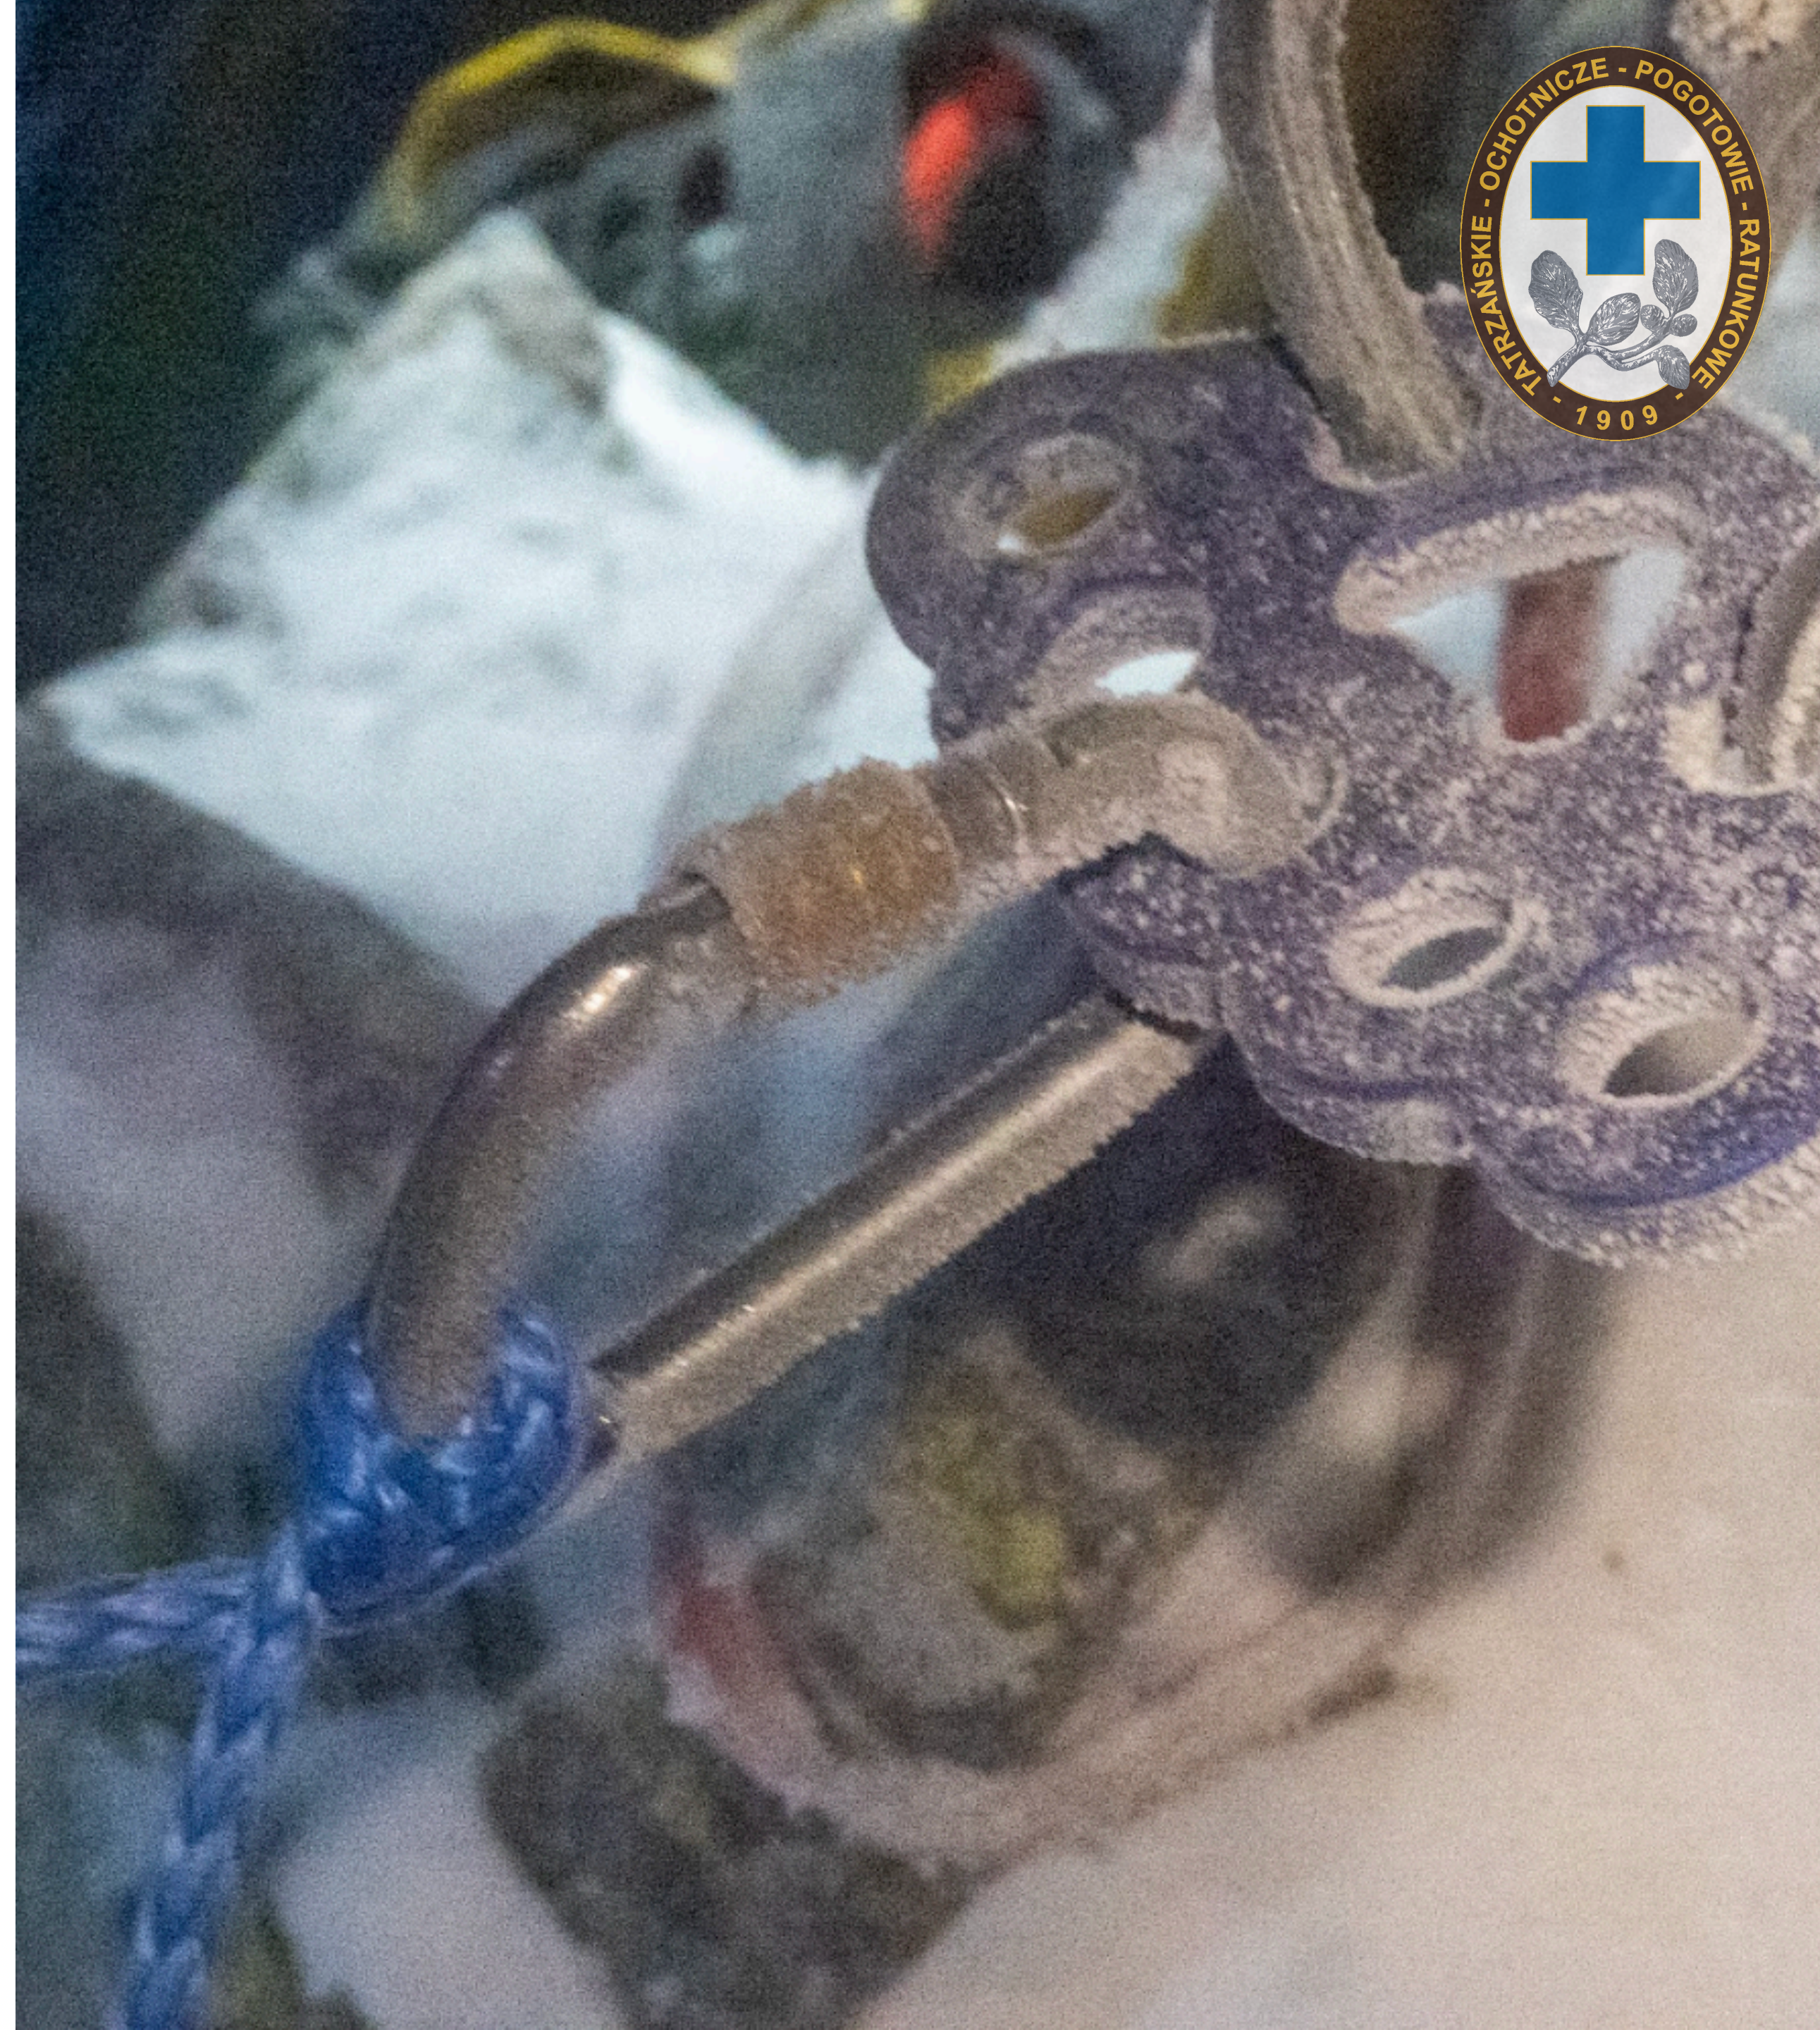
- one of the rescuers on the belay station descends and finds out that the blue rope has been cut, he connects the loose ends of the rope,
- the hoisting scenario is deemed too risky,
- the rescuer and the climbers retreat from the face using electric drill carried by the rescuer and climbers' ropes,
- no avalanche accident occurs,
